Failure analysis of shot–sleeves used in brass high pressure die–casting process

Dorra Abid^a, Ahmed Ktari^{a,b,*}, Dhouha Mellouli^a, Nedja Gafsi^a, Nader Haddar^a

A failure investigation has been conducted on two cases of shot-sleeve used in brass–die casting and made up of AISI H10 tool steels to study their failure mechanisms. The chemical composition of the shot–sleeves material and the hardness profiles were evaluated. A preliminary examination of shot–sleeves reveal the presence of cracks network on their inner surfaces which proves that thermal fatigue was probably the main cause of their failure. A Meticulous investigation of these damaged surfaces reveal the presence of an additional small zone cited in the vicinity of the plunger entry side. This zone presents several scratches sign of abrasive wear. Then, the measurement of the cracks length and their linear density along longitudinal and transversal cuts of the damaged shot–sleeve sample are carried out. Results show that the observed cracks network can be divided into two zones. The first one was the most damaged in terms of cracks density and length given that it is the first zone which enter in contact with the mo

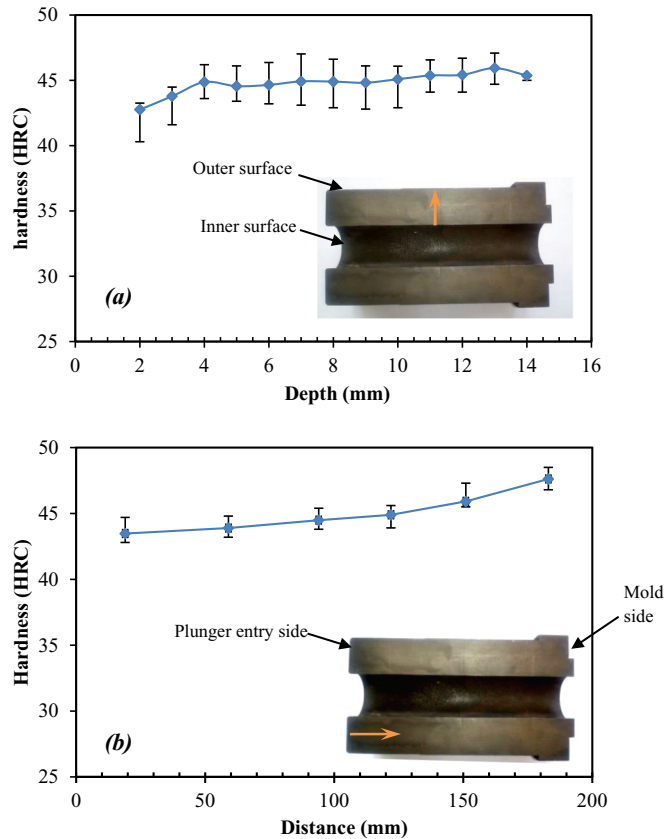
Fig. 7. Hardness shot-sleeve profiles, (a) from the entry to the mold zones, (b) from inner to the outer surfaces.

The hardness profiles were measured, on a shot-sleeve longitudinal section (Fig. 6 (b)) polished until mirror state, from the entry plunger zone to the mold side and from the inner to the outer surface (Fig. 7). These profiles are performed with a Vickers hardness machine using a load of 15 kg. The measured profiles reveal that the hardness appears to be constant for all tested samples.

average of measured hardness is about of $44.8_{-2.4}^{+3.8}$ HRC. This shows that the hardness was remained quasi-constant even after a few thousands of thermal heating and cooling phases (more than 74,000 cycles) and which indicate that the mechanical behaviour of the material is stable (i.e. absence of significant cyclic hardening or softening) under service conditions. Furthermore, micro-hardness measurements were performed with a Wilson hardness machine 402MVD using a load of 1 kg at a distance of approximately 400 μ m from the inner surface. The average of measured micro-hardness is about $49.8_{-6.4}^{+5.5}$ HRC. This result proves that is no significant increase of the hardness from the heart to the inner surface of the shot-sleeve.

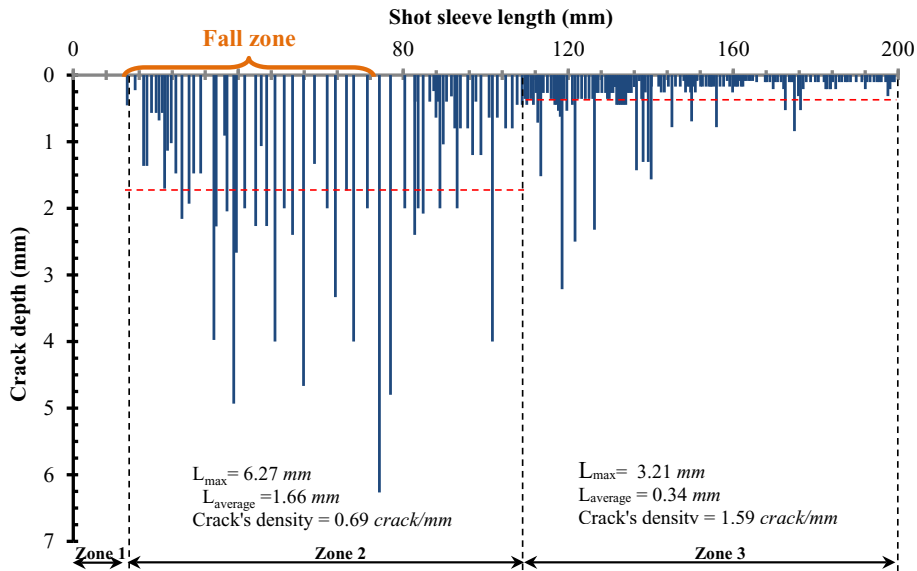
Fig. 10. Crack lengths distribution along the shot sleeve (longitudinal section $\theta = 0$).

In this section, a meticulous investigation on the cracks distribution and density was performed by means of longitudinal and transversal observations (Figs. 10 and 11). The cracks depth according to the axial distance was presented in Fig. 10. It is to be noted that the cracks depth trend along the shot-sleeve follows the Gaussian distribution. Fig. 10 shows that the cracks depth is maximal around the zone 2, which corresponds to the casting zone (fall zone). This zone is characterized by a maximum crack length and average values of 6.23mm and 1.66mm respectively. In zone 3 the cracks deep is less than those observed in zone 2 nevertheless their density is more pronounced (*i.e.* $1.59\text{crack}/\text{mm}$ in zone 3 against $0.69\text{crack}/\text{mm}$ in zone 2). The presence of the shielding effect between neighbouring cracks existing in zone 2 cause the propagation slows down of the smaller cracks and only a few of the biggest ones continue to propagate. Such a phenomenon was observed in many applications in which the thermal fatigue was the main cause of damage [19–20,28].

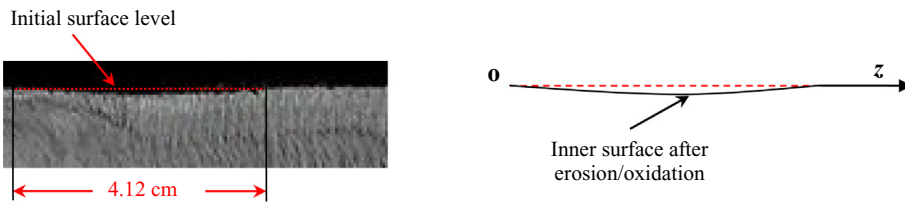
Fig. 12. Oxidation / erosion effect in the fall zone (Zone 2) of the shot-sleeve.

The initial level of the shot–sleeve casting zone (cited in zone 2) was decreased probably due to oxidation and erosion effects as shown in Fig. 12. The cracks situated surroundings the shot–sleeve centre (near $\theta = 0^\circ$) are in reality longer compared to their effective length due to the small decrease of the shot sleeve inner surface level produced after the oxidation / erosion effect. Others micro cracks are totally removed what favoured the propagation of persistent cracks because the motive force was located in them, is confirmed by previous research [1,29].
