# Detection and evaluation of barely visible impact damage in woven glass fabric reinforced polyamide 6.6/6 composite using ultrasonic imaging, X-ray tomography and optical profilometry

## Abstract

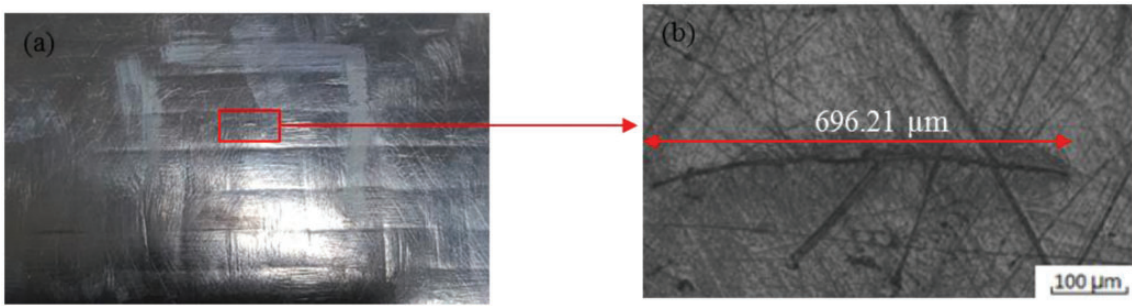
**Figure 12.** Images of the micro crack seen on the back of the plate damaged at 13.45 J: (a) naked eye observation (b) image obtained using an optical microscope.

The first observed damage stage is on the specimen impacted at an energy level of 13.45 J. This damage appeared as a small opening on the non-impacted side, barely visible to the naked eye. To investigate the small damage closely on the plate impacted at 13.45 J, an observation using the optical microscope is performed. Figure 12 exhibits the obtained images of the superficial damage with a dimension of 696.21  $\mu\text{m}$ . However, on the samples impacted at 15.28 J and 17.60 J, cracks propagating longitudinally and transversely leading to fibre breakage are easily observed (Figure 13).

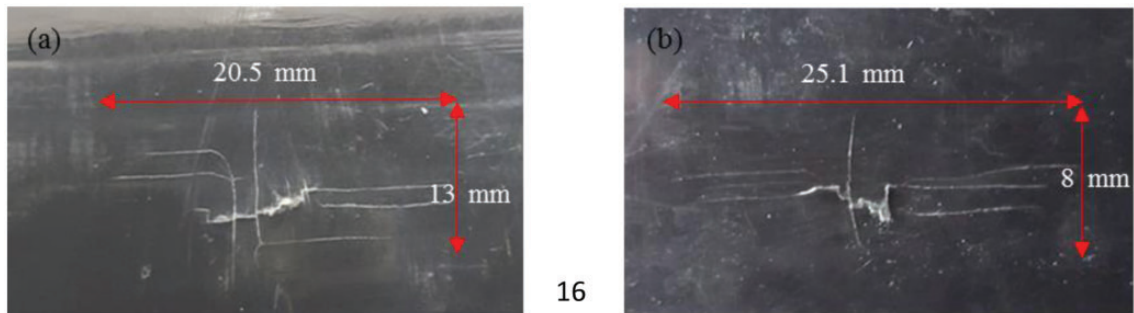
After the impact tests, no visible damage is observed on the specimen loaded at an energy level of 7.30 J. However, on the three other specimens, damage appearing on the non-impacted surface could be observed by the naked eye. It should be mentioned that all damage observed during this study occur on the non-impacted side of the specimens. Indeed, based on the literature (Abrat, 1998) for the case of thin plates, the damage is initiated on the bottom layer and propagate in a pine tree path caused by the bending stress and waves propagation.

**Figure 13.** Dimensions of the damage occurring on the impacted samples loaded at energy of (a) 15.28 J and (b) 17.60 J observed by naked eye.

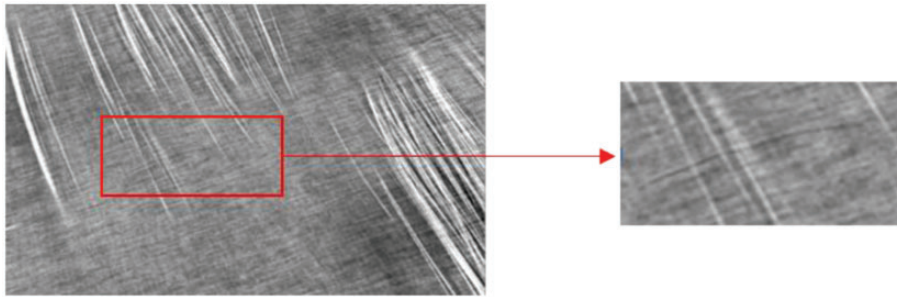
Several damage phenomena are observed on the 3D reconstruction. The severity of the damage grows at increased impact energy. On the plate impacted at 7.30 J, no damage is observed. Indeed, impact energy of the magnitude of 7.30 J appears to be not sufficient for bring about a permanent internal damage in the material. Figures 14 to 16 represent the images resulting from X-Ray tomography inspection for each impacted sample. On the plate impacted at 13.45 J, shown in Figure 14, a small crack is noticed to be superficial. For the other two plates (15.28 J and 17.60 J), damage reaching fibres-breakage is observed (Figures 15 and 16).

**Figure 14.** X-ray tomography observations performed on the samples impacted at an energy level of 13.45 J showing the matrix micro-crack.

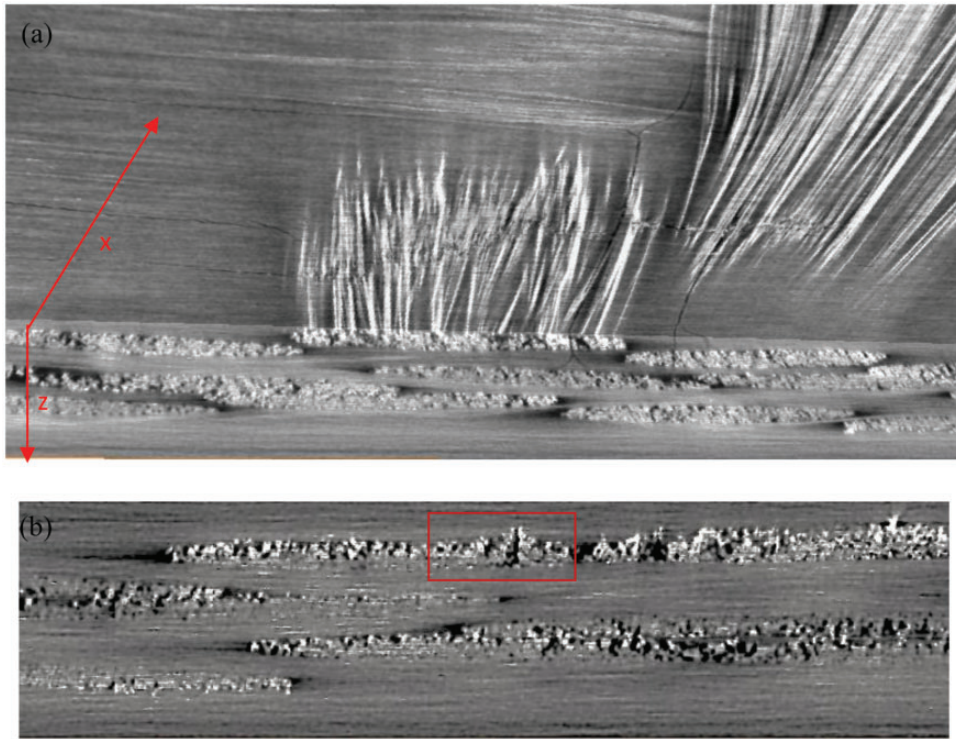
The primary damage mechanism detected for the plates impacted at 15.28 J and 17.60 J during X-Ray tomography investigation is matrix cracking. The cracks detected on the non-impacted side are propagated, in thickness, in the composite following the fibre orientation. These cracks diffuse into and along the yarns in a transversal and longitudinal path. After crossing the first ply and assuming that the propagation energy is high enough, the cracks could evolve and turn into

delamination that spread around the yarns. This damage mechanism is called pseudo-delamination. It is highly relevant to note that in a laminate composite made of plies having the same fibre orientation, no delamination could occur on the interface between the layers (Abrat, 1998). As shown in Figure 15, some cracks penetrate the yarns of the second ply but do not extend to the third layer. It should be highlighted that matrix cracks, and the resulting delamination engender defects inside the samples. The latter, when exposed to X-Rays, appear as black areas that constitute the crack network.

**Figure 15.** X-ray tomography observations performed on the samples impacted at an energy level of 15.28 J showing (a) the crack network and (b) a transversal crack and delamination.

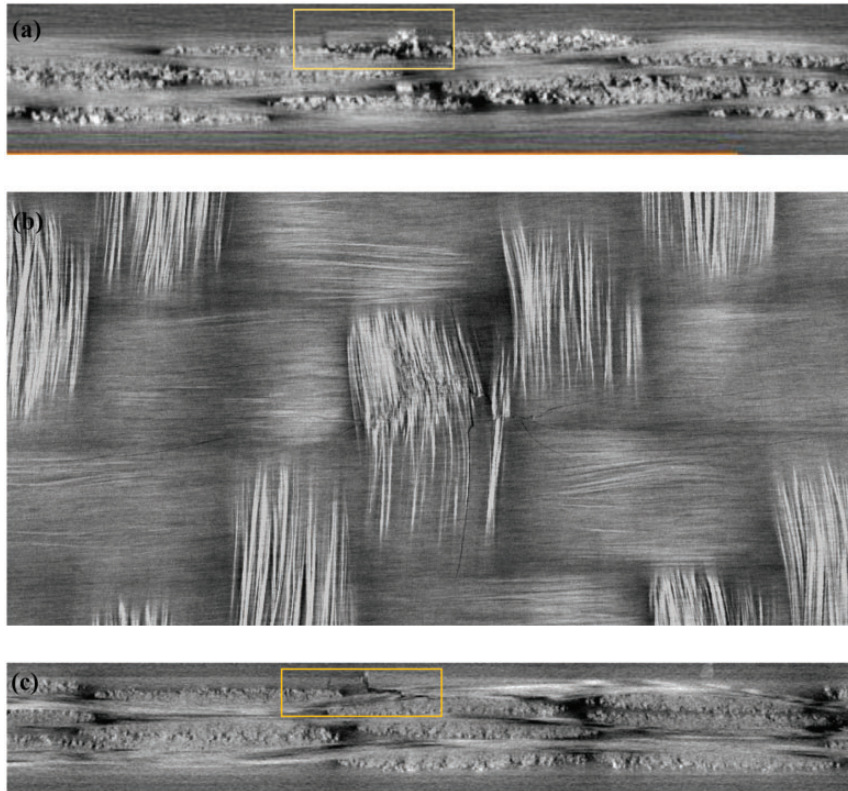
On the sample side containing visible damage, fibre breakage can be observed. When observing the fibre breakage area in the perpendicular plane, a slight lift of the broken zone is noticed. This uplift induces delamination that appears between transversal and longitudinal yarns inside the same ply.

**Figure 16.** X-ray tomography observations performed on the samples impacted at an energy level of 17.60 J showing (a) a local uprising of the fibres localized between two transversal crack, (b) the crack network and (c) delamination and stair-shape failure.

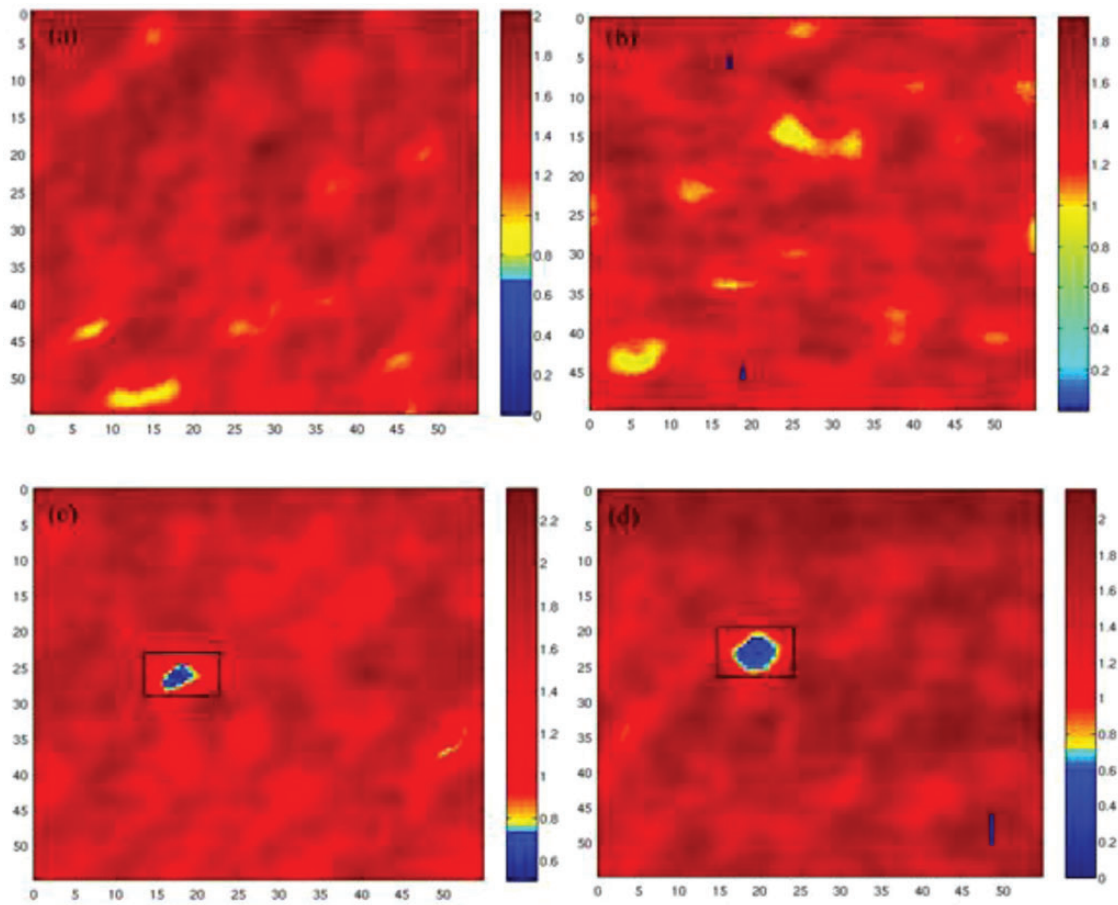
Figure 18 shows the results of reflection C-scans. The color scale is adjusted to focus more on the areas of amplitude attenuation. Pulse/echo C-scan results (Figure 18(c) and (d)), for 15.28 J and 17.60 J as energy level) presented damage surface evolution when the impact energy increased. On

the other hand, no defect is detected for the two samples damaged at 7.30 J and 13.45 J. In Table 4, the detected defect dimensions are shown. For an energy level of 15.28 J, the damaged area observed on the C-scan image corresponds to a dimension of 5 mm, while for the plate corresponding to an energy level of 17.60 J, the dimension is 7 mm. These given measures might only represent the area with severe damage due to the limited spatial resolution of such imaging method (300  $\mu\text{m}$ ).

**Figure 18.** Pulse/echo C-scan results for the four impacted samples: (a) 7.30 J, (b) 13.45 J, (c) 15.28 J and (d) 17.60 J using a 10 MHz transducer.

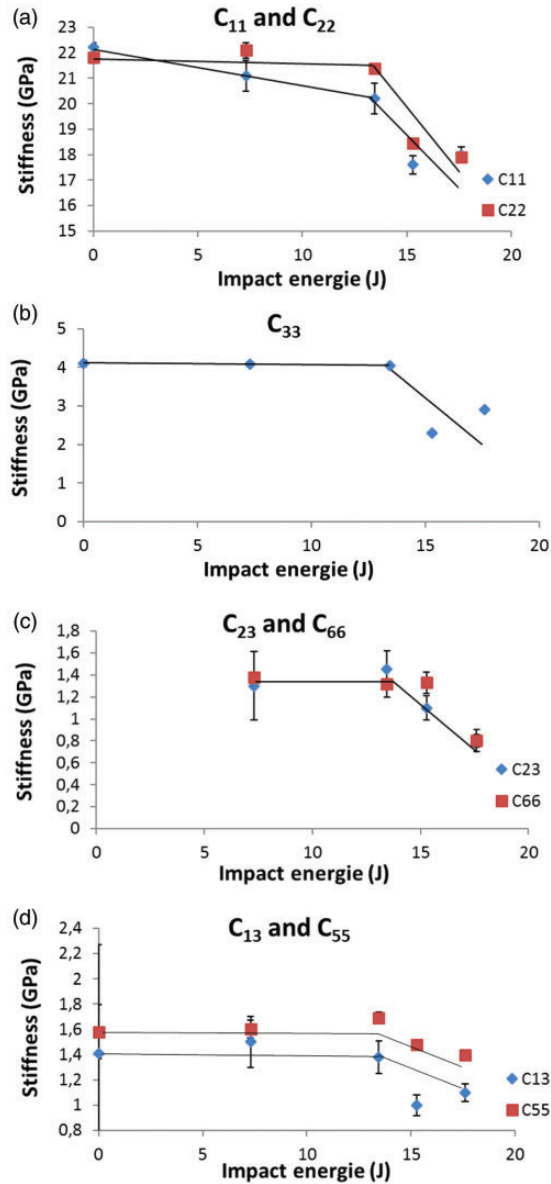
Figure 23(a) to (d) represent the experimentally determined stiffness components for the four studied samples. An overall decrease of the stiffness components is noticed starting from 15.28 J. The results are in agreement with those obtained using other techniques. Indeed, one can notice that all the components, namely:  $C_{11}$ ,  $C_{22}$ ,  $C_{33}$ ,  $C_{13}$ ,  $C_{55}$ ,  $C_{23}$  and  $C_{66}$  exhibit a distinguished decrease starting from the energy of 15.28 J. Furthermore, the stiffness reduction of the components  $C_{11}$  and  $C_{13}$  is more pronounced between 15.28 J and 17.60 J rather than between 7.30 J and 13.45 J.

**Figure 23.** Experimental stiffness components for the samples impacted at energies of 7.30 J, 13.45 J, 15.28 J and 17.60 J showing: (a)  $C_{11}$  and  $C_{22}$ , (b)  $C_{33}$ , (c)  $C_{23}$  and  $C_{66}$  and (d)  $C_{13}$  and  $C_{55}$ .
