Paola MAZZANTI, Bertrand MARCON, Linda COCCHI, Giacomo GOLI, Lorenzo RIPARBELLI, Luca UZIELLI - An Innovative Method Based on In Situ Deformometric Monitoring to Support Decisions for the Structural Restoration of a Historic Panel Painting - Heritage - Vol. 7, n°8, p.4193-4205 - 2024

An Innovative Method Based on In Situ Deformometric Monitoring to Support Decisions for the Structural Restoration of a Historic Panel Painting

This paper presents an innovative method developed by the authors to provide guidance in planning the structural restoration of a large-scale historic panel painting. Its overly rigid constraints had resulted in severe transverse tensile cracking following major changes in moisture content.

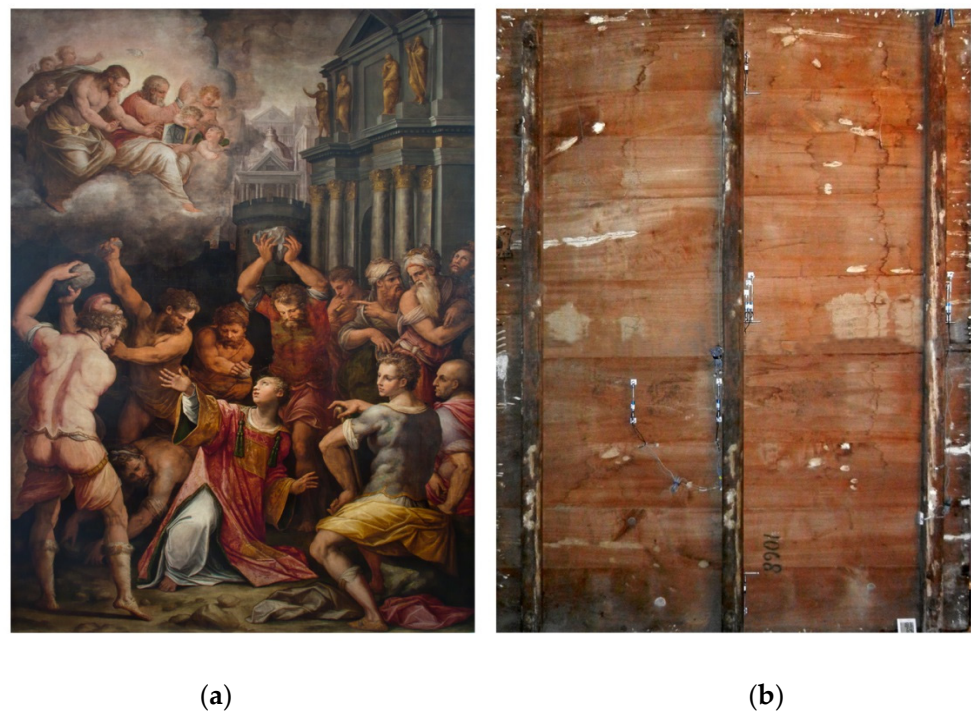
Figure 1. The *Lapidazione di Santo Stefano* by Giorgio Vasari (1571): (a) the painting after the restoration performed in 2012–2013; (b) the panel's back face with the monitoring instruments installed. (Photographs are courtesy of the Soprintendenza BAPSAE di Pisa e Livorno and the restorers Nadia Presenti and Mario Verdelli.).

The ten horizontal boards are glued together along their edges and stiffened by three vertical dovetailed crossbeams (Figure 1b). The crossbeams are made of silver fir (*Abies alba* Mill.). Their cross-sections at mid-length are approximately 70 × 110 mm²; for all three crossbeams, both the entire section and the width of the dovetail are tapered by approximately 2 to 3 cm over the length of 392 cm, that is, by approximately 0.5 to 0.8%. The weight of each crossbeam is estimated at around 13 kg, assuming an average density of 440 kg/m³ for silver fir.

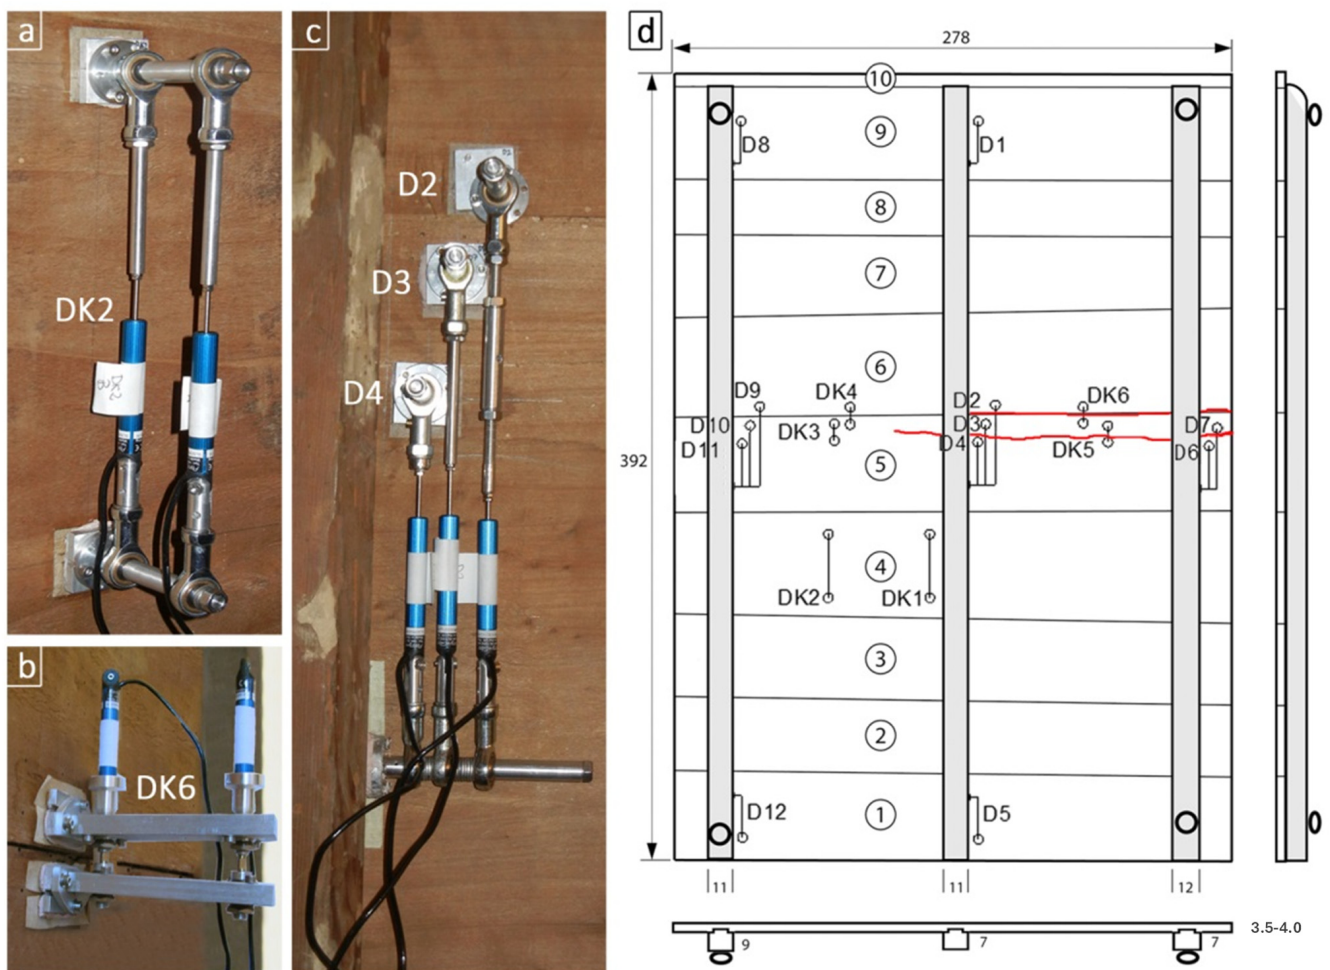
Figure 3. The monitoring equipment installed on the back face of the panel. (a) A “long” deformed-metric kit (DK2), installed on board 4; (b) a “short” DK (DK6), installed across a crack (the broken glue line); (c) three dilatometers (D2, D3, D4), installed with their lower ends at the same level on the central crossbeam, and their upper ends on three locations on the back face of the panel; (d) the structure of the panel and the arrangement of the monitoring equipment, with the red lines representing the two cracks (above, the broken glue line; below, the opened ring shake).

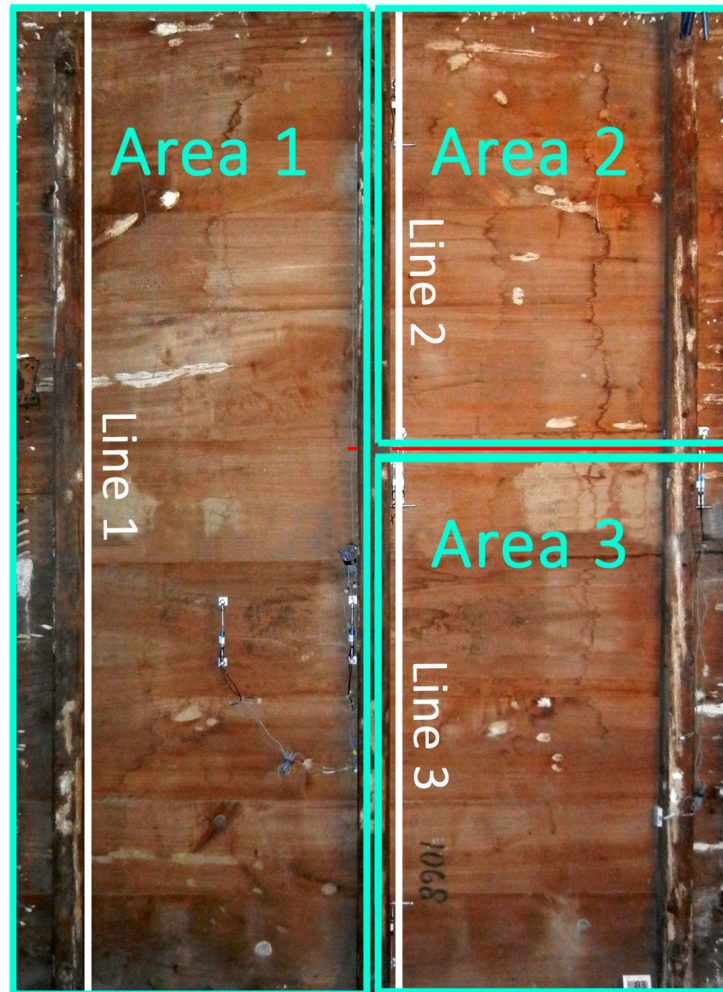
The analysis (see further) of the variations in the sizes of the cracks and various parts of the panel led to the identification of three large areas of the panel which were deforming almost independently of each other (Figure 4):

Figure 4. The three main areas and three main lines, before restoration. Note: Figure 4 is intended to show the three main areas of the panel painting rather than the location of the instrumentation. However, DK1 and DK2 (Area 1) and D2, D3, D4, D6 and D7 (across Areas 2 and 3) are visible, while DK5 and DK6 were not yet mounted when the picture was taken.

This is explained by the fact that the right part of the panel is divided into two parts: Areas 2 and 3 (see Figure 4). As they are no longer connected to each other, Areas 2 and 3 will shrink independently. However, they are still connected with the left part of the panel and hence cannot further approach each other, so both the open joint and ring shake widths will increase.

Significant variations in the width of both the open joint and the ring shake were recorded between Areas 2 and 3. In contrast, no crack evidence nor significant deformations were observed in Area 1 along the potential prolongation of the two cracks; this area deformed as a single structural unit. The RH decreased from about 70% to about 45% in four months, causing the panel to shrink by about 8 mm and the cracks to widen by about 2.7 mm (1.6 mm for the open joint and 1.1 mm for the ring shake).

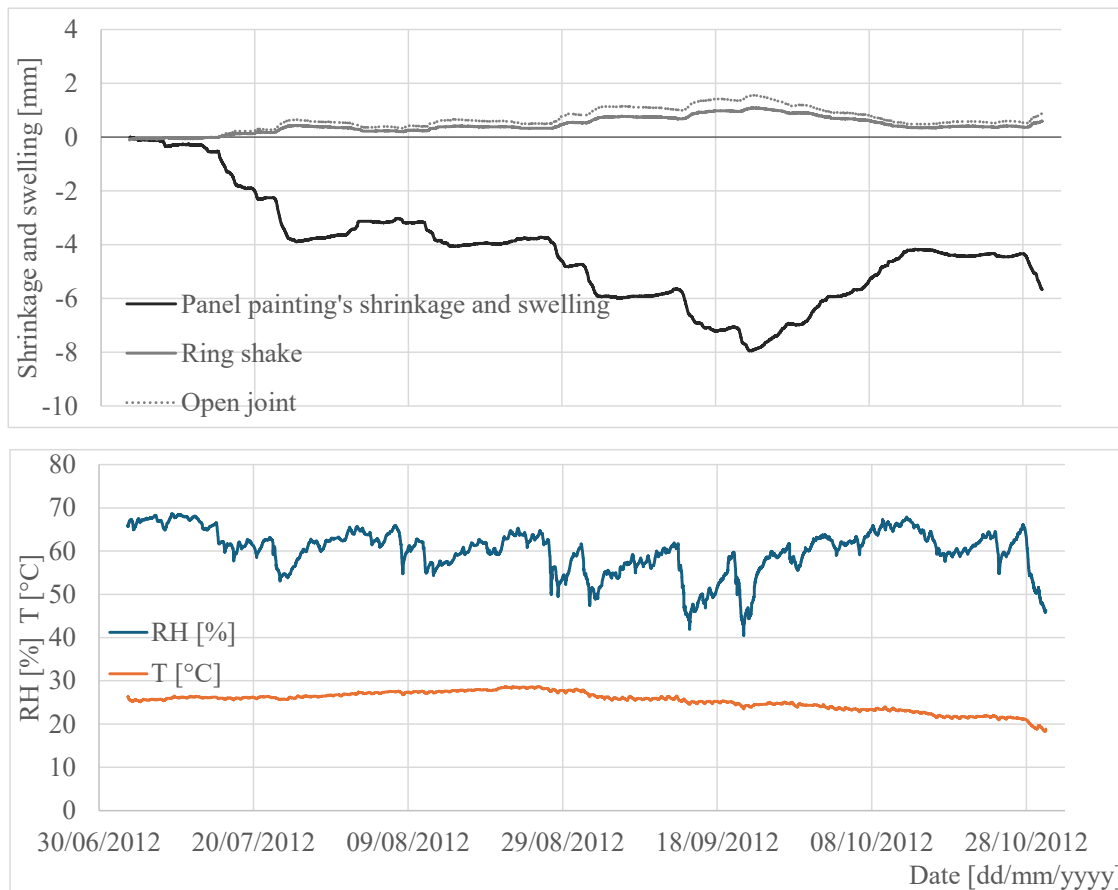
Figure 6. Before restoration: Width variation of the ring shake and open joint and vertical shrinkage/swelling of the whole panel along Line 1; the RH and T variation are also reported. Note. The accuracy of the swelling and shrinkage curves is ± 0.002 mm, the accuracy of the temperature sensor is ± 0.35 °C and the accuracy of the RH sensor is $\pm 2.5\%$.

The graphs show that as the RH decreases, the wood shrinkage perpendicular to the grain makes the panel's height decrease and the width of the cracks increase and vice versa. The shrinkage was measured along Line 1, where the planking is whole (i.e., not divided by the cracks) and therefore represents the shrinkage of the entire panel. In Figure 6, we can see that the whole panel shrinks considerably due to the decrease in RH. However, the widths of the broken glue line and the ring shake increase due to the decreasing RH.

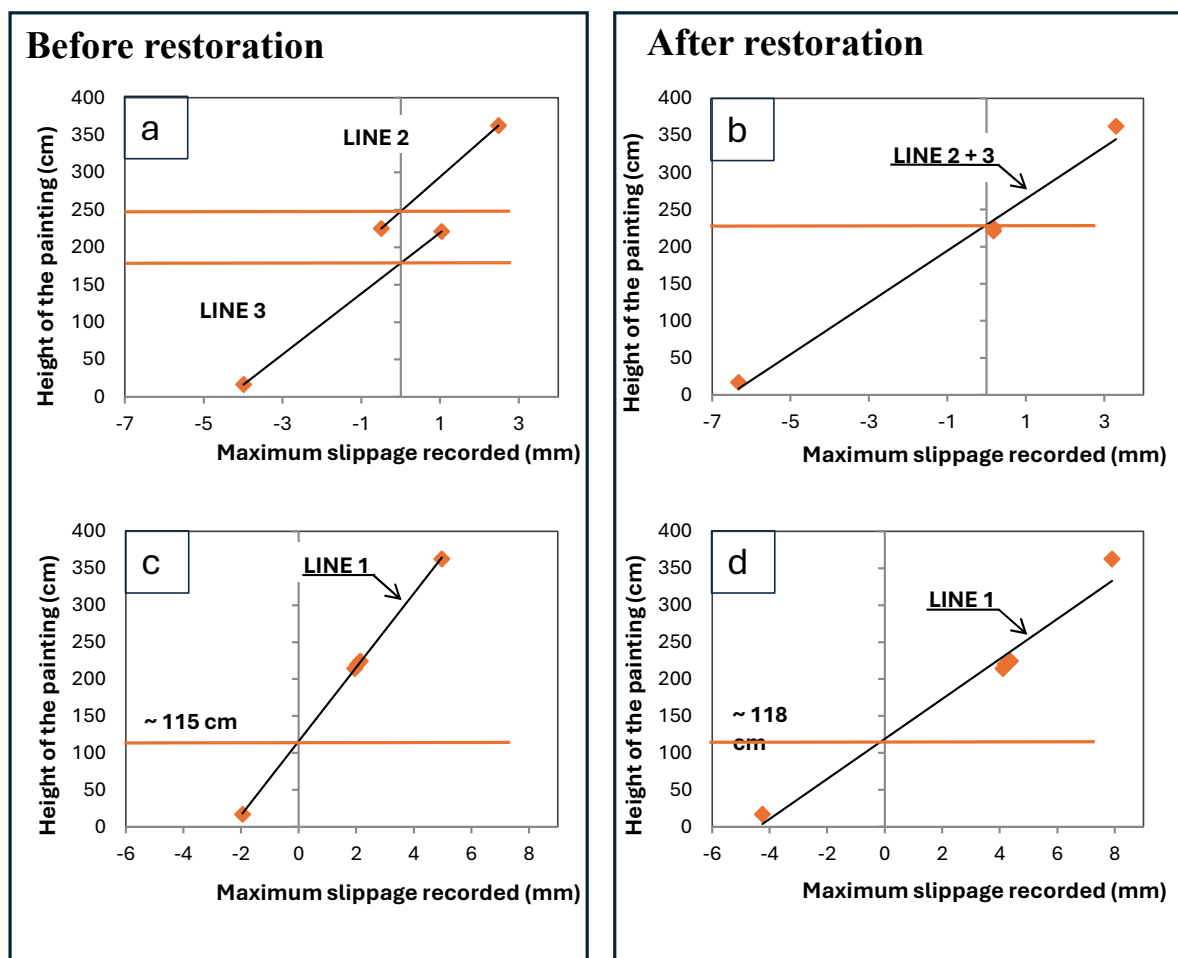
The assumptions about the zero-slippage zones not being produced by actual local blockages were crucial to deciding strategies for structural restoration. In summary, the appropriateness of a restoration intervention that would completely reconnect the cracks depended on whether such reconnection would result in a different slippage behaviour of the two areas and the appearance of a new common “zero-slippage zone”. In other words, we had to determine whether or not the cracks were a necessary “release valve” to prevent unacceptable stresses resulting from the foreseeable hygroscopic movements of the panel. After the restoration, the panel showed consistent deformation even on the right side (where former Areas 2 and 3 were reconnected), behaving as a single structure with only one central “zero-slippage zone” (Figure 7). This confirmed the correctness of the hypothesis we formulated.

Data were recorded for 12 months. Based on the examination of the “zero-slippage zones”, it was concluded that repairing both cracks could be a safe intervention, although the success of the repair would have to be verified by subsequent monitoring. After the restoration, the right section of the panel showed consistent deformation, behaving as a single structure, with only one central “zero-slippage zone” (Figure 7b).

Figure 7. Approximate geometric construction to estimate the location of the “zero-slippage zones” on the central and left crossbeams, (a,c) before and (b,d) after the structural restoration.
