Common features on damage mechanisms identified on various metal and ceramic on polyethylene articulating surfaces of total hip prostheses

D. Najjar¹, F. Hennebelle², A. Iost¹, H. Migaud³

Keywords: Total hip prostheses, articulating surfaces, wear mechanisms, Ultra High Molecular Weight Polyethylene.

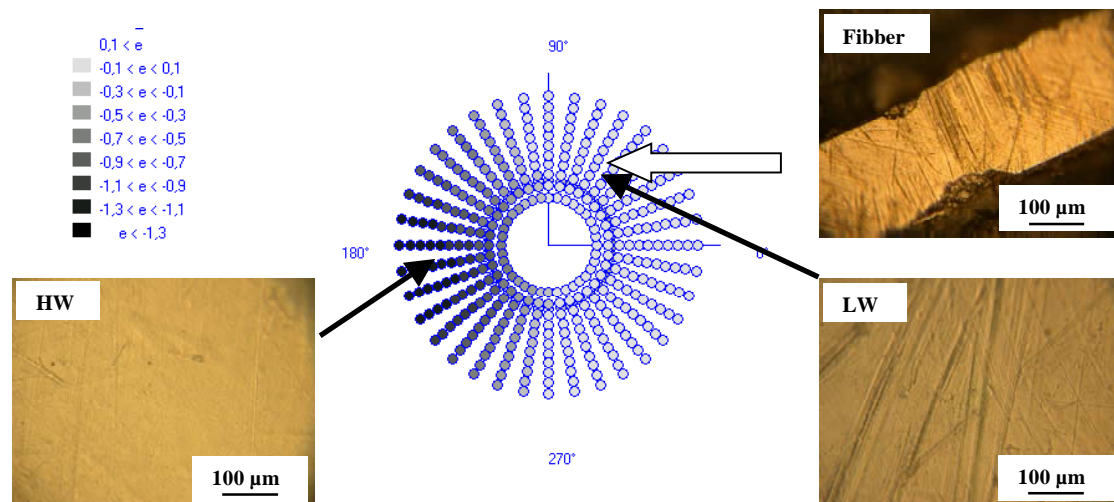
Damage analysis of the UHMWPE acetabular inserts. Whatever the retrieved acetabular cup analysed, the damage of the retrieved consists of dimensional changes at a macroscopic scale associated with degradation of surface topography at a microscopic scale. These retrieved acetabular cups exhibit two distinct areas that are symmetrically located. A first region is characterised by large deviations at a macroscopic scale and has a highly polished smooth appearance at naked-eye. Little scratches are detected by optical microscopic observations in this region denoted HW contrary to the other one denoted LW; region for which the recorded deviations are small (Fig. 2).

Fig. 2: Example of stereographic projection of deviations (e in mm) between points located on the internal surface of the retrieved acetabular cup and those located on a theoretical hemisphere of 14 mm radius (clinical case A). The white arrow indicates the location of the embedded fibber.

In agreement with the conclusions of these authors, it can be concluded that the large deviations recorded in the area HW indicate the effective direction of loading and are the consequence of the femoral head penetration in the UHMWPE acetabular cup by the combination of creep and a fatigue/adhesion wear mechanism. The related values of the maximum linear penetration rates in the UHMWPE are summarised in Table 2 for the four studied clinical cases. Such values are consistent with the clinical penetration rates reported in the literature. While these clinical penetration rates exhibit a great variability, they are generally less than about $0.25 \text{ mm}\cdot\text{year}^{-1}$ and often correspond to an average of $0.1 \text{ mm}\cdot\text{year}^{-1}$ or less [4,6]. Moreover, substantial clinical evidence now accumulating indicates that long term survival of the implant is associated with penetration rates of less than $0.1 \text{ mm}\cdot\text{year}^{-1}$ while case requiring revision often exhibit penetration rates of about $0.2 \text{ mm}\cdot\text{year}^{-1}$ or higher [6].

As far as the region LW is concerned, it is thought that the numerous scratches observed at the surface of the UHMWPE acetabular cups are the consequence of a third-body wear mechanism. Indeed, it is worth noting that some of the detected scratches exactly have the same shape and dimension as the metallic fibbers of millimetre size. Moreover, the surface of these metallic fibbers, always located in this region LW, are also severely scratched (Fig. 2).

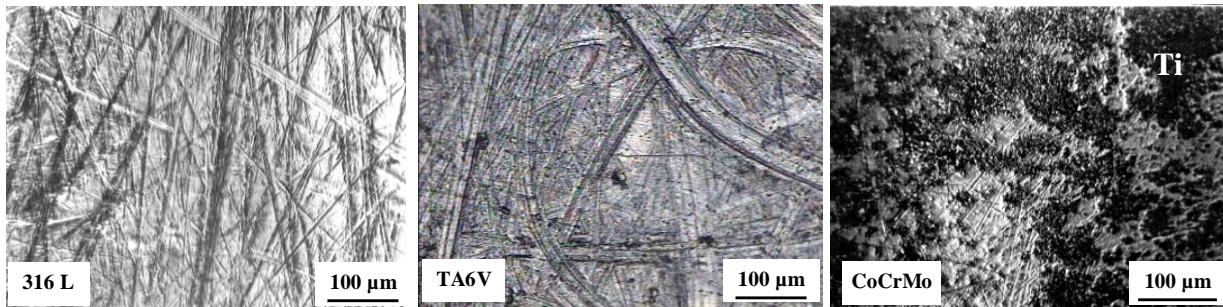
Damage analysis of the femoral heads. Hard foreign bodies undoubtedly increases the rate of removal of polyethylene, but they might be also responsible for the degradation of the retrieved femoral heads [2,4,7]. The deleterious effect of the embedded foreign third bodies of large dimensions is also evident at the surface of all the retrieved femoral heads under investigation in this study. However, the present results show that the wear mechanism at the origin of the degradation of the initial surface finish depends on the nature of femoral head. Indeed, numerous scratches are detected at naked-eye at the surface of the femoral heads made in 316L and TA6V passive alloys. Microscopic observations of such scratches obtained by means of an optical microscope are shown in Fig. 3. These scratches covers approximately 25% of the total surface of the femoral head in the case of the 316L alloy and more than 60% in the case of the TA6V alloy that, among the biomaterials used for manufacturing the femoral heads of THR prostheses, is known to be the less resistant one to abrasive wear. In the case of the CoCrMo alloy, the initial bright finish is only altered on a small area covering less than 10% of the total surface of the femoral head. Observations by means of a Scanning Electron Microscope (SEM) reveal that this area consists of very small scratches combined with an adherent metallic deposit (Fig. 3). As for the zirconia femoral head, this latter can be identified as a titanium deposit by Energy Dispersive Analysis of X rays (EDAX); chemical element which is contained in the original chemical composition of the fibbermesh deposited on the Harris-Galante Mark I metallic shells but not in those of the femoral heads under consideration. In other words, these metallic deposits result from an adhesive wear mechanism due to the friction between the embedded metallic fibbers of large dimensions and the femoral heads.

Fig. 3: Damage of the metallic femoral heads observed by means of an optical microscope for the 316L and TA6V femoral heads and by means of a SEM for the CoCrMo femoral head.

Whatever the wear mechanism, i.e. abrasive wear in the case of the 316L and TA6V alloys and mainly adhesive wear in the case of CoCrMo alloy and zirconia which are more resistant to abrasive wear, the degradation of the topography of the femoral heads leads to an increase of the effective roughness which has been shown to be a major factor in determining the wear of polyethylene and the long term performance of implants [1,3,8,9]. Indeed, whatever the femoral head, the experimental results reported in Table 3 show that the values of the average arithmetic roughness parameter recorded in the damaged areas are always significantly higher than those recorded in undamaged areas having a bright finish. Besides, these latter values are similar as those mentioned in the ISO 7206-2 standard which specifies the guidelines for new acetabular components of THR prostheses [10]. In agreement with others authors [4,6-9], it is also thought that, from a global point of view, the degradation of the initial surface finish by hard foreign bodies is a random phenomenon suspected to be a major factor responsible for the discrepancy existing in the literature between the average clinical and laboratory wear factors as well as the wide spread of results.
