Abir ABDESSALEM, Sahbi TAMBOURA, Joseph FITOUSSI, Hachmi Ben DALY, Abbas TCHARKHTCHI, Fodil MERAGHNI - Microstructure investigation of hydrothermal damage of aged SMC composites using Micro-computed tomography and scanning electron microscopy - Engineering Failure Analysis - Vol. 121, p.105177 - 2021

# Microstructure investigation of hydrothermal damage of aged SMC composites using Micro-computed tomography and scanning electron microscopy

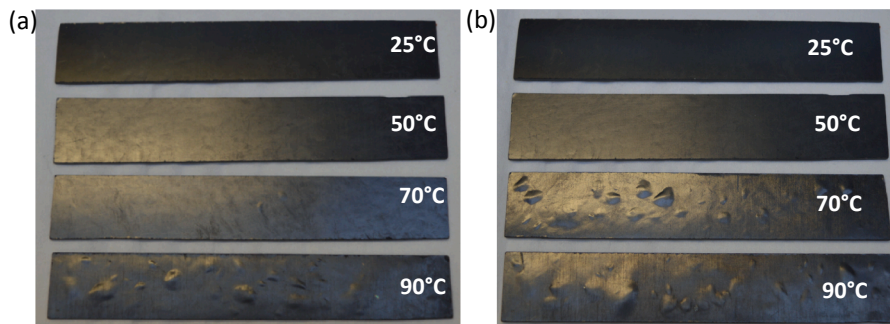
The outer surfaces of aged samples at 25 °C, 50 °C, 70 °C and 90 °C were visually controlled during the hydrothermal conditioning. Fig. 6 shows the external surfaces aspects of aged specimens after 500 h and 2500 h in tempered water. Blisters appear in the exposed surfaces, and their kinetics is accelerated with time and temperature.

After 500 h in water, the blisters size is more and more marked when the aging temperature is close to the glass transition temperature of the polyester resin used in this work ( $T_g = 91$  °C) as it can be seen in Fig. 6(a). However, at 50 °C and 25 °C, the blistering phenomenon does not occur since at these temperatures the material is in a glassy state. It will probably appear for much longer immersion times. Otherwise, it can be noted that the increase in immersion time from 500 h to 2500 h increases the number of blisters as shown in Fig. 6(b).

This result is actually expected. Indeed, increasing the immersion parameters (time and Temperature) increases both the diffusion and the amount of moisture introduced into the sample. Over time, the pressure of the water inside the material, called osmotic pressure, increases and can, thus, reach a critical value giving rise to local damage. It was very recognized that blistering induced by humid aging is a very important mode of failure in these materials [7]. That is the reason why it became of major interest to understand the microcrack nucleation mechanism in SMC composite in order to study their propagation and to quantify their evolution.

**Fig. 6.** appearance of blisters on the outer surfaces of aged SMC samples (a) after 500 h, (b) after 2500 h in water immersion at 25 °C, 50 °C, 70 °C and 90 °C.

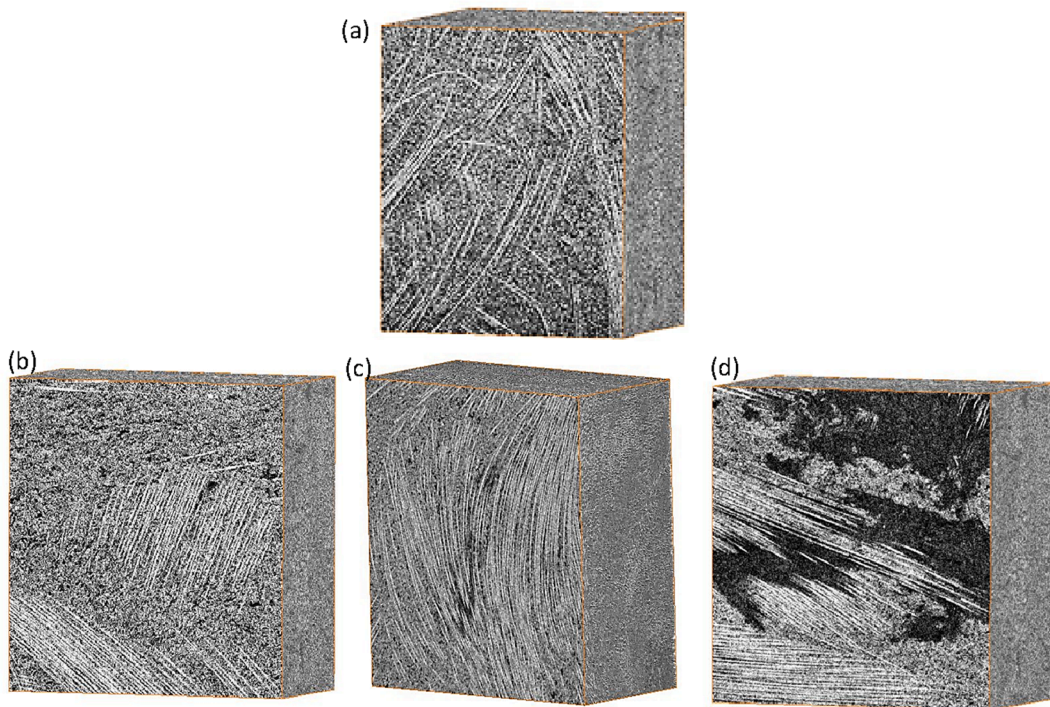
The X $\mu$ CT was performed to visualize and understand the 3D damage evolution during hydrothermal conditions. In Figs. 7 and 8, three-dimensional reconstructions of a 50 °C and 90 °C aged samples after three water uptake levels (15%, 30% and 60%) are shown. The focus was put on the inner parts to visualize the most important damage mechanisms namely matrix cracking and fibre–matrix debonding.

At low water uptake (15%  $M_s$ ), matrix cracking have occurred which are often attributed in literature to osmotic stresses due to the water molecules diffusion in mico-voids during immersion [24]. This damage is much more marked at high temperature.

At 30% of water uptake, significant damage were emerged and propagates in fibre direction in samples aged at 90 °C. Cracks appeared at the interface between the matrix and the fiber, as shown in Fig. 9. The interface detachment developed and progressed in the form of long crack as the hygrothermal aging time was increased. Interface cracking is a result of failure of the internal interfaces [20]. However, only few micro-cracks appear in the inner structure of 50 °C aged samples at this water uptake level.

At high water uptake (60%  $M_s$ ), the fibre/matrix bond weakened with the increase of the moisture content. Fibre-matrix debonding occurred at the edges of the fibre bundles. The fibre–matrix debonding and splitting of the fibre bundle are the predominant damage mechanism suggesting that the majority of the damage occurs during aging at high temperatures. This might indicate that the long-term aging strengthens the damage progress. However, the moisture diffusion did not seem to have had a large influence on the quality of the fiber/matrix interface at low temperatures. Significant interfacial degradation have occurred only after a long exposure to moisture.

Fig. 7. 3D damage observation of (a) non aged sample, and 90 °C aged SMC samples after (b) 15%  $M_s$ , (c) 30%  $M_s$ , and (d) 60%  $M_s$ .

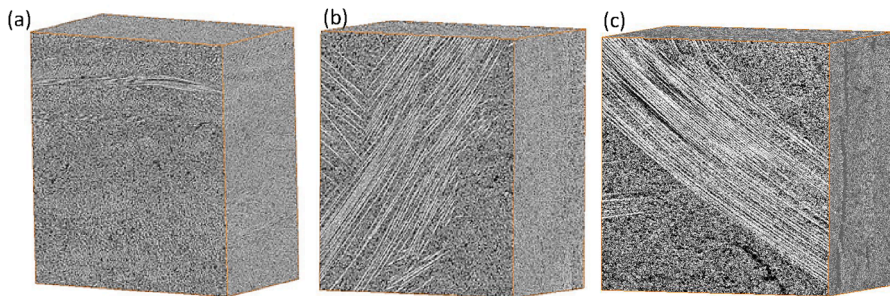
Fig. 8. 3D damage observation of 50 °C aged SMC samples after (a) 15%  $M_s$ , (b) 30%  $M_s$ , and (c) 60%  $M_s$ .

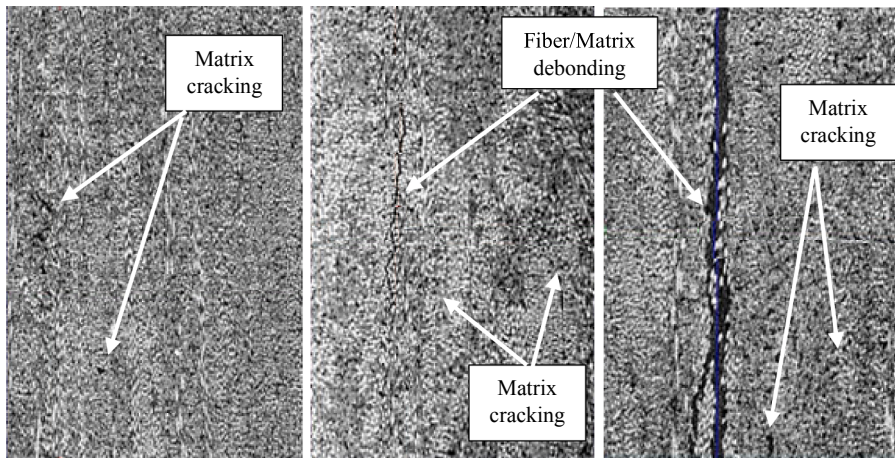
In Fig. 9, cross sections of the 90 °C aged composite after different water uptake are shown. Overall, the damage development in the aged SMC composite proceeded faster which is in line with the evolution in water uptake properties as discussed in the previous work [22].

Fig. 9. Cross-section of 90 °C conditioned SMC composite after (a) 15%  $M_S$ , (b) 30%  $M_S$ , and (c) 60%  $M_S$ .

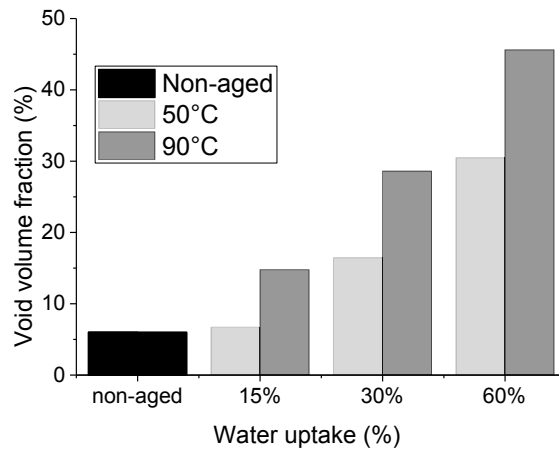
In Fig. 10, quantitative data of the increase in voids during the hygroscopic ageing is shown.

It was supposed that the initial void fraction corresponds to the defects present in the material before conditioning. The increase in voids was attributed to the development of damage. The calculated increase is prone to error which could be a result of small variations in image quality, segmentation and examined volume.

Both the quantitative and visual analysis indicate that there was a clear influence of the water diffusion. The tomographic results revealed that specimens experienced harsher damaging when exposed to hot/wet aging condition suggesting that the temperature as an environmental factor play an accelerating role for damage mechanism of SMC composite under hydrothermal aging. However, with X $\mu$ CT it was not possible to study separately the identified damages during aging. Detailed future analysis of the damages with scanning electron microscopy might point out separately the evolution of each identified hydrothermal damage.

Fig. 10. Evolution of the void volume fraction of non aged sample and 50 °C and 90 °C aged samples versus the water uptake level.

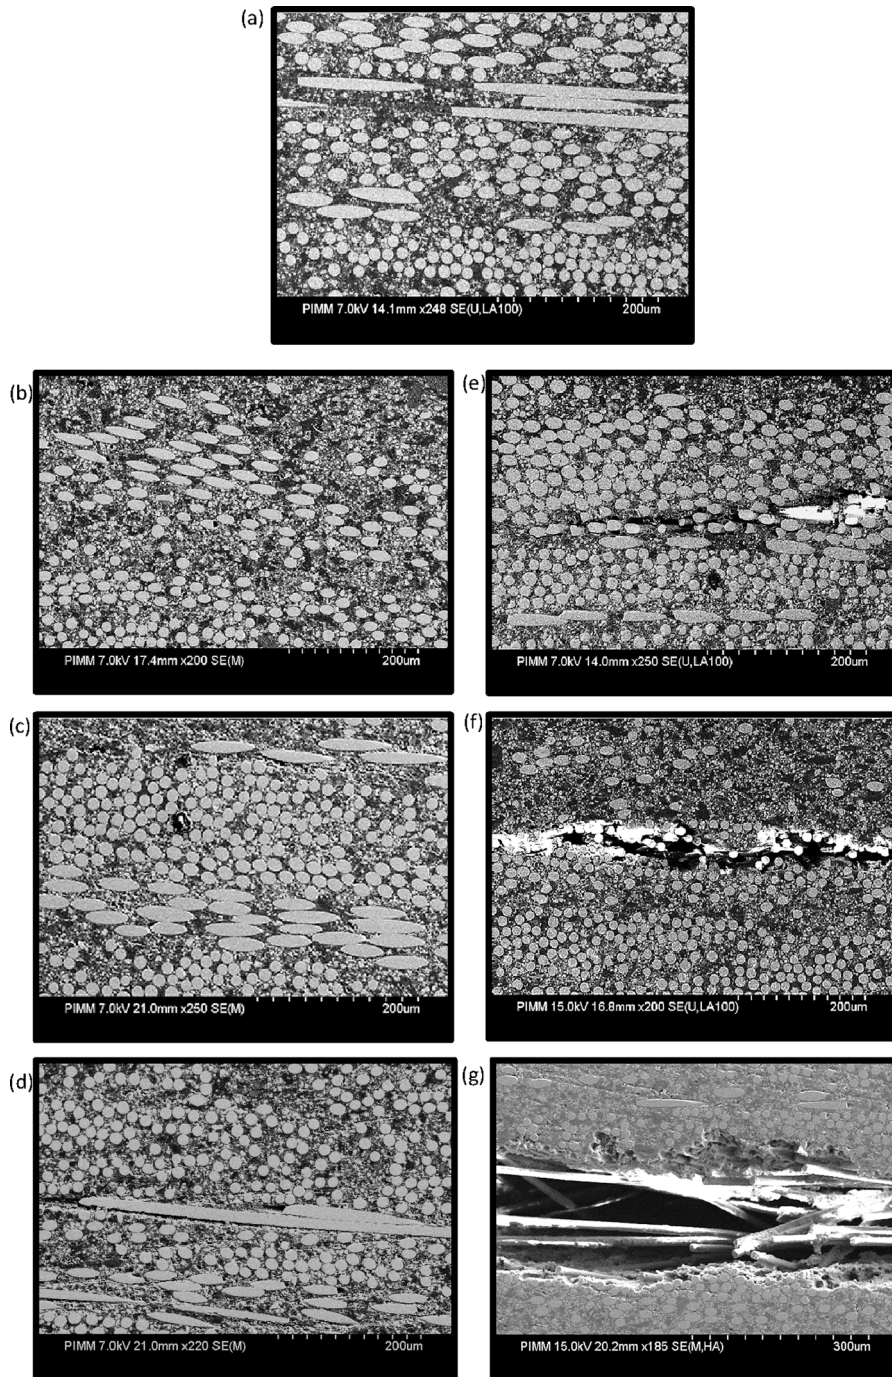
Cracks within the matrix were observed when conditioning at all aging temperatures which was a consequence of water molecules diffusion to the free volume spaces and porosities. However, cracks within fiber/matrix interface were found to be dependent on time, temperatures and moisture content. Indeed, for low immersion temperature (25 °C and 50 °C) and low humidity content (15%  $M_S$ ), no visible damages were detected in the aged samples. When increasing the humidity content (30%  $M_S$ ), large size porosities in the matrix area were noted, followed by a weak interfacial cohesion which becomes more significant at relatively high humidity content (60%  $M_S$ ).

However, at high immersion temperatures (70 °C and 90 °C), we noted, in addition to the matrix degradation, a very significant interfacial damage starting at low humidity content (15%  $M_S$ ). Then, clean and smooth surfaces of pulled out fibers were found for 60%  $M_S$  indicating that the SMC composite was extensively attacked under hot-wet conditions.

**Fig. 11.** SEM micrographs of the inner microstructure evolution of the (a) non aged sample, (b)–(d) 50 °C aged samples after respectively 15%  $M_S$ , 30%  $M_S$ , and 60%  $M_S$ , and (e)–(g) 90 °C aged samples after respectively 15%  $M_S$ , 30%  $M_S$ , and 60%  $M_S$ .

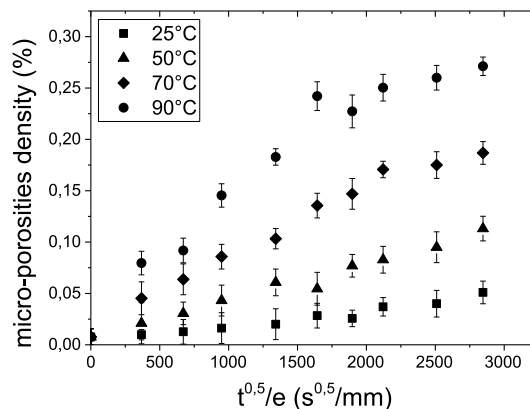
It is clear that the more the immersion parameters (time, Temperature) have increased, the more the density of the cavities displayed in the matrix increases. This growth is linked to the increase in the amount of the diffused moisture into the sample which results essentially in:

- An increase in the porosities sizes due to an increase in the osmotic pressure inside these sites.
- An increase in the number of porosities caused by the phenomena of the chalks particles leaching; i.e this phenomena was discussed and analysed in the previous work [22].

Fig. 12. Micro-porosities density evolution at 25 °C, 50 °C, 70 °C and 90 °C aver aging time.

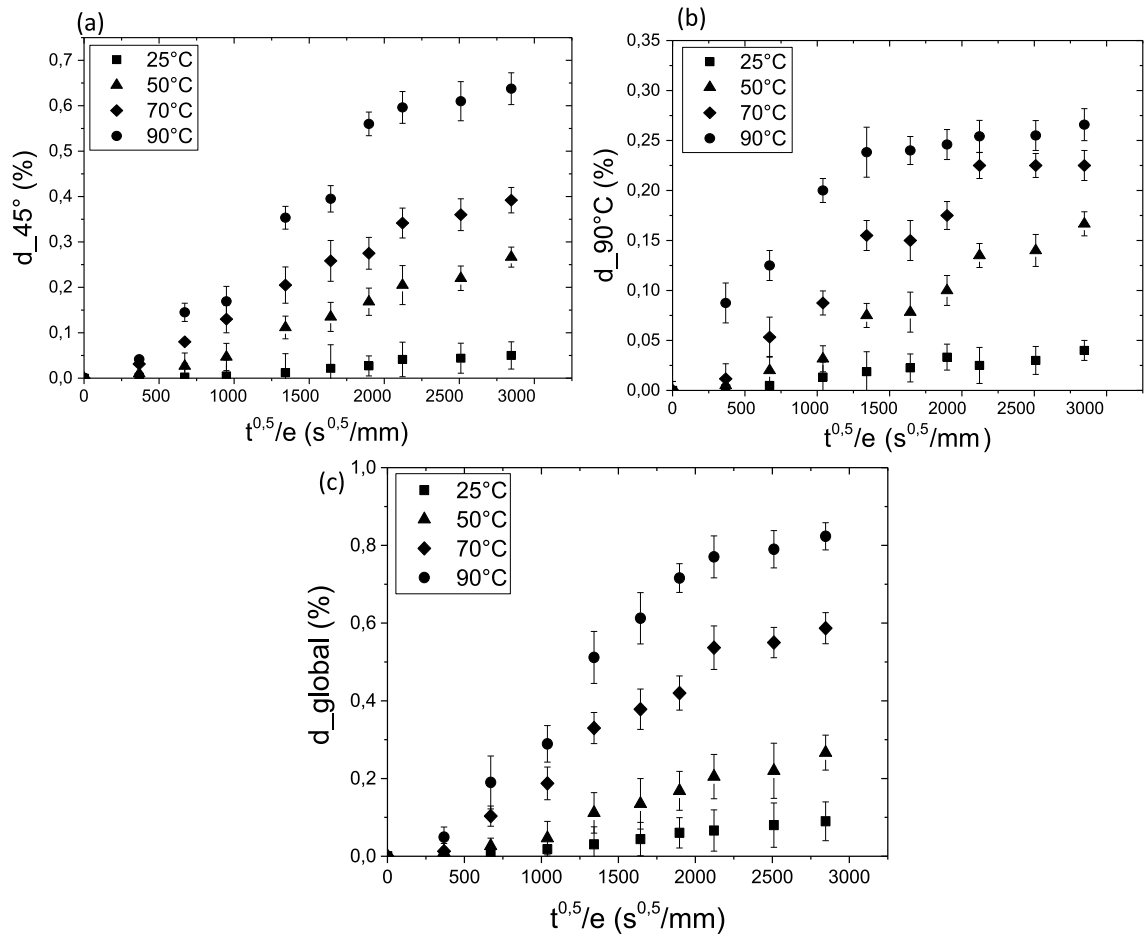
Fibre-matrix debonding occurred at the edges of the fibre bundles which is a result of water attack and stresses accumulating at the interface during sorption. Cracking of the fibre bundles is a result of failure of the internal interfaces. We can notice that the interfacial crack density,  $d_{global}$ , increases with aging parameters ( $t$ ,  $T$ ). Such irreversible structural change is consistent and it is linked to the build-up of the critical stress inside the fibre bundle due to moisture sorption.

**Fig. 13.** Interfacial crack evolution associated to (a) 45° oriented glass fibers, (b) 90° oriented glass fibers and (c) the global density at 25 °C, 50 °C, 70 °C and 90 °C over aging time.

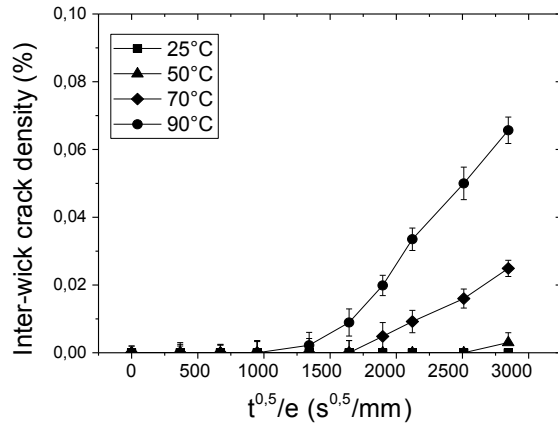
The obtained results, illustrated in Fig. 14, highlight a weak trend in the inter-wick cracks evolution compared to matrix cracking and interfacial degradation. The inter-wick cracks were observed only on specimens exposed to 90 °C and 70 °C in water immersion and after an extended aging period. Small fracture were observed in samples aged at 50 °C. However, no inter-wick cracks were observed at 25 °C. It will probably appear for much longer immersion times.

Fig. 14. Evolution of the inter-wick cracks density over time at different temperatures.

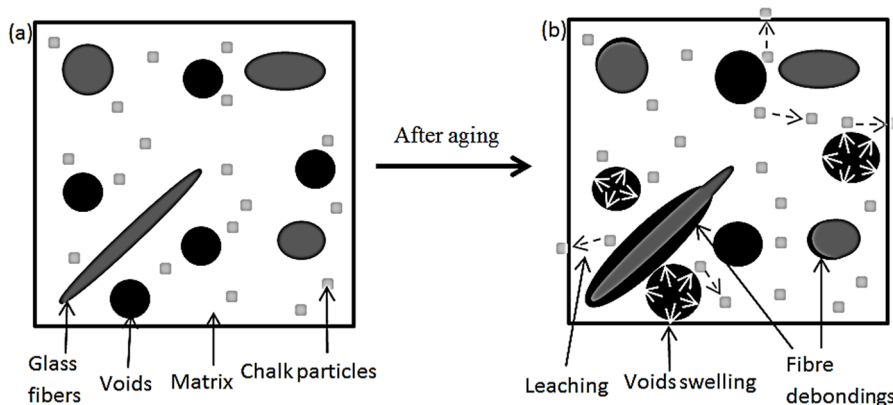
These interfacial cracks and matrix cracks may result in a catastrophic crack propagation in the composite. Propagation results can be interpreted in terms of osmotic process and can be schemed as shown in Fig. 15.

The initiation and growth of the cracks are interpreted on the basis of osmotic stress distribution as follow: under immersion, water molecules diffuses preferably in the the heterogeneities pre-exist in the matrix. Therefore, the stress concentration occurs, firstly, in these sites. The accumulation of water molecules inside these sites increases the osmotic pressure. At a critical value, the microcrack size increases, thus leading to an increase in water sorption and therefore to an osmotic pressure. This pressure stabilizes the micropocket size until the osmotic pressure reaches a critical value. Therefore, the occurrence and the growth of the crack increases the concentrated stress in the voids and at the interfaces as water molecules diffuses largely in these sites, and further the micocrack growth

Fig. 15. Schematic description of swelling and leaching of  $\text{CaCO}_3$  particles due to water diffusion in the existent voids (a) initially before aging and (b) after aging.

will be encouraged. The resultant high stress causes interaction of stresses between neighbouring interfacial cracks, and the band of microcracks connecting fibres will be generated. The osmotic interface damage appears therefore responsible for the material degradation.
