Dorra ABID, Dhouha MELLOULI, Nedja GAFSI, Nader HADDAR, Ahmed KTARI - Failure analysis of shot-sleeves used in brass high pressure die-casting process - Engineering Failure Analysis - Vol. 104, p.177-188 - 2019

Failure analysis of shot–sleeves used in brass high pressure die–casting process

Dorra Abid^a, Ahmed Ktari^{a,b,*}, Dhouha Mellouli^a, Nedja Gafsi^a, Nader Haddar^a

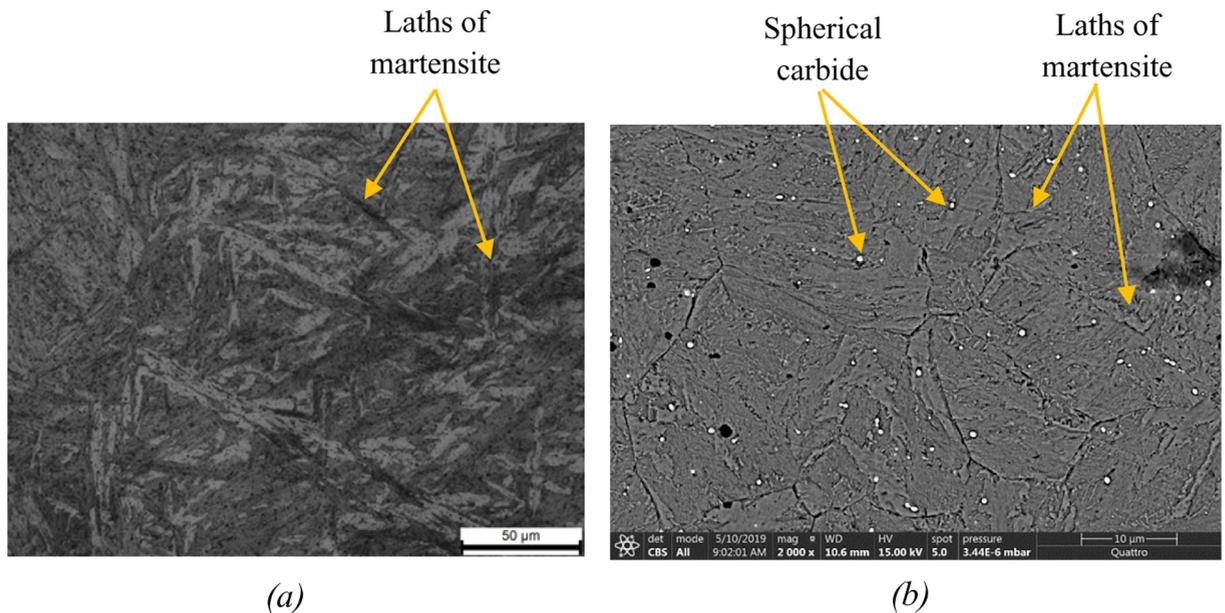
Fig. 2. Microstructure of the shot-sleeve: (a) Light Optical Microscopy (LOM), (b) The SEM microanalysis.

Our studied material is H10, a metallographic observations were realized by means of an optical microscope (Leica[®]) on the same taken sample polished until mirror state then attacked by Nital (5% of nitric acid diluted in methanol). These observations show the presence of a martensitic structure ([Fig. 2](#)).

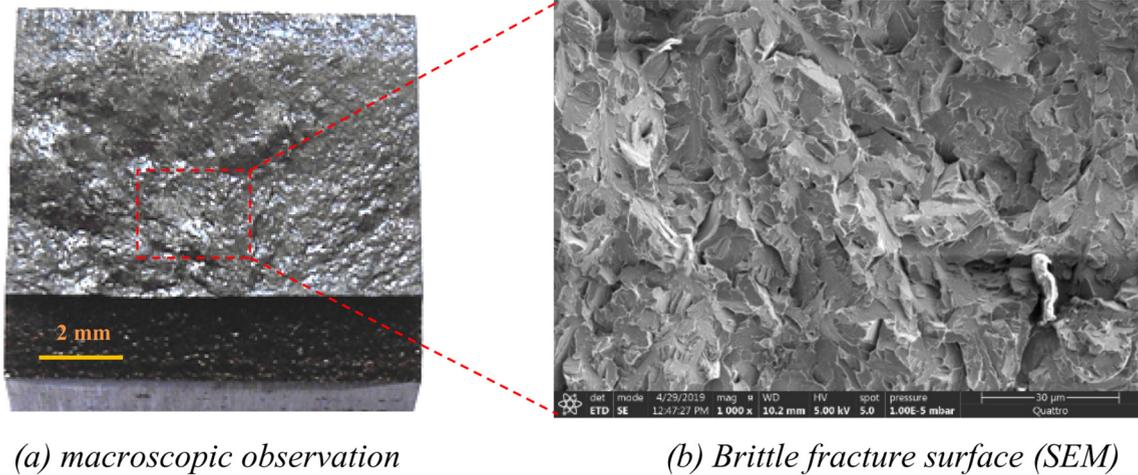
Fig. 5. Fracture surface of Charpy specimen. (a) macroscopic observation, (b) binocular microscope observation.

Standard Charpy V-notched specimens were machined from the failed shot-sleeve by a wire EDM machine (Fig. 4). Then, three tests were conducted at room temperatures to determine the material toughness. The average of the measured CVN energy (CVN = 3.4 ± 0.1 J) and the feature of the fractured surface prove the brittle nature of the specimen material (Fig. 5).

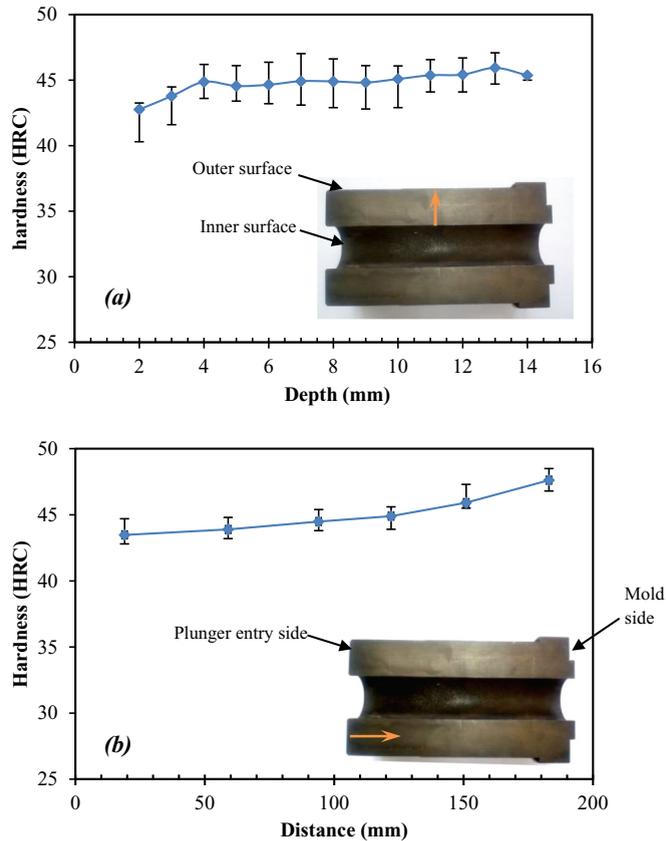
Fig. 7. Hardness shot-sleeve profiles, (a) from the entry to the mold zones, (b) from inner to the outer surfaces.

The hardness profiles were measured, on a shot-sleeve longitudinal section (Fig. 6 (b)) polished until mirror state, from the entry plunger zone to the mold side and from the inner to the outer surface (Fig. 7). These profiles are performed with a Vickers hardness machine using a load of 15 kg. The measured profiles reveal that the hardness appears to be constant for all tested samples.

average of measured hardness is about of $44.8_{-2.4}^{+3.8}$ HRC. This shows that the hardness was remained quasi-constant even after a few thousands of thermal heating and cooling phases (more than 74,000 cycles) and which indicate that the mechanical behaviour of the material is stable (i.e. absence of significant cyclic hardening or softening) under service conditions. Furthermore, micro-hardness measurements were performed with a Wilson hardness machine 402MVD using a load of 1 kg at a distance of approximately $400 \mu\text{m}$ from the inner surface. The average of measured micro-hardness is about $49.8_{-6.4}^{+5.5}$ HRC. This result proves that is no significant increase of the hardness from the heart to the inner surface of the shot-sleeve.

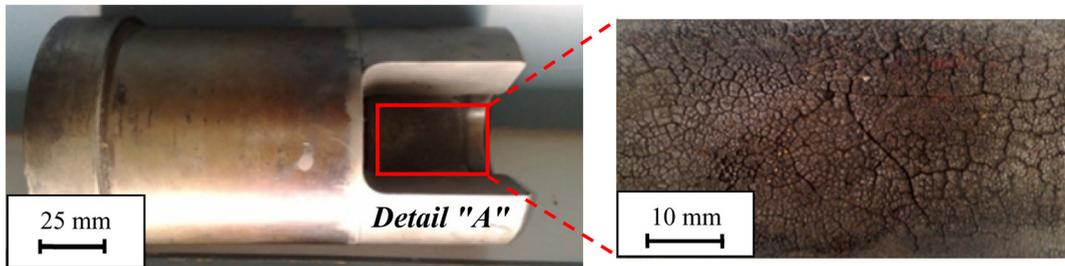
Fig. 8. Cracks network observed on the inner surface of the damaged shot-sleeve.

The second shot-sleeve was cut with a wire EDM machine according to their longitudinal direction to examine the integrity of the damaged surface (Fig. 8). After that, the cut-out parts are subjected to a surface cleaning operations: A chemical pickling with an alkaline solution using a dilute nitric acid was performed, at room temperature, to eliminate all traces of oxides. Then, the damaged shot-sleeve surfaces were subjected to a preliminary assessment with a naked eye to identify their major damage features. The examined surfaces (Fig. 9) clearly show the presence of a cracks network on the inner shot-sleeve surfaces.

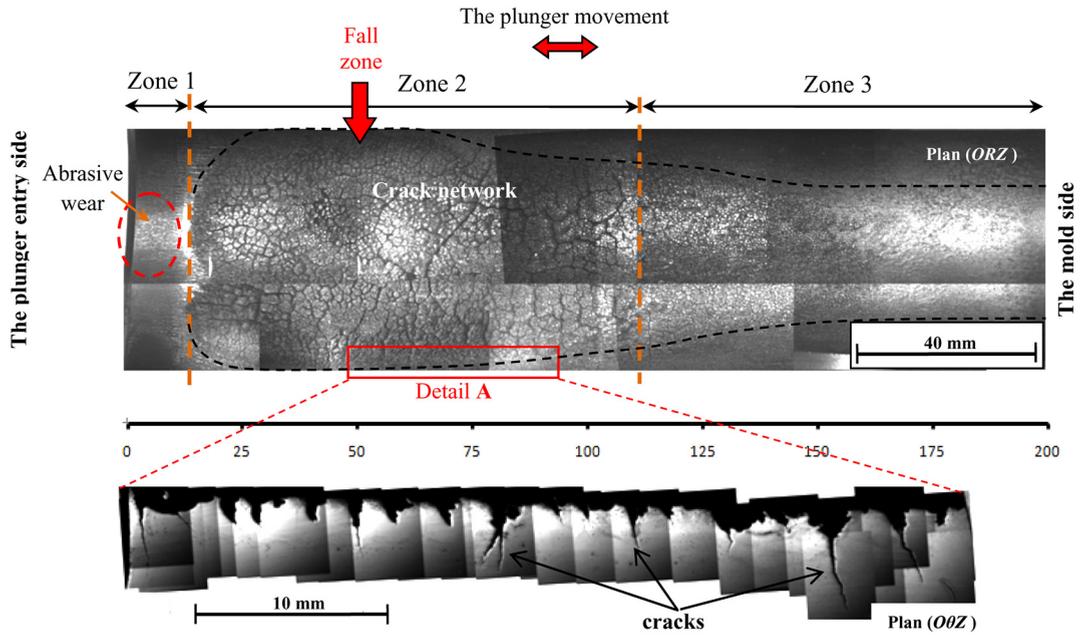
Fig. 9. Shot-sleeve inner surface damage observed with a digital camera.

A finer observations of the shot-sleeve inner side were carried out after a longitudinal cut (Fig. 6 (b)). The examination of the damaged surfaces was made using an experimental device equipped with a digital *Baumer*[®] camera *GIG*E (8 bits). This camera is equipped with a CCD sensor allowing to have a resolution of 1624×1236 pixels. Several photos are taken and then assembled by means of Photoshop[®] software to obtain a large image that cover the entire shot-sleeve examined surface (Fig. 9). This surface reveals the presence of three different zones. The first one is located in the plunger entrance side. It presents a number of scratch according the longitudinal direction which corresponds to abrasive wear caused by the friction between the plunger and the shot-sleeve. The second one corresponds to the first zone which enter in contact with the molten metal ($T = 950^\circ\text{C}$). It undergo cyclic thermal shocks. This zone appears to be the most damaged surface in the shot-sleeve. It presents a dense crack network sign of the thermal fatigue. In addition, the investigation of this zone according to the $O\theta Z$ plan shows that some cracks, after initiation, were propagated in depth along the radial direction (Detail A). The last zone reveals also the presence of a crack network however it is less dense compared to this observed in the 2nd zone (Fig. 9).

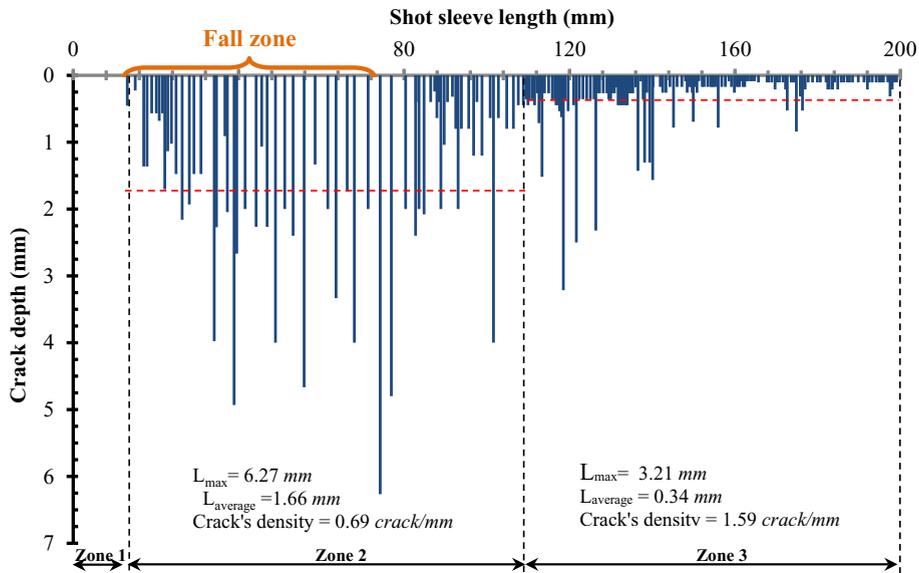
Fig. 10. Crack lengths distribution along the shot sleeve (longitudinal section $\theta = 0$).

In this section, a meticulous investigation on the cracks distribution and density was performed by means of longitudinal and transversal observations (Figs. 10 and 11). The cracks depth according to the axial distance was presented in Fig. 10. It is to be noted that the cracks depth trend along the shot-sleeve follows the Gaussian distribution. Fig. 10 shows that the cracks depth is maximal around the zone 2, which corresponds to the casting zone (fall zone). This zone is characterized by a maximum crack length and average values of 6.23mm and 1.66mm respectively. In zone 3 the cracks deep is less than those observed in zone 2 nevertheless their density is more pronounced (*i.e.* 1.59crack/mm in zone 3 against 0.69crack/mm in zone 2). The presence of the shielding effect between neighbouring cracks existing in zone 2 cause the propagation slows down of the smaller cracks and only a few of the biggest ones continue to propagate. Such a phenomenon was observed in many applications in which the thermal fatigue was the main cause of damage [19–20,28].

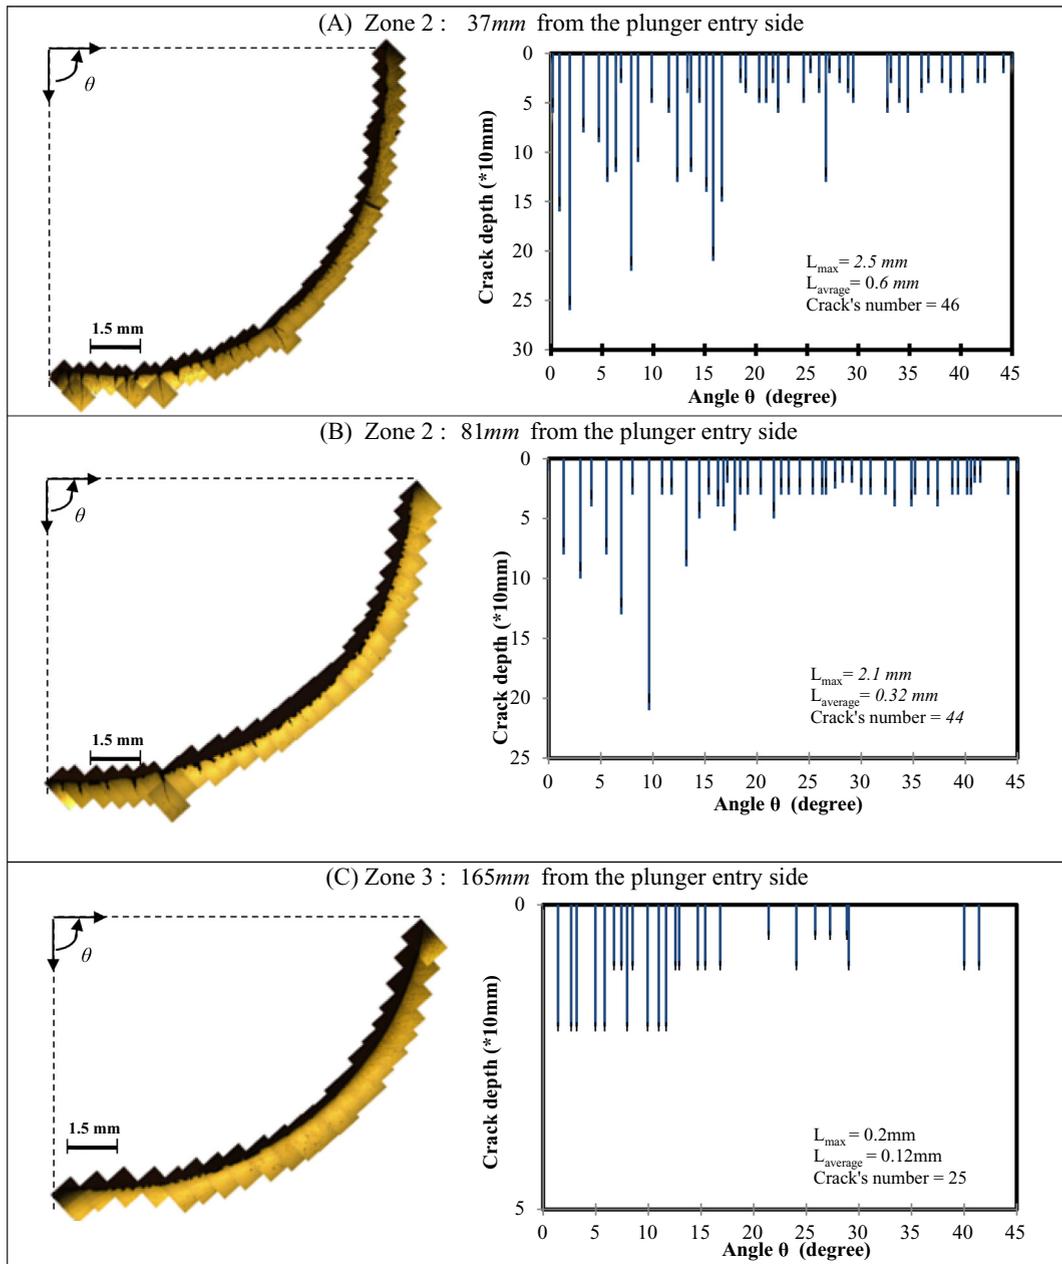
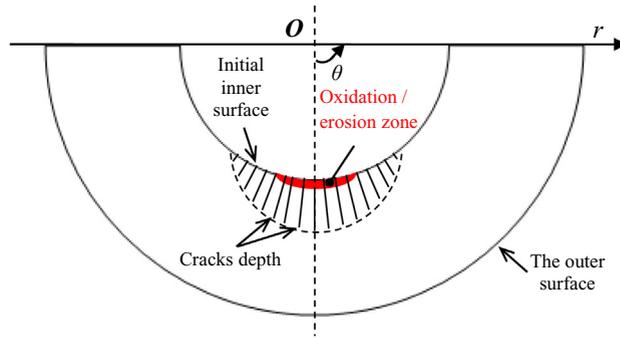
Fig. 11. Crack distribution of damaged shot-sleeve in cross-sections A, B and C.

(b) Cracks distribution along the cross section

The cracks depth investigation from the centre of shot-sleeve ($\theta = 0^\circ$) to the shot-sleeve horizontal plane ($\theta = 45^\circ$) for every shot-sleeve cross-sections A, B and C (Fig. 11). It is obvious that the maximal depths are sited at the level of the zone of casting. This result can be explained by thermal fatigue, oxidation and erosion by the molten brass flow which results in removal of superficial layer.

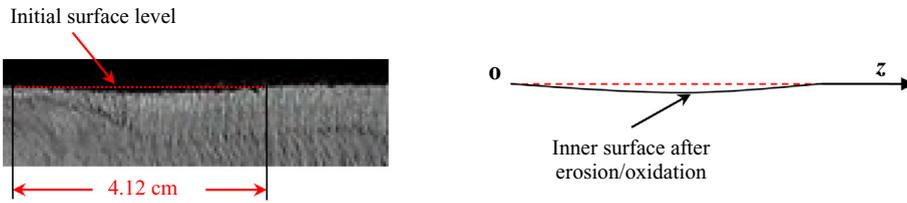
(a) along the axial direction

Fig. 12. Oxidation / erosion effect in the fall zone (Zone 2) of the shot-sleeve.

The initial level of the shot–sleeve casting zone (cited in zone 2) was decreased probably due to oxidation and erosion effects as shown in Fig. 12. The cracks situated surroundings the shot–sleeve centre (near $\theta = 0^\circ$) are in reality longer compared to their effective length due to the small decrease of the shot sleeve inner surface level produced after the oxidation / erosion effect. Others micro cracks are totally removed what favoured the propagation of persistent cracks because the motive force was located in them, is confirmed by previous research [1,29].

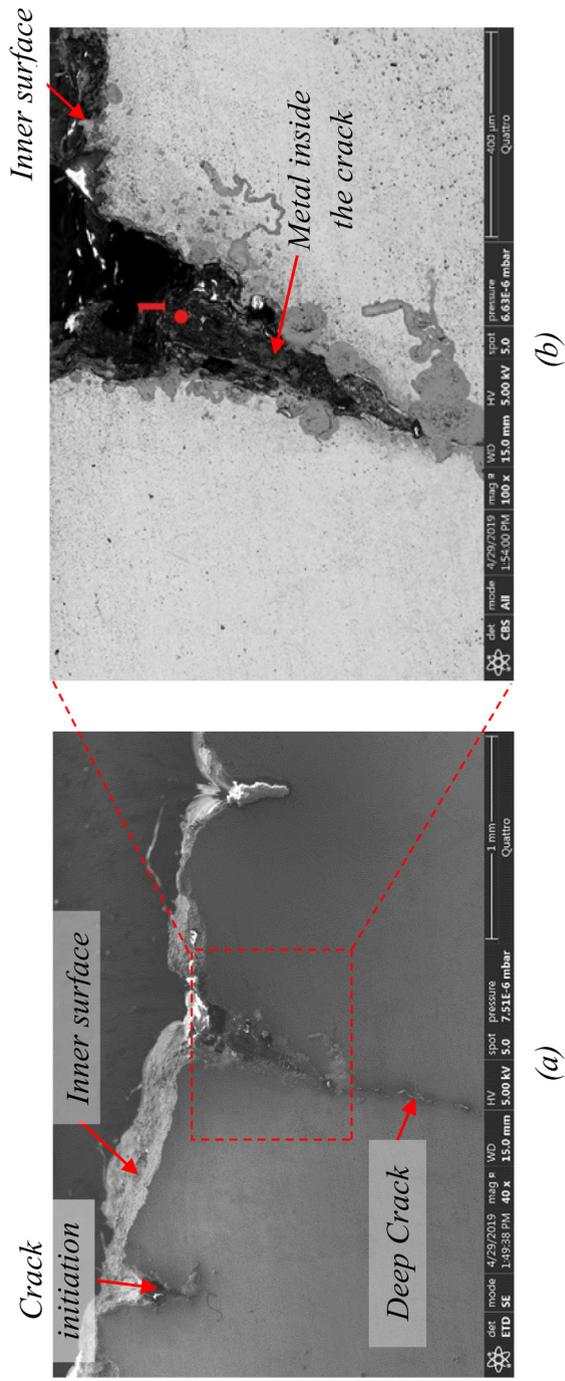
Fig. 13. SEM observation of a damaged shot sleeve cross-section: (a) Short (initiation) and deep crack, (b) Zoom on the examined crack with EDS (point 1).

In addition, in order to more understand the mechanisms leading to the shot sleeve failure, a sample of the cross-section surface was examined using SEM (Fig. 13) and Energy Dispersive X-ray Spectroscopy (EDS) to identify the chemical composition of the metal inside cracks (points 1 in Fig. 13 (b)) (Table 4). According to Fig. 13 (a), the cracks tend to propagate perpendicular to the damaged surface. The initial growth of thermal fatigue cracks is facilitated by an oxidation attack on the crack surface, which forms the Fe, Cu, Zn, Cr, Mo, Si and O rich layer (Table 4). The presence of brass and oxides, in the cracks increases plastic yield ($R_{p0.2}$) and compressive stresses during the heating phase of the thermal cycle [30]. As a result, the tensile stress is further increased during the cooling phase and can leads to the acceleration of the crack growth rate. In addition, the tensile stresses applied on the shot-sleeve inner surface during the cooling phase combined with the erosion phenomenon caused by the molten brass fall in the second zone leads to a local failure, which promote the opening of thermal cracks [13]. These cracks act as channels allowing oxygen to penetrate down to the crack tip area and oxidize both shot sleeve and the filling material. Solidified particles down on the crack act as an obstacle for its closer and the size of the crack openings in the filling material indicates the amount of brass that will fill the crack during the next cycle [20].
