Denis NAJJAR, François HENNEBELLE, Alain IOST, Henri MIGAUD - Common Features on Damage Mechanisms Identified on Various Metal and Ceramic on Polyethylene Articulating Surfaces of Total Hip Prostheses - Materials Science Forum - Vol. 539-543, p.629-634 - 2007

# Common features on damage mechanisms identified on various metal and ceramic on polyethylene articulating surfaces of total hip prostheses

**Abstract.** This paper presents a methodology for assessing the in-vivo degradation mechanisms of articular components of total hip replacement (THR) prostheses of Charnley type. The experimental procedure revealed that common features can be observed even if the clinical cases under investigation were quite different with regard to the demographic data. It particularly emphasises the detrimental effects of foreign bodies on the damage of the articulating surfaces. These foreign bodies can migrate into the joint space before embedding definitely into the Ultra High Molecular Weight Polyethylene (UHMWPE) acetabular cup surface where they further participate to a third body wear mechanism accelerated by a progressive increase of the femoral head roughness. Our experimental results under

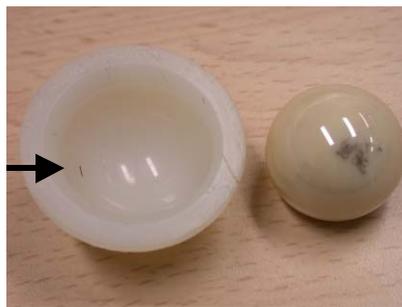
Whatever the diagnosis of revision (wear, osteolysis or broken multicable filament), it must be pointed out that polyethylene debris had been detected by histological analyses on periprosthetic tissues but that no loosening had occurred during lifetime. The four THR prostheses considered in this study were mainly retained because of the visual detection of metallic fibers embedded in the UHMWPE acetabular cups. Fig. 1 presents the retrieved articular components related to clinical case A and shows the presence of such a metallic fiber of millimetre size embedded into the surface of the UHMWPE acetabular cup but detected only after retrieval. Note also the adherent metallic deposit on the ceramic femoral head due to the friction of this counterface with the embedded fiber.

*Fig. 1: Retrieved components related to clinical case A. The fibber is marked by a black arrow.*

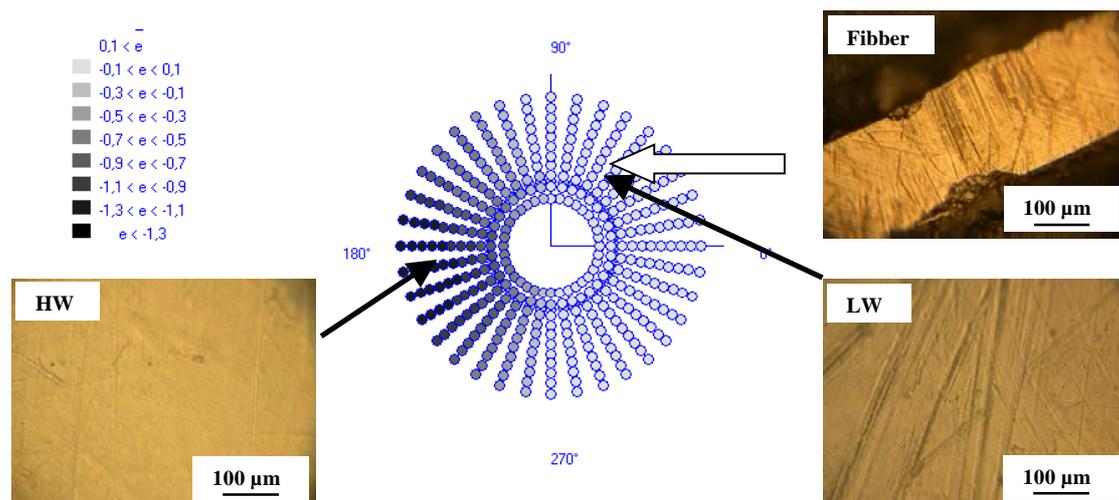
**Damage analysis of the UHMWPE acetabular inserts.** Whatever the retrieved acetabular cup analysed, the damage of the retrieved consists of dimensional changes at a macroscopic scale associated with degradation of surface topography at a microscopic scale. These retrieved acetabular cups exhibit two distinct areas that are symmetrically located. A first region is characterised by large deviations at a macroscopic scale and has a highly polished smooth appearance at naked-eye. Little scratches are detected by optical microscopic observations in this region denoted HW contrary to the other one denoted LW; region for which the recorded deviations are small (Fig. 2).

Fig. 2: Example of stereographic projection of deviations ( $e$  in mm) between points located on the internal surface of the retrieved acetabular cup and those located on a theoretical hemisphere of  $14$  mm radius (clinical case A). The white arrow indicates the location of the embedded fibber.

In agreement with the conclusions of these authors, it can be concluded that the large deviations recorded in the area HW indicate the effective direction of loading and are the consequence of the femoral head penetration in the UHMWPE acetabular cup by the combination of creep and a fatigue/adhesion wear mechanism. The related values of the maximum linear penetration rates in the UHMWPE are summarised in Table 2 for the four studied clinical cases. Such values are consistent with the clinical penetration rates reported in the literature. While these clinical penetration rates exhibit a great variability, they are generally less than about  $0.25 \text{ mm}\cdot\text{year}^{-1}$  and often correspond to an average of  $0.1 \text{ mm}\cdot\text{year}^{-1}$  or less [4,6]. Moreover, substantial clinical evidence now accumulating indicates that long term survival of the implant is associated with penetration rates of less than  $0.1 \text{ mm}\cdot\text{year}^{-1}$  while case requiring revision often exhibit penetration rates of about  $0.2 \text{ mm}\cdot\text{year}^{-1}$  or higher [6].

As far as the region LW is concerned, it is thought that the numerous scratches observed at the surface of the UHMWPE acetabular cups are the consequence of a third-body wear mechanism. Indeed, it is worth noting that some of the detected scratches exactly have the same shape and dimension as the metallic fibbers of millimetre size. Moreover, the surface of these metallic fibbers, always located in this region LW, are also severely scratched (Fig. 2).

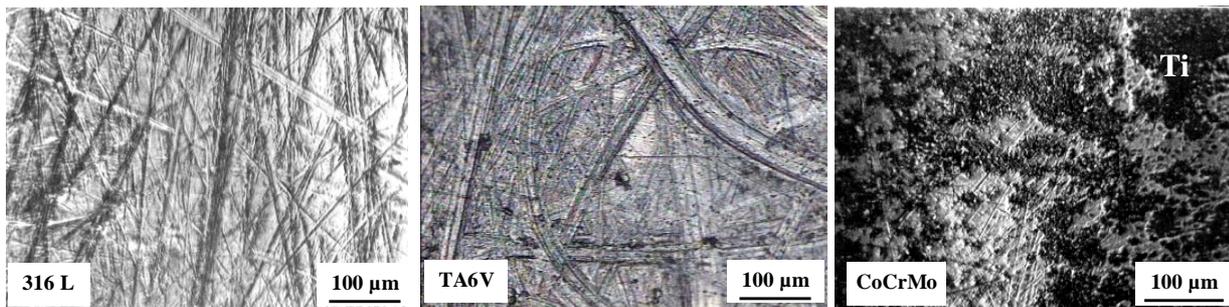
**Damage analysis of the femoral heads.** Hard foreign bodies undoubtedly increases the rate of removal of polyethylene, but they might be also responsible for the degradation of the retrieved femoral heads [2,4,7]. The deleterious effect of the embedded foreign third bodies of large dimensions is also evident at the surface of all the retrieved femoral heads under investigation in this study. However, the present results show that the wear mechanism at the origin of the degradation of the initial surface finish depends on the nature of femoral head. Indeed, numerous scratches are detected at naked-eye at the surface of the femoral heads made in 316L and TA6V passive alloys. Microscopic observations of such scratches obtained by means of an optical microscope are shown in Fig. 3. These scratches covers approximately 25% of the total surface of the femoral head in the case of the 316L alloy and more than 60% in the case of the TA6V alloy that, among the biomaterials used for manufacturing the femoral heads of THR prostheses, is known to be the less resistant one to abrasive wear. In the case of the CoCrMo alloy, the initial bright finish is only altered on a small area covering less than 10% of the total surface of the femoral head. Observations by means of a Scanning Electron Microscope (SEM) reveal that this area consists of very small scratches combined with an adherent metallic deposit (Fig. 3). As for the zirconia femoral head, this latter can be identified as a titanium deposit by Energy Dispersive Analysis of X rays (EDAX); chemical element which is contained in the original chemical composition of the fibbermesh deposited on the Harris-Galante Mark I metallic shells but not in those of the femoral heads under consideration. In other words, these metallic deposits result from an adhesive wear mechanism due to the friction between the embedded metallic fibbers of large dimensions and the femoral heads.

Fig. 3: Damage of the metallic femoral heads observed by means of an optical microscope for the 316L and TA6V femoral heads and by means of a SEM for the CoCrMo femoral head.

Whatever the wear mechanism, i.e. abrasive wear in the case of the 316L and TA6V alloys and mainly adhesive wear in the case of CoCrMo alloy and zirconia which are more resistant to abrasive wear, the degradation of the topography of the femoral heads leads to an increase of the effective roughness which has been shown to be a major factor in determining the wear of polyethylene and the long term performance of implants [1,3,8,9]. Indeed, whatever the femoral head, the experimental results reported in Table 3 show that the values of the average arithmetic roughness parameter recorded in the damaged areas are always significantly higher than those recorded in undamaged areas having a bright finish. Besides, these latter values are similar as those mentioned in the ISO 7206-2 standard which specifies the guidelines for new acetabular components of THR prostheses [10]. In agreement with others authors [4,6-9], it is also thought that, from a global point of view, the degradation of the initial surface finish by hard foreign bodies is a random phenomenon suspected to be a major factor responsible for the discrepancy existing in the literature between the average clinical and laboratory wear factors as well as the wide spread of results.
