# Common features on damage mechanisms identified on various metal and ceramic on polyethylene articulating surfaces of total hip prostheses

D. Najjar<sup>1</sup>, F. Hennebelle<sup>2</sup>, A. Iost<sup>1</sup>, H. Migaud<sup>3</sup>

**Abstract.** This paper presents a methodology for assessing the in-vivo degradation mechanisms of articular components of total hip replacement (THR) prostheses of Charnley type. The experimental procedure revealed that common features can be observed even if the clinical cases under investigation were quite different with regard to the demographic data. It particularly emphasises the detrimental effects of foreign bodies on the damage of the articulating surfaces. These foreign bodies can migrate into the joint space before embedding definitely into the Ultra High Molecular Weight Polyethylene (UHMWPE) acetabular cup surface where they further participate to a third body wear mechanism accelerated by a progressive increase of the femoral head roughness. Our experimental results underline, from a practical point of view, the need for careful manufacturing and clinical handling of porous surfaces, advocate for a systematic assessment of retrieved co

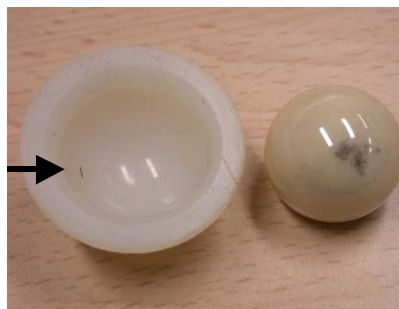
Whatever the diagnosis of revision (wear, osteolysis or broken multicable filament), it must be pointed out that polyethylene debris had been detected by histological analyses on periprosthetic tissues but that no loosening had occurred during lifetime. The four THR prostheses considered in this study were mainly retained because of the visual detection of metallic fibers embedded in the UHMWPE acetabular cups. Fig. 1 presents the retrieved articular components related to clinical case A and shows the presence of such a metallic fiber of millimetre size embedded into the surface of the UHMWPE acetabular cup but detected only after retrieval. Note also the adherent metallic deposit on the ceramic femoral head due to the friction of this counterface with the embedded fiber.

*Fig. 1: Retrieved components related to clinical case A. The fiber is marked by a black arrow.*

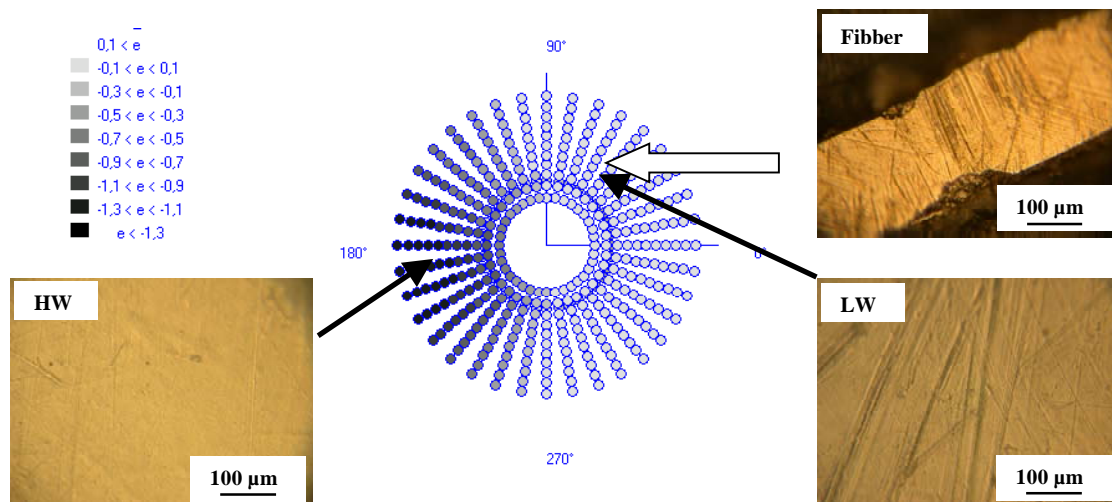
**Damage analysis of the UHMWPE acetabular inserts.** Whatever the retrieved acetabular cup analysed, the damage of the retrieved consists of dimensional changes at a macroscopic scale associated with degradation of surface topography at a microscopic scale. These retrieved acetabular cups exhibit two distinct areas that are symmetrically located. A first region is characterised by large deviations at a macroscopic scale and has a highly polished smooth appearance at naked-eye. Little scratches are detected by optical microscopic observations in this region denoted HW contrary to the other one denoted LW; region for which the recorded deviations are small (Fig. 2).

Fig. 2: Example of stereographic projection of deviations ( $e$  in mm) between points located on the internal surface of the retrieved acetabular cup and those located on a theoretical hemisphere of  $14\text{ mm}$  radius (clinical case A). The white arrow indicates the location of the embedded fibber.

In agreement with the conclusions of these authors, it can be concluded that the large deviations recorded in the area HW indicate the effective direction of loading and are the consequence of the femoral head penetration in the UHMWPE acetabular cup by the combination of creep and a fatigue/adhesion wear mechanism. The related values of the maximum linear penetration rates in the UHMWPE are summarised in Table 2 for the four studied clinical cases. Such values are consistent with the clinical penetration rates reported in the literature. While these clinical penetration rates exhibit a great variability, they are generally less than about  $0.25 \text{ mm}\cdot\text{year}^{-1}$  and often correspond to an average of  $0.1 \text{ mm}\cdot\text{year}^{-1}$  or less [4,6]. Moreover, substantial clinical evidence now accumulating indicates that long term survival of the implant is associated with penetration rates of less than  $0.1 \text{ mm}\cdot\text{year}^{-1}$  while case requiring revision often exhibit penetration rates of about  $0.2 \text{ mm}\cdot\text{year}^{-1}$  or higher [6].

As far as the region LW is concerned, it is thought that the numerous scratches observed at the surface of the UHMWPE acetabular cups are the consequence of a third-body wear mechanism. Indeed, it is worth noting that some of the detected scratches exactly have the same shape and dimension as the metallic fibbers of millimetre size. Moreover, the surface of these metallic fibbers, always located in this region LW, are also severely scratched (Fig. 2).

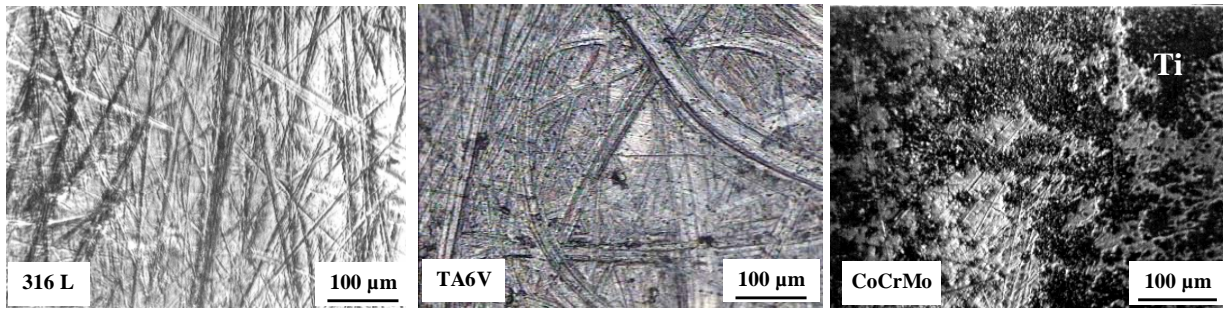
**Damage analysis of the femoral heads.** Hard foreign bodies undoubtedly increases the rate of removal of polyethylene, but they might be also responsible for the degradation of the retrieved femoral heads [2,4,7]. The deleterious effect of the embedded foreign third bodies of large dimensions is also evident at the surface of all the retrieved femoral heads under investigation in this study. However, the present results show that the wear mechanism at the origin of the degradation of the initial surface finish depends on the nature of femoral head. Indeed, numerous scratches are detected at naked-eye at the surface of the femoral heads made in 316L and TA6V passive alloys. Microscopic observations of such scratches obtained by means of an optical microscope are shown in Fig. 3. These scratches covers approximately 25% of the total surface of the femoral head in the case of the 316L alloy and more than 60% in the case of the TA6V alloy that, among the biomaterials used for manufacturing the femoral heads of THR prostheses, is known to be the less resistant one to abrasive wear. In the case of the CoCrMo alloy, the initial bright finish is only altered on a small area covering less than 10% of the total surface of the femoral head. Observations by means of a Scanning Electron Microscope (SEM) reveal that this area consists of very small scratches combined with an adherent metallic deposit (Fig. 3). As for the zirconia femoral head, this latter can be identified as a titanium deposit by Energy Dispersive Analysis of X rays (EDAX); chemical element which is contained in the original chemical composition of the fibbermesh deposited on the Harris-Galante Mark I metallic shells but not in those of the femoral heads under consideration. In other words, these metallic deposits result from an adhesive wear mechanism due to the friction between the embedded metallic fibbers of large dimensions and the femoral heads.

Fig. 3: Damage of the metallic femoral heads observed by means of an optical microscope for the 316L and TA6V femoral heads and by means of a SEM for the CoCrMo femoral head.

Whatever the wear mechanism, i.e. abrasive wear in the case of the 316L and TA6V alloys and mainly adhesive wear in the case of CoCrMo alloy and zirconia which are more resistant to abrasive wear, the degradation of the topography of the femoral heads leads to an increase of the effective roughness which has been shown to be a major factor in determining the wear of polyethylene and the long term performance of implants [1,3,8,9]. Indeed, whatever the femoral head, the experimental results reported in Table 3 show that the values of the average arithmetic roughness parameter recorded in the damaged areas are always significantly higher than those recorded in undamaged areas having a bright finish. Besides, these latter values are similar as those mentioned in the ISO 7206-2 standard which specifies the guidelines for new acetabular components of THR prostheses [10]. In agreement with others authors [4,6-9], it is also thought that, from a global point of view, the degradation of the initial surface finish by hard foreign bodies is a random phenomenon suspected to be a major factor responsible for the discrepancy existing in the literature between the average clinical and laboratory wear factors as well as the wide spread of results.
