Failure analysis of shot–sleeves used in brass high pressure die–casting process

A failure investigation has been conducted on a two cases of shot-sleeve used in brass-die casting and made up of AISI H10 tool steels to study their failure mechanisms. The chemical composition of the shot-sleeves material and the hardness profiles were evaluated. A preliminary examination of shot-sleeves reveal the presence of cracks network on their inner surfaces which proves that thermal fatigue was probably the main cause of their failure. A Meticulous investigation of these damaged surfaces reveal the presence of an additional small zone cited in the vicinity of the plunger entry side. This zone presents several scratches sign of abrasive wear. Then, the measurement of the cracks length and their linear density along longitudinal and transversal cuts of the damaged shot-sleeve sample are carried out. Results show that the observed cracks network can be divided into two zones. The first one was the most damaged in terms of cracks density and length given that it is the first zone which enter in contact with the molten metal. However, the cracks network examined in the second zone appears to be s

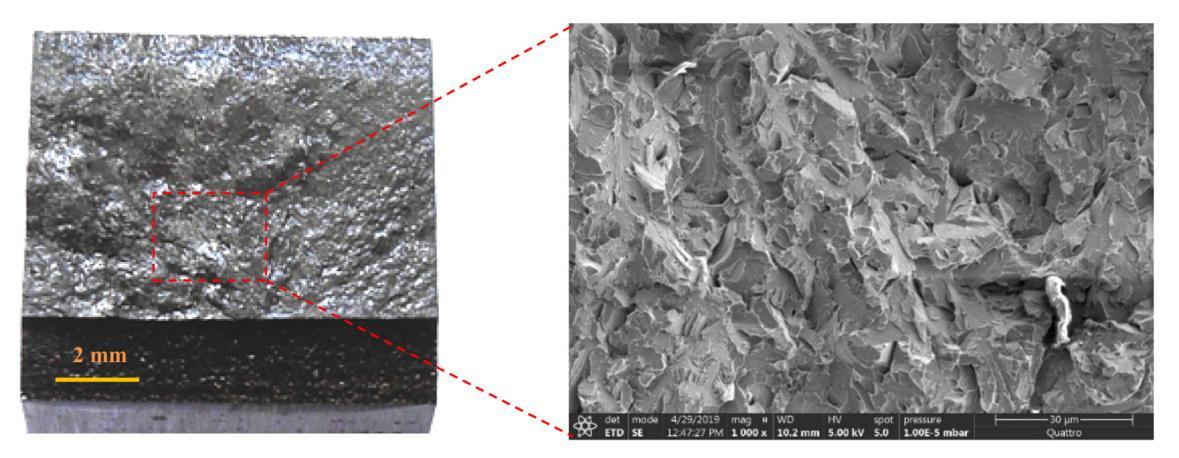
Fig. 5. Fracture surface of Charpy specimen. (a) macroscopic observation, (b) binocular microscope observation.

Standard Charpy V-notched specimens were machined from the failed shot-sleeve by a wire EDM machine (Fig. 4). Then, three tests were conducted at room temperatures to determine the material toughness. The average of the measured CVN energy (CVN = $3.4 \pm 0.1 \text{ J}$) and the feature of the fractured surface prove the brittle nature of the specimen material (Fig. 5).

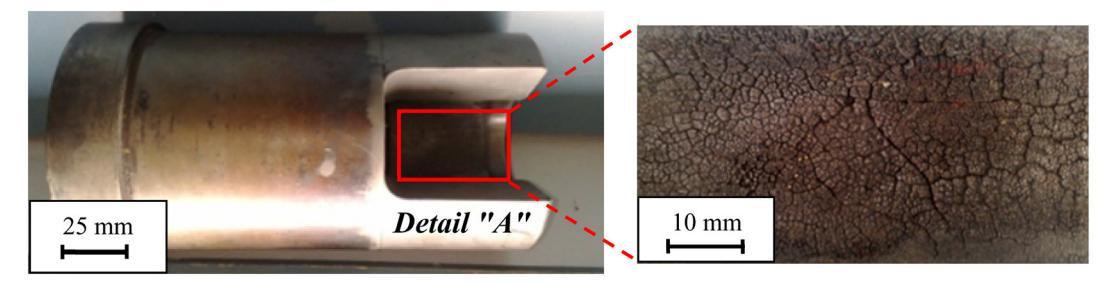
Fig. 8. Cracks network observed on the inner surface of the damaged shot-sleeve.

The second shot–sleeve was cut with a wire EDM machine according to their longitudinal direction to examine the integrity of the damaged surface (Fig. 8). After that, the cut–out parts are subjected to a surface cleaning operations: A chemical pickling with an alkaline solution using a dilute nitric acid was performed, at room temperature, to eliminate all traces of oxides. Then, the damaged shot–sleeve surfaces were subjected to a preliminary assessment with a naked eye to identify their major damage features. The examined surfaces (Fig. 9) clearly show the presence of a cracks network on the inner shot–sleeve surfaces.

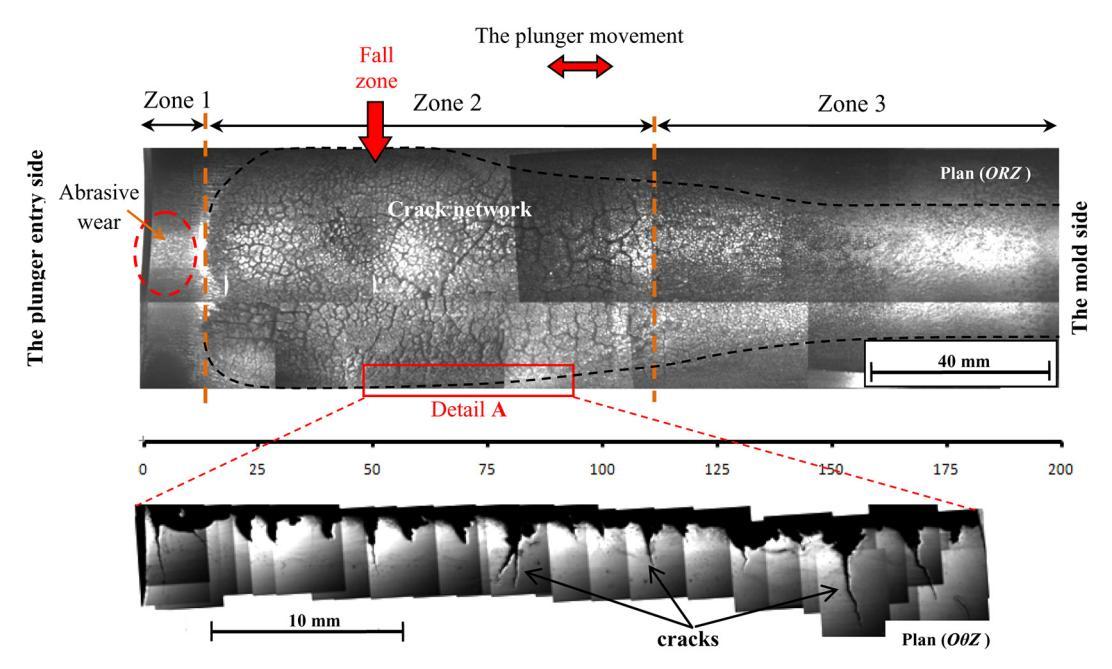
Fig. 9. Shot-sleeve inner surface damage observed with a digital camera.

A finer observations of the shot-sleeve inner side were carried out after a longitudinal cut (Fig. 6 (*b*)). The examination of the damaged surfaces was made using an experimental device equipped with a digital *Baumer*[®] camera *GIgE* (8 bits). This camera is equipped with a CCD sensor allowing to have a resolution of 1624×1236 pixels. Several photos are taken and then assembled by means of Photoshop[®] software to obtain a large image that cover the entire shot-sleeve examined surface (Fig. 9). This surface reveals the presence of three different zones. The first one is located in the plunger entrance side. It presents a number of scratch according the longitudinal direction which corresponds to abrasive wear caused by the friction between the plunger and the shot-sleeve. The second one corresponds to the first zone which enter in contact with the molten metal (T = 950 °C). It undergo cyclic thermal shocks. This zone appears to be the most damaged surface in the shot-sleeve. It presents a dense crack network sign of the thermal fatigue. In addition, the investigation of this zone according to the *OOZ* plan shows that some cracks, after initiation, were propagated in depth along the radial direction (Detail A). The last zone reveals also the presence of a crack network however it is less dense compared to this observed in the *2nd* zone (Fig. 9).

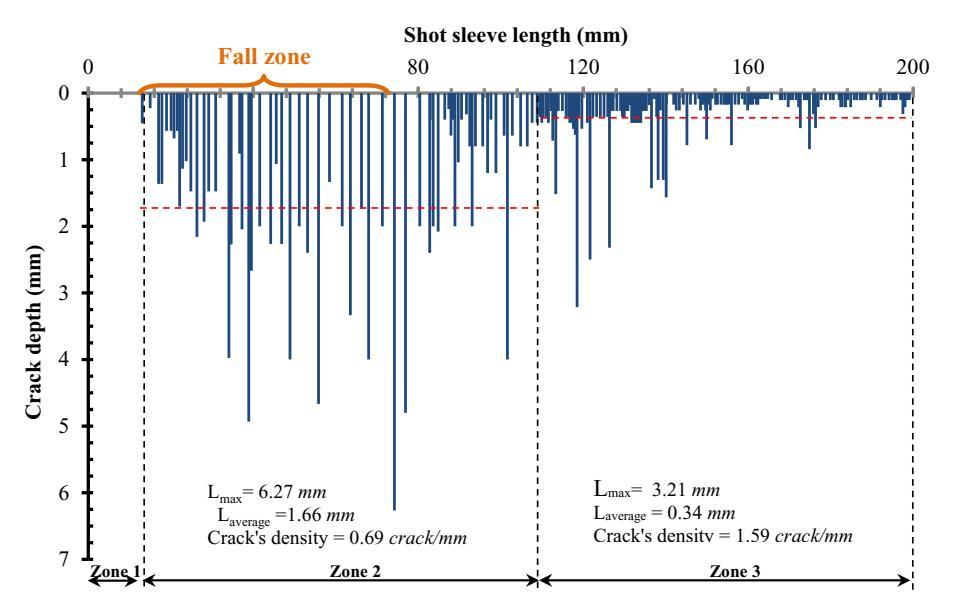
Fig. 10. Crack lengths distribution along the shot sleeve (longitudinal section $\theta = 0$).

In this section, a meticulous investigation on the cracks distribution and density was performed by means of longitudinal and transversal observations (Figs. 10 and 11). The cracks depth according to the axial distance was presented in Fig. 10. It is to be noted that the cracks depth trend along the shot–sleeve follows the Gaussian distribution. Fig. 10 shows that the cracks depth is maximal around the zone 2, which corresponds to the casting zone (fall zone). This zone is characterized by a maximum crack length and average values of 6.23mm mm and 1.66mm respectively. In zone 3 the cracks deep is less than those observed in zone 2 nevertheless their density is more pronounced (*i.e.* 1.59crack/mm in zone 3 against 0.69crack/mm in zone 2). The presence of the shielding effect between neighbouring cracks existing in zone 2 cause the propagation slows down of the smaller cracks and only a few of the biggest ones continue to propagate. Such a phenomenon was observed in many applications in which the thermal fatigue was the main cause of damage [19–20,28].

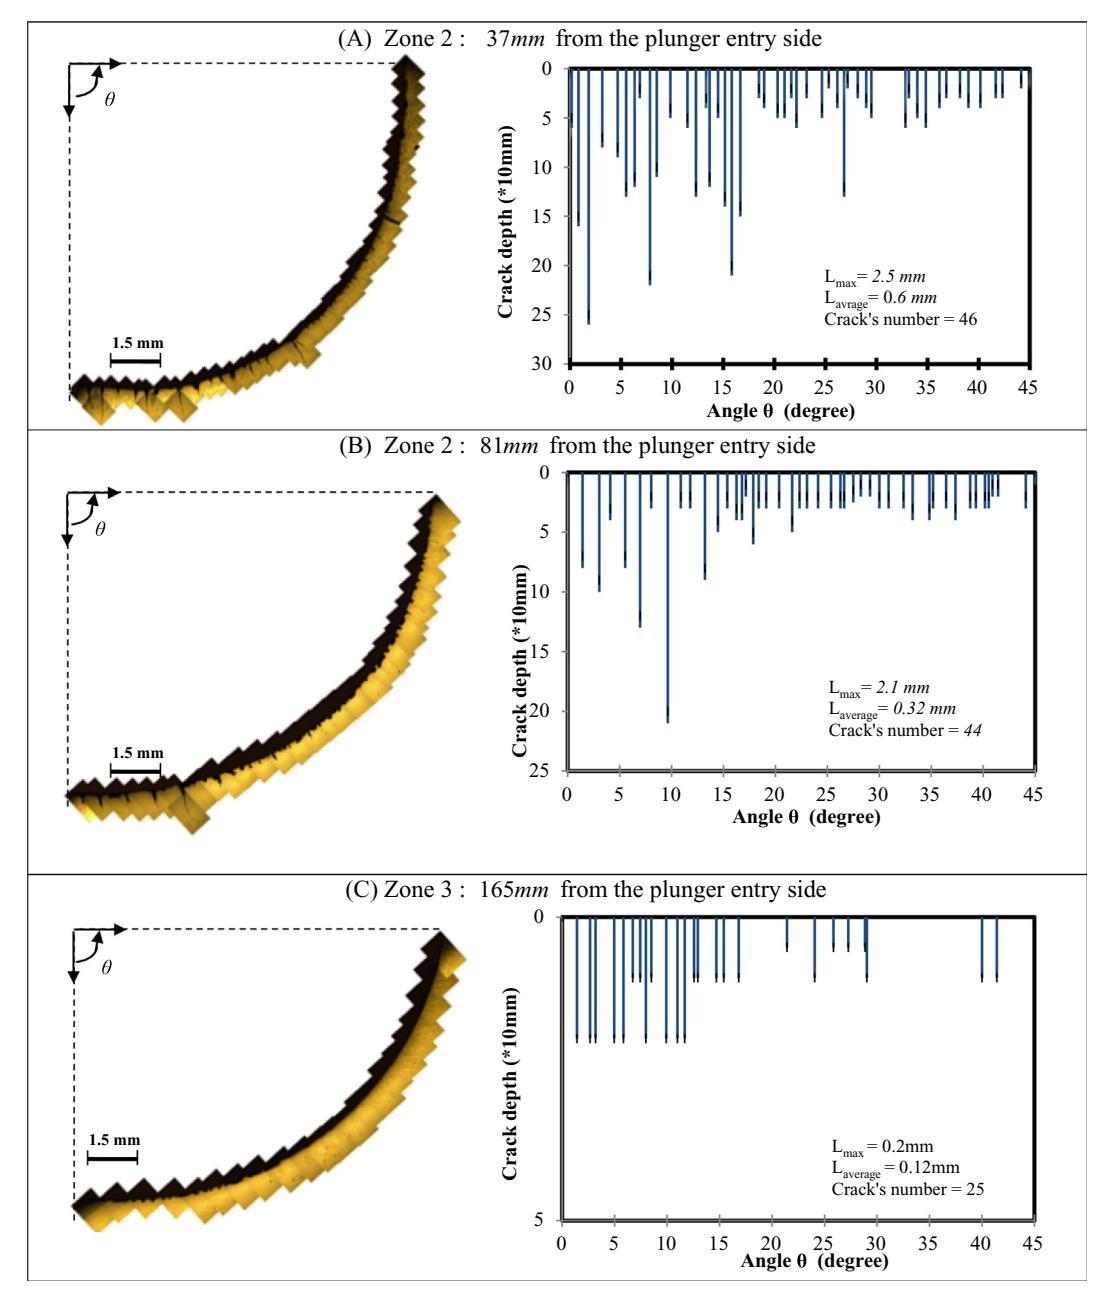
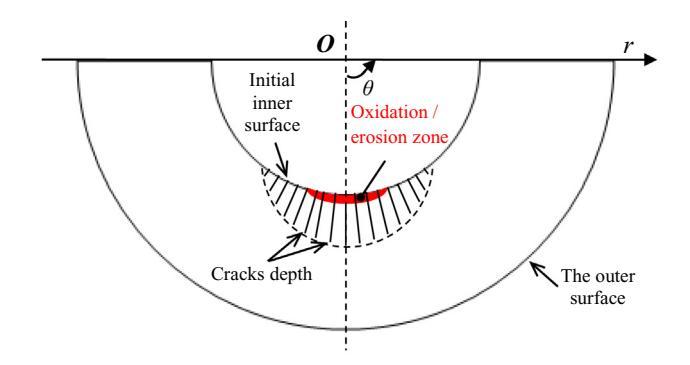
Fig. 11. Crack distribution of damaged shot-sleeve in cross-sections A, B and C.

(b) Cracks distribution along the cross section

The cracks depth investigation from the centre of shot–sleeve ($\theta = 0^{\circ}$) to the shot–sleeve horizontal plane ($\theta = 45^{\circ}$) for every shot–sleeve cross–sections A, B and C (Fig. 11). It is obvious that the maximal depths are sited at the level of the zone of casting. This result can be explained by thermal fatigue, oxidation and erosion by the molten brass flow which results in removal of superficial layer.

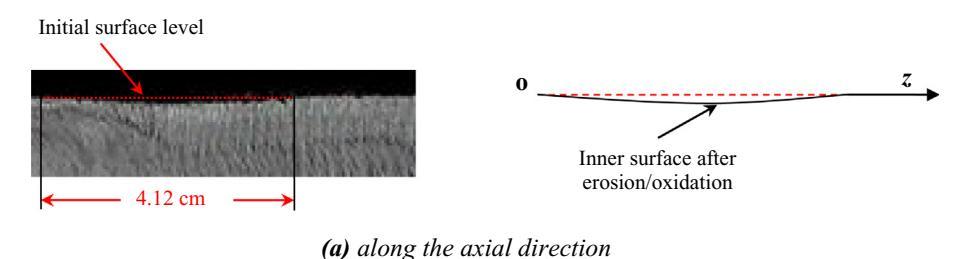
Fig. 12. Oxidation / erosion effect in the fall zone (Zone 2) of the shot-sleeve.

The initial level of the shot-sleeve casting zone (cited in zone 2) was decreased probably due to oxidation and erosion effects as shown in Fig. 12. The cracks situated surroundings the shot-sleeve centre (near $\theta = 0^{\circ}$) are in reality longer compared to their effective length due to the small decrease of the shot sleeve inner surface level produced after the oxidation / erosion effect. Others micro cracks are totally removed what favoured the propagation of persistent cracks because the motive force was located in them, is confirmed by previous research [1,29].

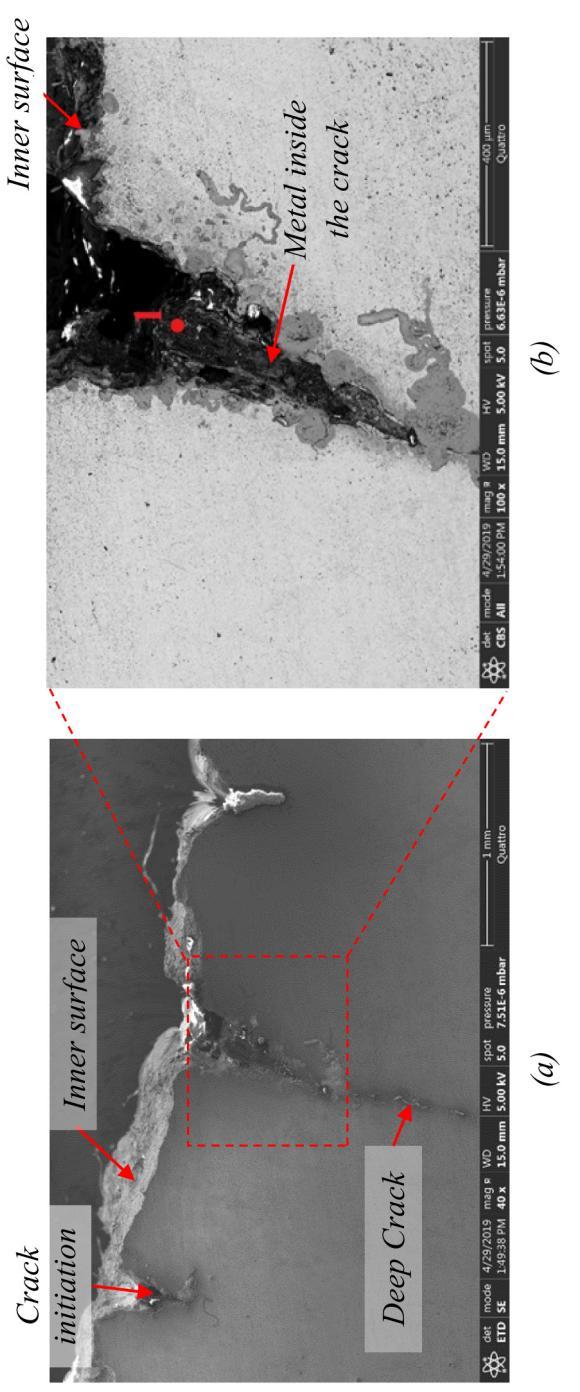
In addition, in order to more understand the mechanisms leading to the shot sleeve failure, a sample of the cross-section surface was examined using SEM (Fig. 13) and Energy Dispersive X-ray Spectroscopy (EDS) to identify the chemical composition of the metal inside cracks (points 1 in Fig. 13 (b)) (Table 4). According to Fig. 13 (a), the cracks tend to propagate perpendicular to the damaged surface. The initial growth of thermal fatigue cracks is facilitated by an oxidation attack on the crack surface, which forms the Fe, Cu, Zn, Cr, Mo, Si and O rich layer (Table 4). The presence of brass and oxides, in the cracks increases plastic yield ($Rp_{0,2}$) and compressive stresses during the heating phase of the thermal cycle [30]. As a result, the tensile stress is further increased during the cooling phase and can leads to the acceleration of the crack growth rate. In addition, the tensile stresses applied on the shot-sleeve inner surface during the cooling phase combined with the erosion phenomenon caused by the molten brass fall in the second zone leads to a local failure, which promote the opening of thermal cracks [13]. These cracks act as channels allowing oxygen to penetrate down to the crack tip area and oxidize both shot sleeve and the filling material. Solidified particles down on the crack act as an obstacle for its closer and the size of the crack openings in the filling material indicates the amount of brass that will fill the crack during the next cycle [20].
