Helmi DEHMANI, Thierry PALIN-LUC, Charles MAREAU, Samuel KOEHLIN, Charles BRUGGER - Study of the contribution of different effects induced by the punching process on the high cycle fatigue strength of the M330-35A electrical steel - Procedia Structural Integrity - Vol. 2, p.3256-3263 - 2016

Study of the contribution of different effects induced by the punching process on the high cycle fatigue strength of the M330-35A electrical steel

Helmi Dehmani^{a,b,c*}, Charles Brugger^b, Thierry Palin-Luc^b, Charles Mareau^c, Samuel Koechlin^a

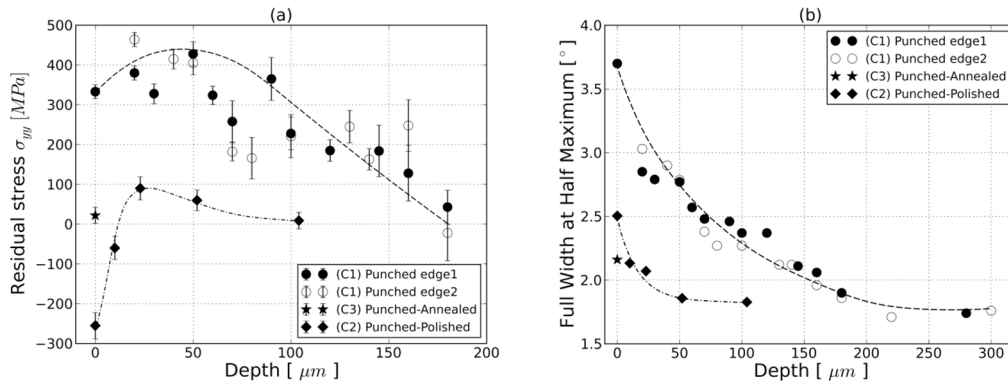
Fig. 5. (a) Longitudinal residual stress σ_{yy} profile for punched, punched-polished and punched-annealed specimens (b) Full Width at Half Maximum relative to X-ray analyses

X-ray diffraction techniques offer a better resolution for estimating the hardened depth. In the present work, because of the low sheet thickness, analyses were performed on a stack of 10 sheets. Each stress value was estimated on an irradiated zone which approximately corresponds to a 2 mm diameter disk. Residual stresses were determined first on punched edges, then on surfaces obtained after successive layer removal operations using electrochemical polishing techniques. Analyses were conducted for C1, C2 and C3 specimens. The results relative to the in-depth evolution of longitudinal residual stresses σ_{yy} are presented in Fig. 5a. Punched specimens exhibit high tensile residual stresses. However, for punched-polished specimens, important compression residual stresses exist on edges. For punched-annealed specimens, residual stress analyses were performed only on edges (zero depth). Results show that the high tensile residual stresses initially induced by punching are fully relieved after the annealing treatment. The Full Width at Half Maximum (FWHM) provides a qualitative evaluation of hardening. The evolution of the FWHM, associated with X-ray analyses, as a function of depth is plotted for C1, C2 and C3 specimens in Fig. 5b. The maximum value is obtained on the top surface of the edge, then values decrease and stabilize with an increasing depth. For punched specimens, the results show that the depth affected by punching operations is about 200 μm , which is consistent with micro-hardness measurements.
