Alexander NIKITIN, Thierry PALIN-LUC, Andrey SHANYAVSKIY, Claude BATHIAS - Comparison of crack paths in a forged and extruded aeronautical titanium alloy loaded in torsion in the gigacycle fatigue regime - Engineering Fracture Mechanics p.1-14 - 2016

## Engineering Fracture Mechanics

## Comparison of crack paths in a forged and extruded aeronautical titanium alloy loaded in torsion in the gigacycle fatigue regime

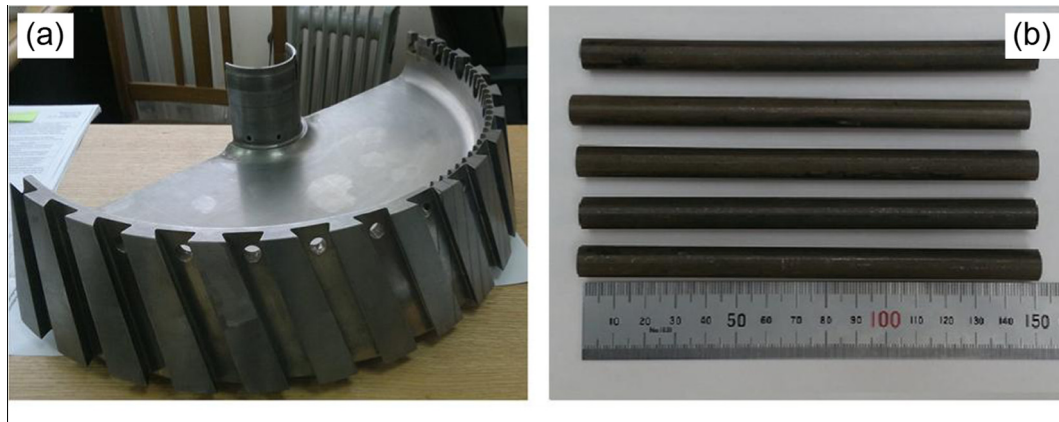
**Fig. 1.** Origin of the VT3-1 titanium alloy specimens, (a) compressor disk, (b) extruded bars and (c) the ultrasonic torsion specimen geometry, all the dimensions are in mm.

Two sets of specimens were used. The first set was machined from a real compressor disk of Tu-154 aircraft engine D30, (see Fig. 1a). This disk was produced by forging and was used in service for 6000 flight cycles (takeoff–landing). An estimation of in-service time is approximately 18,000 h. After having been taken out of service, the compressor disk was examined by two non-destructive techniques (NDT): (i) ultrasonic NDT and (ii) alternating current field measurement. The aim of these methods is to detect cracks. The typical detectable crack length is 50  $\mu\text{m}$  for ultrasonic NDT and about 5 mm for alternating current field. The results of these analyses did not show any noticeable fatigue damage due to the in-service loads and the disk was used to machine the ultrasonic fatigue specimens. The second set of specimens was machined from virgin extruded bars (Fig. 1b), produced by the “All Russian Institute of Light Alloys” with respect to their national standards [22]. The heat treatment of these bars was performed to obtain a fully lamellar microstructure (see Fig. 2) and mechanical properties close to those of the forged VT3-1 alloy, (see Table 2).

The geometry of the ultrasonic torsion specimens is the same for the two alloys and is shown in Fig. 1c.

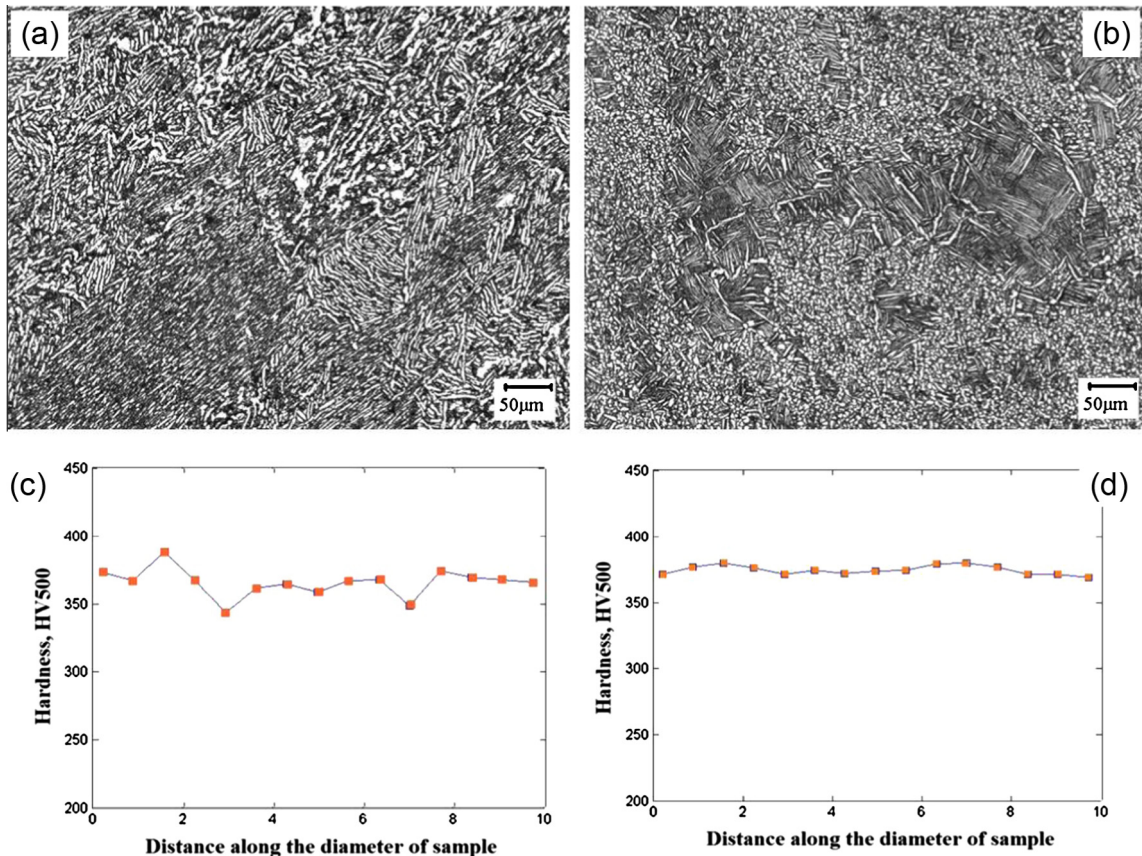
**Fig. 2.** Microstructure of the two VT3-1 alloys, (a) forged, (b) extruded and micro-hardness profiles along one diameter of the specimen cross section, (c) forged, (d) extruded.

[Fig. 2a](#) and [b](#) shows the microstructure of the forged and extruded alloys respectively. At the grain-size scale these alloys have a similar fully lamellar microstructure with elongated alpha-platelets. However, the platelet size in the forged alloy is larger (with a width of approximately  $w \approx 2 \mu\text{m}$  and a length of  $l \approx 10\text{--}15 \mu\text{m}$ ) compared to the extruded alloy ( $w \approx 1 \mu\text{m}$  and  $l \approx 2\text{--}3 \mu\text{m}$ ). At the macroscopic scale the microstructure of the extruded titanium alloy is more homogeneous compared to the forged alloy (except some zones in the core of the bar). The microstructure of the forged titanium contains large zones of length up to several hundred micrometers with similar platelets morphology and crystallographic orientation. These zones have been observed in forged Ti-alloys and referred to as ‘macro-zones’ [[23,24](#)].

The micro-hardness of the two materials is approximately the same: 364 HV<sub>500</sub> for the forged alloy and 373 VH<sub>500</sub> for the extruded VT3-1 alloy. Micro-hardness measurements were done in a plane perpendicular to the longitudinal axis of the specimen along one diameter. The results show significant scatter for the forged alloy (see [Fig. 2c](#)). The observed difference between the min and max values is 44 HV<sub>500</sub> for points spaced 1.2 mm apart. For the extruded alloy this difference is less than 5 HV<sub>500</sub> (see [Fig. 2d](#)). This result can be associated with the difference microstructures observed for the forged and extruded alloys. Indeed, the micro-hardness is lower in the macro-zones because the platelets have a similar crystallographic orientation. The existence of “macro-zones” in the forged VT3-1 microstructure explains the large scatter observed in the micro-hardness values.

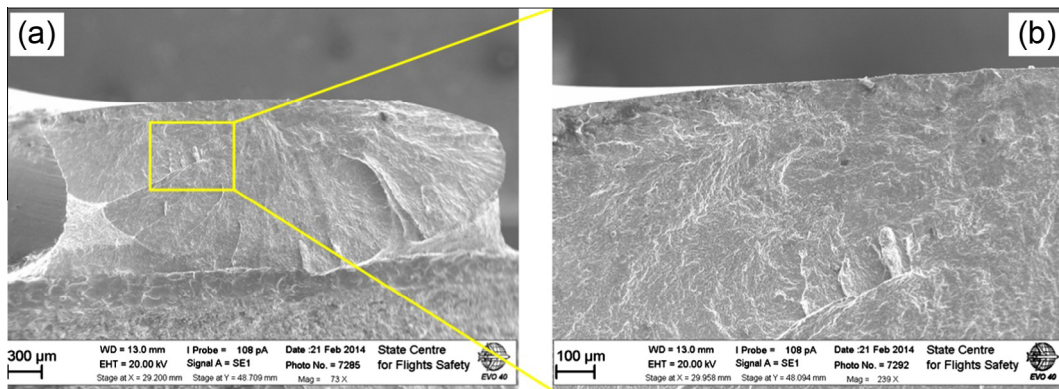
**Fig. 6.** ‘River-like’ marks for surface initiation in the extruded titanium alloy (a) overview of the failure surface and (b) zoomed view at the beginning of branching.

The zone of first stage crack growth is very small and limited by several tens of micrometers, (Fig. 5c and d). Moreover, due to the Mode II cracking this first zone is significantly destroyed by shear and friction, which makes it impossible to determine a specific feature of the microstructure at the origin of the crack initiation. This first zone is surrounded by separated areas with a crumpled failure surface that are formed due to contact at the crack edges. The same zones, destroyed by contact because of the fully reversed loads, were observed on the forged titanium alloy. The crumpled zones are located at a distance of about 100  $\mu\text{m}$  from the crack initiation site. Note that the non-crumpled failure surface is covered by small spherical particles that are mainly located in individual dimples as it can be seen later. Beyond the crack initiation area with the crumpled zones, the torsion crack propagates on a plane of maximum normal stress with the formation of a quasi-flat surface with slight perturbation by ‘river-marks’. Far from the crack initiation site, at a distance of about 300–400  $\mu\text{m}$ , an initial crack branch appears that can be seen as “river-like” marks on the failure surface, (Fig. 6).

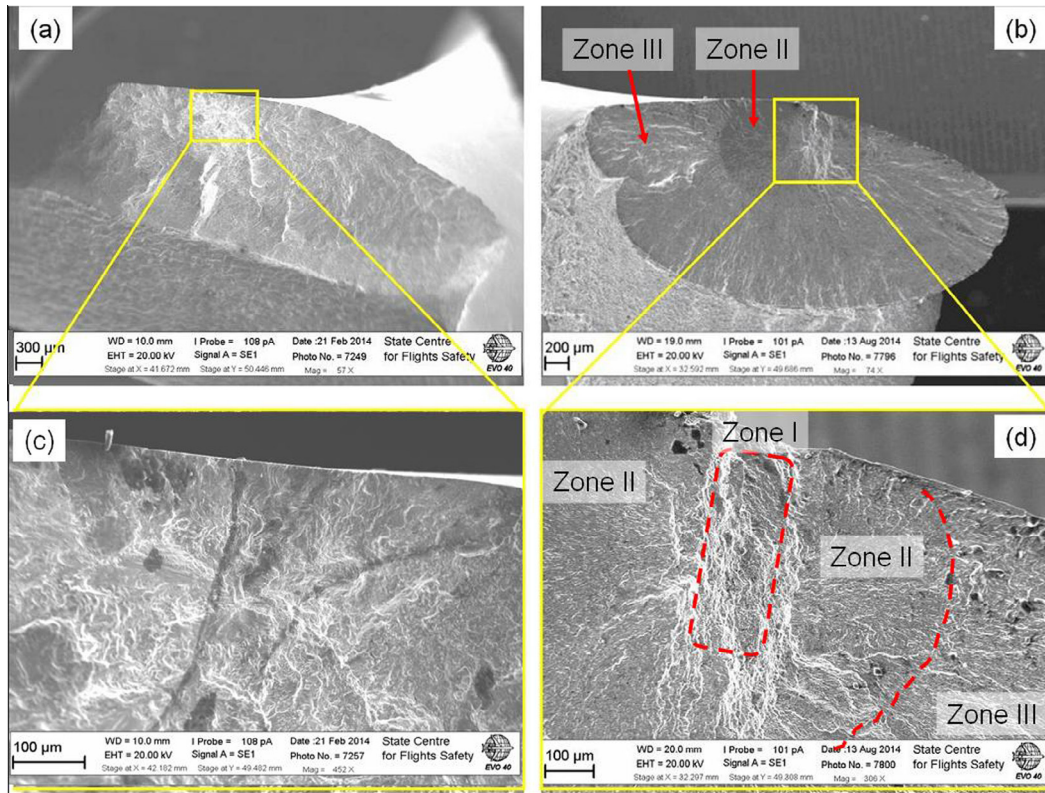
**Fig. 7.** Fatigue failure surfaces with subsurface crack initiation: macroscopic view for (a) forged and (b) extruded Ti-alloy, and zoomed views of the crack initiation area for (c) forged and (d) extruded alloys.

For the case of subsurface crack initiation the shape of the final macroscopic crack front also has an elliptical shape on the plane of maximum normal stress, as per surface crack initiation. The small axis of this ellipse is also orientated toward the center of the specimen for the two titanium alloys (see Fig. 7(a and b)).

A second remarkable feature of the failure surfaces for subsurface initiation is the clear transition from subsurface (zone II) to surface (zone III) crack propagation (see Fig. 7a and b). The subsurface crack propagation stage produces a smoother failure surface that is clearly seen as a “darker” area. When the torsion crack reaches the specimen surface the failure surface becomes rougher and its color is clearer. “Torsion wings”, already observed for surface crack initiation were also observed for subsurface crack initiation. It is important to outline that these “torsion wings” are formed during the subsurface crack propagation stage and continue to grow when the torsion crack reaches the specimen surface. Nonetheless, branching is less active in the case of subsurface crack initiation compared to surface initiation. This means that for subsurface crack initiation, the growth of several cracks in 45° planes is also possible, but limited. It is interesting to point out, that for high strength steel [16], a fracture surface with internal crack initiation does not show branching patterns (no 45° “wings”).

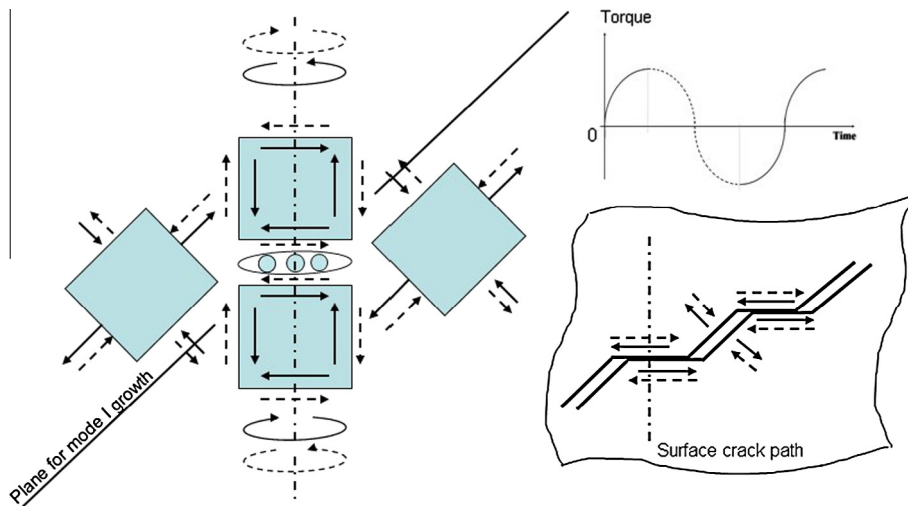
Fig. 9. Schematic illustration for the formation of spherical particles under cyclic torsion loads.

SEM observations on fracture surface show surface and subsurface crack initiations in the two materials. For the forged titanium alloy as well as the extruded VT3-1 alloy, the crack initiation site is found in the plane of maximum shear stress regardless the initiation mode. These planes are covered by spherical particles occurring in individual dimples. The spectral analysis of these spherical particles shows that they have the same chemical composition as the titanium alloy. The geometry of the dimples, where these particles are located, shows that there was no significant relative linear displacement of the crack lips during the formation of the particles (see Fig. 8a). Indeed, the shape of dimples is close to a hemisphere. The mechanism of formation of these particles seems to be similar to that proposed by A. Shanyavskiy [30] for bi-axial loads. Under torsion loads small modifications to the proposed mechanism [30] should be made as illustrated in Fig. 9.

The main idea behind the explanation is the local contact between the crack lips on the local plane (at meso-scale) of maximum shear stress when the long fatigue crack propagates under tensile stresses on the macroscopic plane experiencing the maximum normal stress. Due to the local loading conditions, the spherical particles are formed under a mixed mode (II + III) loading condition. The relative opening displacement of the lips in contact is limited and the cyclic loading produces particles formed in individual dimples (similar to fretting fatigue). The destruction of the crack initiation site by the previously described mechanism makes it impossible to study in detail the surface crack initiation mechanism in the VT3-1 titanium alloy under VHCF torsion loads. Concerning subsurface crack initiation, the crack initiation sites are usually located at a distance of about 200  $\mu\text{m}$  from the surface for the two titanium alloys. Moreover, for the forged titanium alloy it appears that the subsurface crack initiation site can be observed at different distances from the surface. The perturbed failure surfaces do not allow the confirmation of this, but some elements of the failure surface morphology make the assumption possible. It is clearly seen from the failure surfaces of the extruded titanium alloy, that the color of the failure surface is not the same for the subsurface and the surface crack propagation stages. The darker color is for subsurface crack propagation stage. As can be seen in Fig. 10 two zones with different colors can be distinguished.

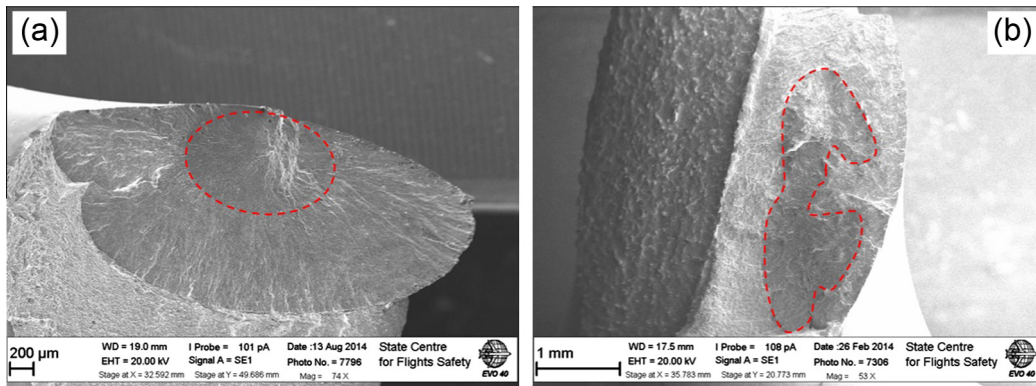
Fig. 10. Subsurface crack initiation with “fish-eye” failure surfaces in torsion, (a) the extruded VT3-1 alloy and (b) the forged alloy.

One zone surrounds the surface crack initiation site, which is on a plane of maximum shear stress and a second darker zone can also be seen. This zone is defined by the dotted red line in Fig. 10. The second zone is surrounding a feature of the fracture surface that is similar to that found for subsurface crack initiation in the forged VT3-1 alloy. This implies that for the forged titanium alloy, the complex structure containing macro-zones can have a very strong influence on crack initiation in torsion. For the case of subsurface crack initiation, the crack opening displacement is limited and the areas close to the crack initiation zone remain in contact during fatigue crack growth. This can be clearly seen on the failure surface where spherical
