# Isothermal fatigue damage mechanisms at ambient and elevated temperature of a cast Al-Si-Cu aluminium alloy

Pablo Wilson<sup>a,b</sup>, Nicolas Saintier<sup>a,\*</sup>, Thierry Palin-Luc<sup>a</sup>, Sebastien Bergamo<sup>b</sup>

<sup>a</sup> Arts et Metiers ParisTech, 12M bordeaux, CNRS, Esplanade des Arts et Metiers, 33405 Talence, France

<sup>b</sup> Renault S.A.S, 1 avenue du Golf, 78280 Guyancourt, France

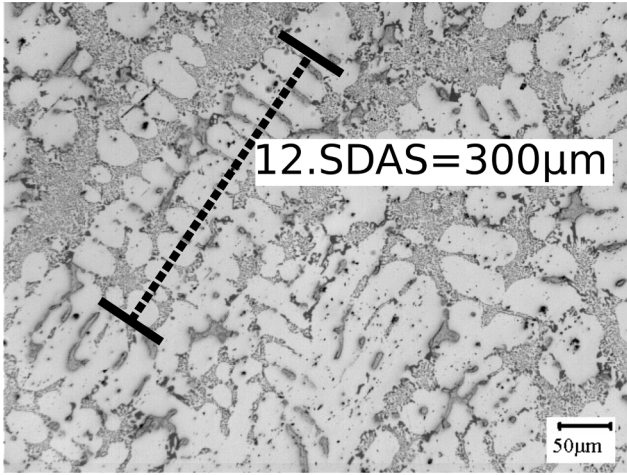
**Fig. 1.** Optical microstructure of specimen and SDAS measurement.

The microstructure exhibits dendritic solidification shown in Fig. 1. The secondary dendritic arm spacing (SDAS) is measured over 1 mm<sup>2</sup> in the center of the round bar, corresponding to the fatigue tested zone. Table 2 shows the observed mean SDAS value equal to 24 μm (measured on 102 values), which is among the values observed in the literature for similar casting process [16]. The casting process of the bars was specifically tailored in order for the SDAS to be relatively low and reproduce high cooling rates locations in components.

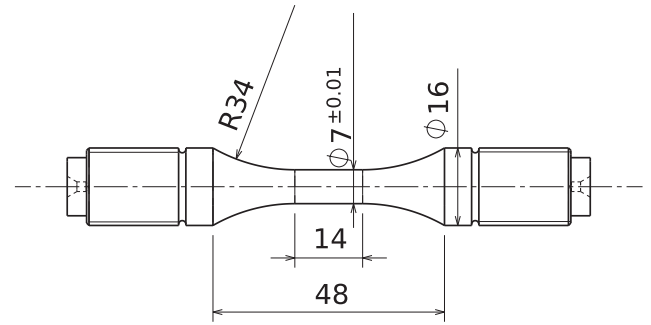
**Fig. 2.** Specimen geometry for low-cycle fatigue test.

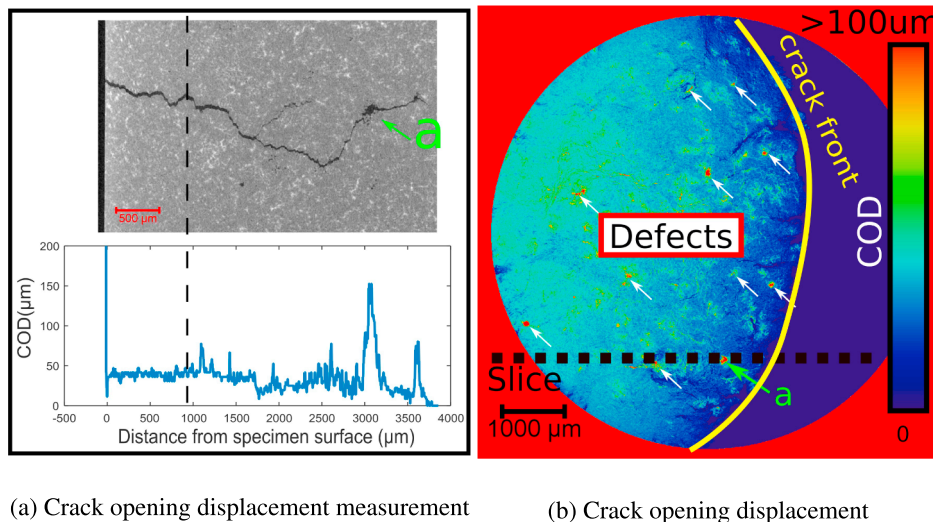
**Fig. 14.** Crack opening displacement and defect interaction. (specimen 62T5,  $\Delta\epsilon/2 = \pm 0.3\%$ ,  $250\text{ }^\circ\text{C}$ ,  $R_\epsilon = -1$ ,  $N_f = 2089$  cycles).

By analysing a specimen interrupted before final failure by tomography, defect interaction with crack can be seen in Fig. 14 for a high temperature test. The method applied is similar to that in [22]: the crack is thresholded and the crack opening displacement (COD) measured by counting the number of voxels belonging to the crack per vertical line  $l$  and converting using voxel resolution (see Fig. 14a). It must be noted the opening displacement is measured after testing, implying the specimen is not under tensile loading. In presence of defects, the measured displacement is the sum of COD and defect height, causing defects to appear red<sup>1</sup> on the map. Several defects can be seen for all crack advances. Especially, for the latter stages of crack propagation, defects influence the crack path at larger scales ( $\approx 1\text{ mm}$ ). This can be seen on the slice (see Fig. 14a) which displays a defect (label (a) in Fig. 14) that strongly influences the crack path.
