Evaluation of the performance of coated and uncoated carbide tools in drilling thick CFRP/aluminium alloy stacks

M. Montoya · M. Calamaz · D. Gehin · F. Girot

Keywords Drilling · Composite/aluminium stacks · Tools wear · Holes quality · Thrust force

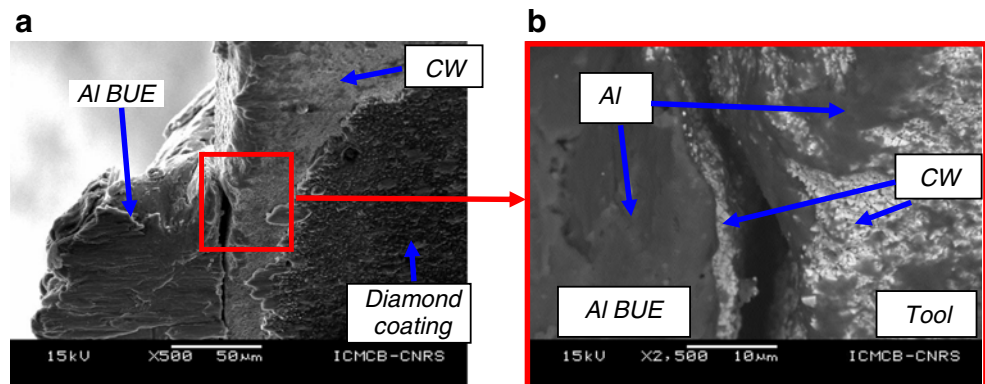
Fig. 7 a Attrition phenomenon on the cutting edges for tool B. **b** Zoom of the zone of interest, in chemical contrast (magnitude, 2,500)

For uncoated tools, abrasion was observed on the chisel edge, on the corner, on the primary and on the second cutting edges. Before the coating failure, coated drill B underwent the same type of wear as the uncoated drill. It was subjected to abrasion, followed by coating failure on the cutting edge. After the coating failure, an aluminium layer replaced it on the cutting edge and created a build-up edge (BUE). This adhesive wear is then the site of WC attrition. The BUE, stuck on the cutting edge, tears WC particles when it is removed, as observed on Fig. 7a, b.

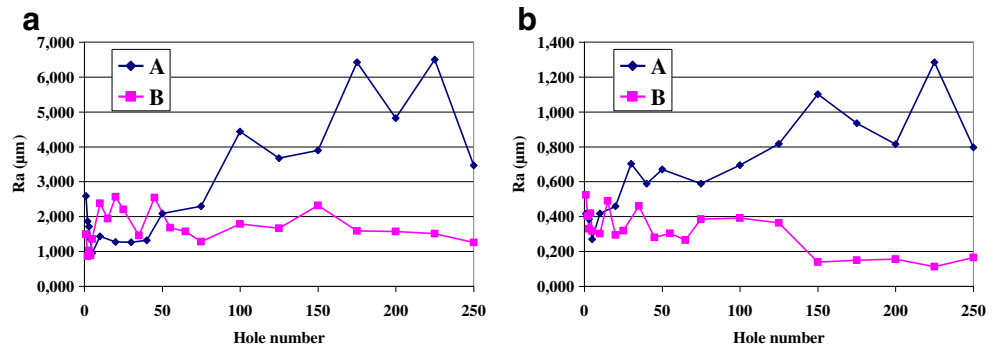
Fig. 14 Roughness Ra for the **a** CFRP part and **b** Al part

As it can be seen in Fig. 14, the hole wall roughness on the first 50 drillings was similar for uncoated (A) and coated (B) tools. The same roughness level was found by Zitoune et al. [12] in their study on the influence of machining parameters on drilling performance of CFRP/aluminium stacks.

The roughness of the holes performed by the uncoated tool (A) increases with the number of drilled holes, in both materials (Fig. 14a, b). This phenomenon is greatly problematic, because the roughness can become higher than the one required in the aeronautics industry. Currently, the maximum acceptable roughness in aeronautics is $1.6 \mu\text{m}$ in Al and $3.2 \mu\text{m}$ in CFRP. In the Al, the roughness increase is slight and remains at an acceptable level. In the CFRP part, the uncoated tool produces hole wall roughnesses higher than $3.2 \mu\text{m}$, after 75 drilled holes.

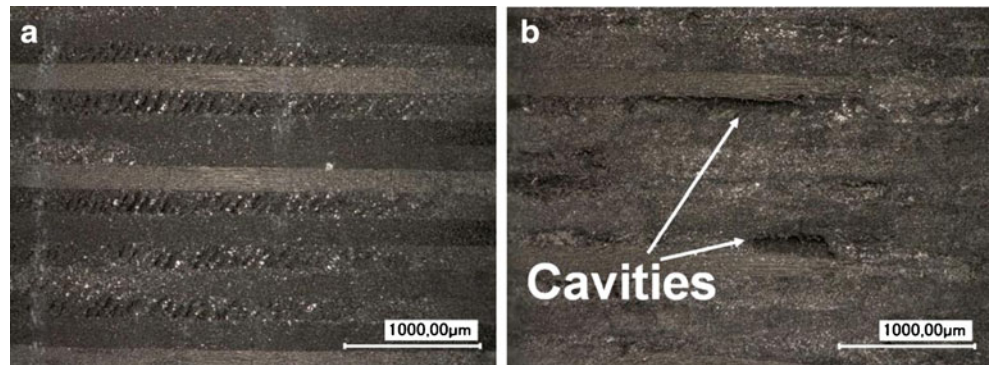
Fig. 15 CFRP hole wall on the **a** 1st and **b** 250th hole drilled by the uncoated tool A

The increasing of the roughness is due to the wear undergone by tool A and its rapid growth. Sharp cutting edges generate no defect on the holes wall (Fig. 15a) and low roughness is measured. When the tool cutting edge sharpness becomes too low, the drill is unable to cut the carbon fibres. These fibres are rather pulled out than cut, especially when the cutting direction and the fibres create a -45° angle. As a consequence, little cavities are generated on the holes wall (Fig. 15b) and therefore, the roughness increases. The same phenomenon was observed by Iliescu [20] when drilling CFRP plates.
