Evaluation of the performance of coated and uncoated carbide tools in drilling thick CFRP/aluminium alloy stacks

M. Montoya · M. Calamaz · D. Gehin · F. Girot

Abstract This paper aims to establish the wear mechanisms of coated and uncoated tungsten carbide drills when drilling carbon fibre reinforced plastics (CFRP)/aluminium alloy (Al) stacks. During the drilling experiments, thrust forces were measured. A scanning electron microscope (SEM) and a numerical microscope, provided with a scanning device, were periodically used to analyse tool wear mechanisms and to measure wear progression of the tool cutting edges. For both coated and uncoated drills, abrasion was the dominant tool wear mechanism, affecting the entire cutting edges. Higher wear was observed on uncoated tools which caused a significant increase in thrust force during drilling both Al and CFRP materials. The influence of these phenomena on the quality of the holes and on the generated roughness was also discussed.

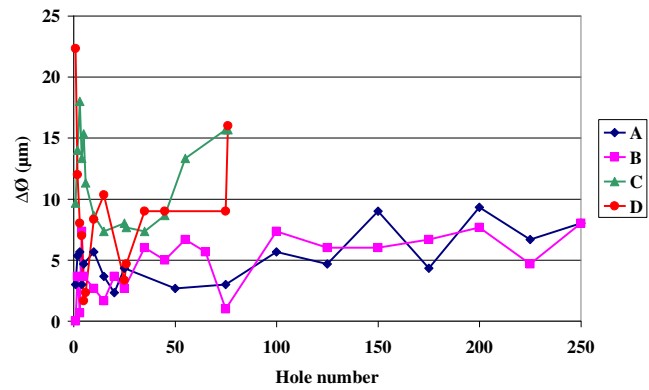
Fig. 12 $\Delta\phi$ evolution with the number of drilled holes

The difference between the average diameter in both altitudes in CFRP, and the diameter in metal, noted $\Delta\phi$, is shown in Fig. 12. Best results are observed for drills A and B with a $\Delta\phi$ of 8 to 9 μm against 16 to 18 μm for drills C and D. As it can be seen in Figs. 11 and 12, the presence of a coating has little or no influence on the diameter difference ($\Delta\phi$). No diameter deviation was observed with the number of holes, as it can be seen in Fig. 11. With a similar drill diameter, different results were obtained by Benezech et al. [17] where the diameter difference was nearly 30 μm .

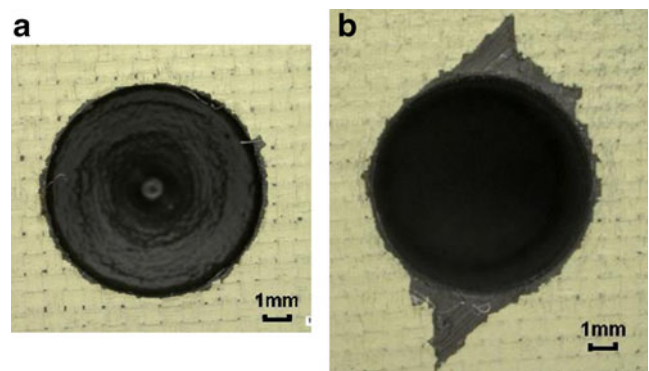
Fig. 13 CFRP damages at the hole entry a before and b after aluminium chip evacuation

The CFRP damage at the hole entrance, shown in Fig. 13b, was observed whatever the drill used, starting with the first hole. Therefore, it can be concluded that this phenomenon is not due to the tool wear. It can be caused by the tool geometry, as described by Hocheng et al. [19], where the drill flute pulls out the first layers of the composite material. Or, in the case of a multi-material, this damage can be due to the metallic chip evacuation through the hole, as observed by Brinksmeier et al. [8]. The last hypothesis has been proved in our case by observations made before aluminium part drilling and chip evacuation. Due to the chip removing cycle, the drilling process can be stopped at any time. For ten holes, the drilling process was stopped before creating aluminium chips. A workpiece photo was taken at this moment and no CFRP damage was observed, as it can be seen in Fig. 13a. After completed drilling process, the CFRP damage reaches more than 2 mm (Fig. 13b). The drill flute does not guide the chip

enough all along its length and, as seen by a CCD high speed camera, the metal chip is in contact with the hole entrance. As shown in Fig. 13b, this damage is not localised all around the hole entrance. It is situated in places where the direction of the chip movement (due to drill rotation) and the fibre orientation creates a -45° angle. In this configuration, similar damages have been observed by Iliescu [20] during CFRP cutting.

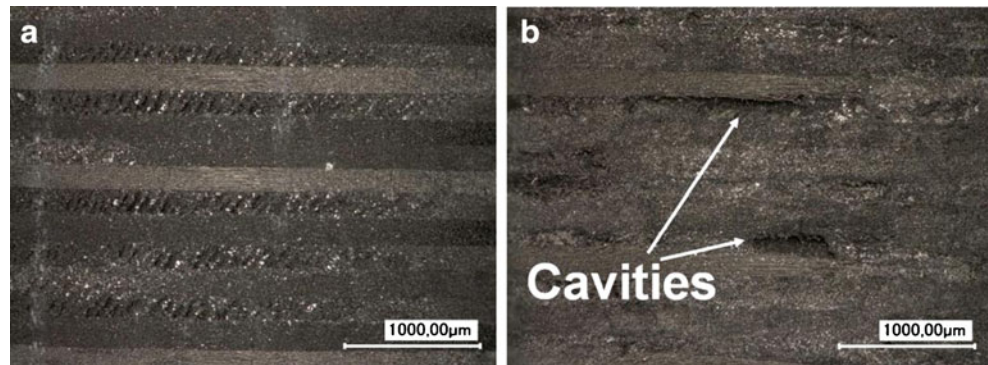
Fig. 15 CFRP hole wall on the **a** 1st and **b** 250th hole drilled by the uncoated tool A

The increasing of the roughness is due to the wear undergone by tool A and its rapid growth. Sharp cutting edges generate no defect on the holes wall (Fig. 15a) and low roughness is measured. When the tool cutting edge sharpness becomes too low, the drill is unable to cut the carbon fibres. These fibres are rather pulled out than cut, especially when the cutting direction and the fibres create a -45° angle. As a consequence, little cavities are generated on the holes wall (Fig. 15b) and therefore, the roughness increases. The same phenomenon was observed by Iliescu [20] when drilling CFRP plates.
