Benoit FURET, Guénaél GERMAIN, Yessine AYED, Amine AMMAR - Degradation modes and tool wear mechanisms in finish and rough machining of Ti17 Titanium alloy under high-pressure water jet assistance - Wear - Vol. 305, n°1-2, p.228-237 - 2013

Degradation modes and tool wear mechanisms in finish and rough machining of Ti17 Titanium alloy under high-pressure water jet assistance

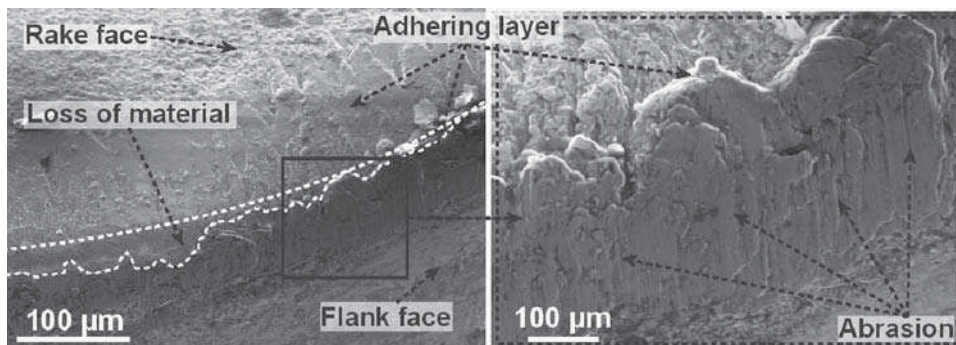
Fig. 4. SEM image of the tool rake/flank face after 20 min of machining in the finishing configuration with conventional lubrication.

Figs. 4–6 show the SEM images of the worn areas on the tool rake face and on the tool flank face for the three tests in the finishing condition. For conventional lubrication, significant flank wear at the nose radius (VBc) is observed. In addition, layers adhering to the rake face are noticed. During machining, the chip rubs on these adherent layers which appear to protect the rake face. However, when the formation of these layers reaches a stagnation level, they become instable and may be peeled-off

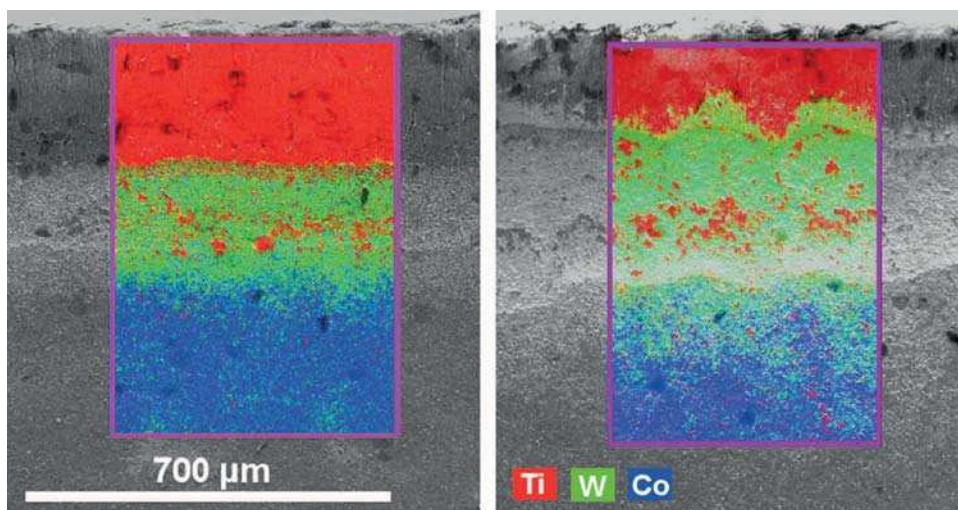
Fig. 15. EDS analysis after 4 min of roughing machining (100 bars and 250 bars, respectively).

Fig. 15 shows the tool rake face of two inserts after 4 min of roughing machining at 100 bars and 250 bars, respectively. It can be seen that the area of the adherent layers becomes smaller when the pressure is increased from 100 bars to 250 bars. In fact, the order of magnitude of the contact length is close to that found in the finishing condition.
