Yessine AYED, Guénaël GERMAIN, Amine AMMAR, Benoit FURET - Degradation modes and tool wear mechanisms in finish and rough machining of Ti17 Titanium alloy under high-pressure water jet assistance - Wear - Vol. 305, n°1-2, p.228-237 - 2013

# Degradation modes and tool wear mechanisms in finish and rough machining of Ti17 Titanium alloy under high-pressure water jet assistance

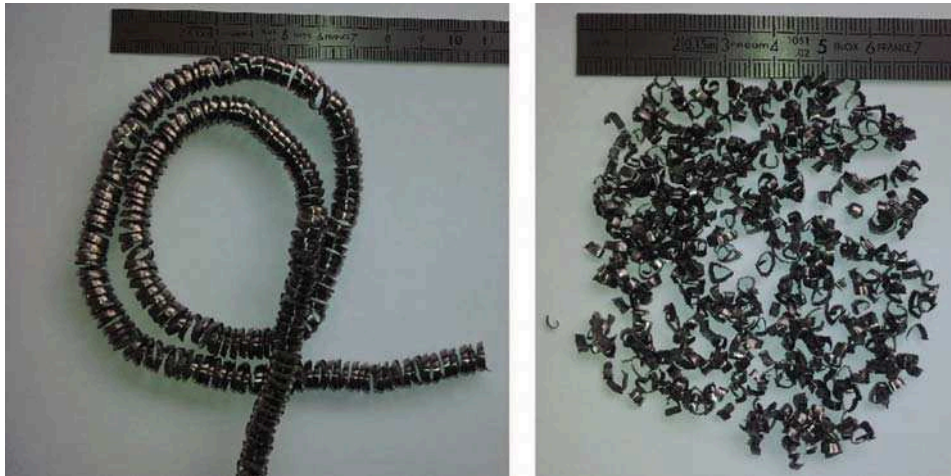
Fig. 2. Chip fragmentation at 100 bars (finishing condition).

Fig. 2 shows the morphology of the chips obtained when machining with conventional lubrication and with HPWJA at 100 bars, respectively. It can be seen that HPWJA ensures chip fragmentation.

After visual observation of the machined surface, the existence of scratches caused by the projection of the chips under the action of the lubricant jet was noticed. In fact, under the action of the high-pressure water jet, the chips are fragmented (with a length of about 3 mm) and are projected at high velocity onto the machined

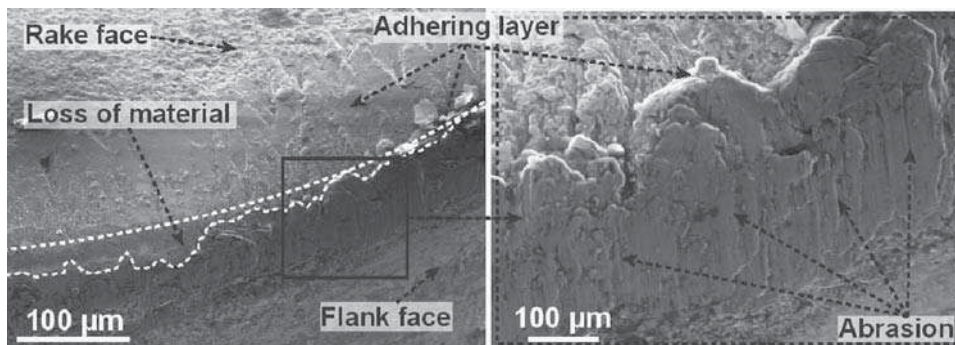
Fig. 4. SEM image of the tool rake/flank face after 20 min of machining in the finishing configuration with conventional lubrication.

Figs. 4–6 show the SEM images of the worn areas on the tool rake face and on the tool flank face for the three tests in the finishing condition. For conventional lubrication, significant flank wear at the nose radius (VBc) is observed. In addition, layers adhering to the rake face are noticed. During machining, the chip rubs on these adherent layers which appear to protect the rake face. However, when the formation of these layers reaches a stagnation level, they become instable and may be peeled-off

leading to wear by adhesion [10]. Alternatively, with HPWJA, a loss of material on the tool rake face and the formation of a crater can be seen. Damage in these areas is more important at a pressure of 250 bars. In this case, it seems that the most important wear mechanism is adhesion accompanied by abrasion and erosion.
