Yessine AYED, Guénaël GERMAIN, Amine AMMAR, Benoit FURET - Degradation modes and tool wear mechanisms in finish and rough machining of Ti17 Titanium alloy under high-pressure water jet assistance - Wear - Vol. 305, n°1-2, p.228-237 - 2013

# Degradation modes and tool wear mechanisms in finish and rough machining of Ti17 Titanium alloy under high-pressure water jet assistance

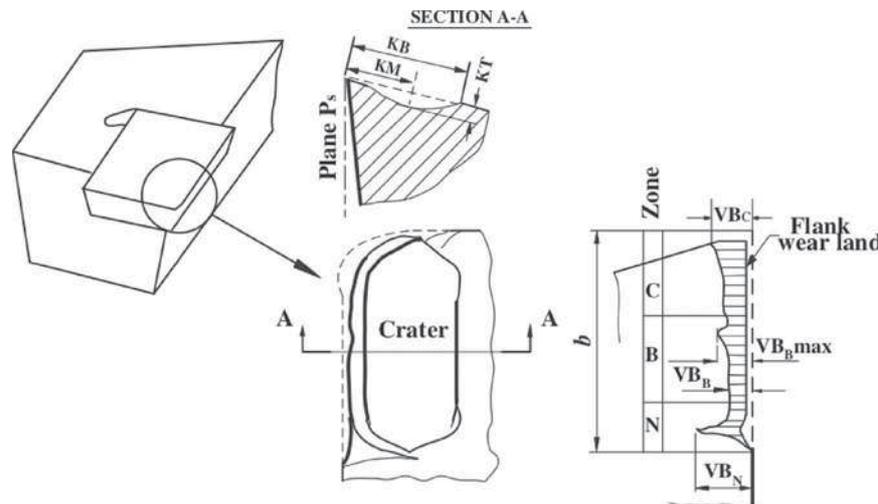
**Fig. 1.** Types of wear [9].

Tests were carried out to highlight the wear mechanisms and their evolution in conventional machining (without assistance) as well as under high-pressure water jet assistance. The machine used for these tests is a LEADAWELL LTC25iL lathe with a maximum power of 24 kW. Force measurement is done using a Kistler 9257B dynamometer which allows the acquisition of the three cutting force components. In order to inspect tool wear, a binocular microscope and a scanning electron microscope (SEM) were used. Fig. 1 shows the types of wear.

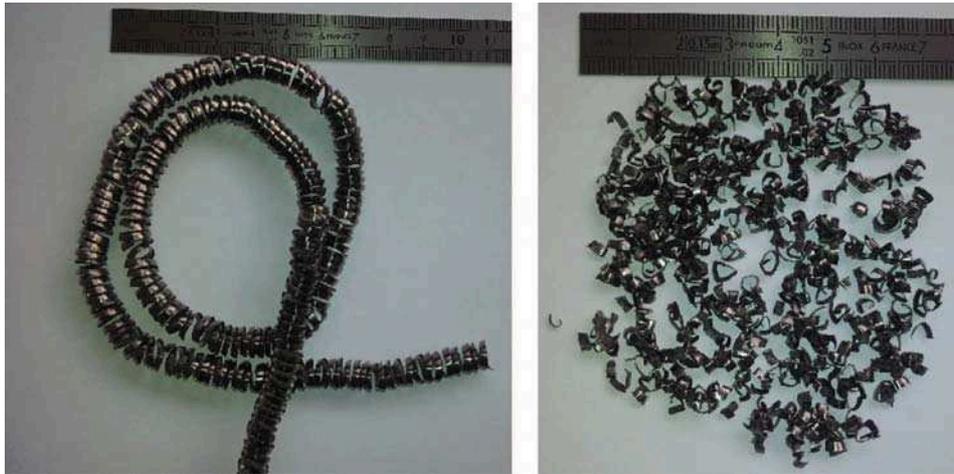
Fig. 2. Chip fragmentation at 100 bars (finishing condition).

Fig. 2 shows the morphology of the chips obtained when machining with conventional lubrication and with HPWJA at 100 bars, respectively. It can be seen that HPWJA ensures chip fragmentation.

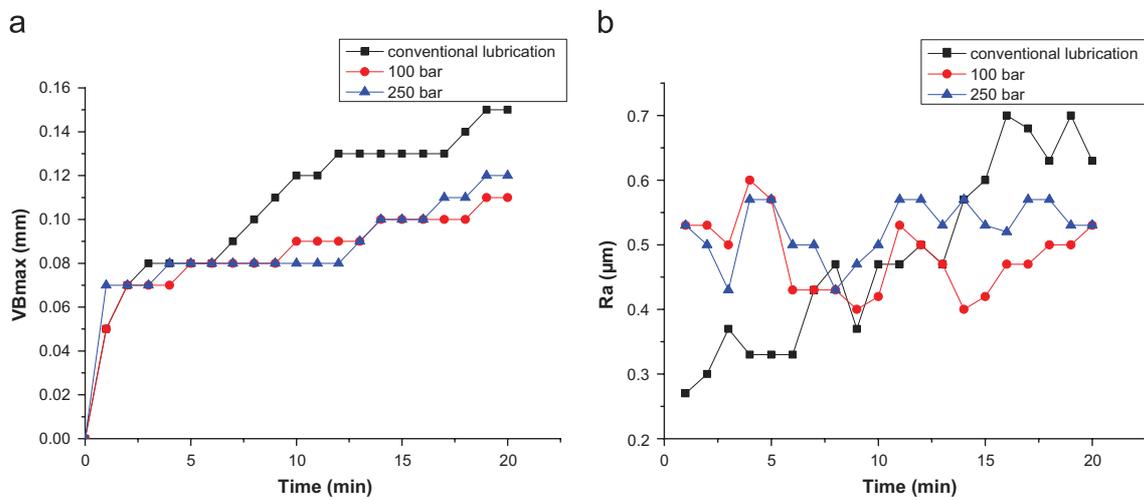
Fig. 3. (a) Flank wear (VB) and (b) surface roughness ( $R_a$ ).

Fig. 3(a) shows the evolution of the flank wear criterion (VB) and (b) the evolution of the  $R_a$  criterion. For all the configurations, flank wear (VB) does not exceed 0.15 mm after 20 min of machining, but its evolution is slower with HPWJA. Indeed, in conventional lubrication after the running-in phase, flank wear increases linearly to 0.15 mm after 20 min.

However, for the HPWJA condition, after the running-in phase, the flank wear remains constant for a significant period. Indeed, in both assistance configurations (100 bars and 250 bars), flank wear remains constant at about 0.08 mm for approximately 6 min at a pressure of 100 bars and for about 9 min at a pressure of 250 bars. After this stable regime, flank wear increases in a way similar to conventional lubrication. Fig. 3(b) shows a significant variation of surface roughness. For conventional lubrication, the surface roughness tends to increase linearly as a function of machining time, going from  $R_a = 0.25 \mu\text{m}$  to  $R_a = 0.7 \mu\text{m}$  (i.e.  $R_a$  reaches three times its initial value). For tests with high-pressure water jet assistance, the initial surface roughness is higher, but its value remains globally constant (between  $0.4 \mu\text{m}$  and  $0.6 \mu\text{m}$  throughout the test). In addition, there is no marked tendency for the surface roughness to increase even at the end of the test. The surface roughness thus appears uninfluenced by flank wear.

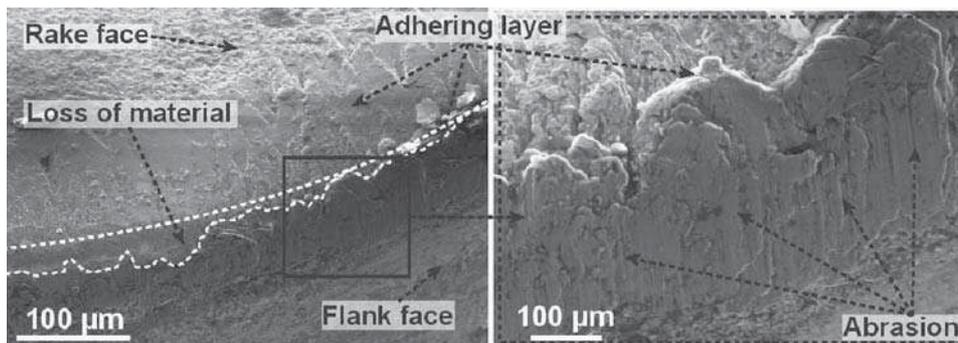
Fig. 4. SEM image of the tool rake/flank face after 20 min of machining in the finishing configuration with conventional lubrication.

Figs. 4–6 show the SEM images of the worn areas on the tool rake face and on the tool flank face for the three tests in the finishing condition. For conventional lubrication, significant flank wear at the nose radius (VBc) is observed. In addition, layers adhering to the rake face are noticed. During machining, the chip rubs on these adherent layers which appear to protect the rake face. However, when the formation of these layers reaches a stagnation level, they become instable and may be peeled-off

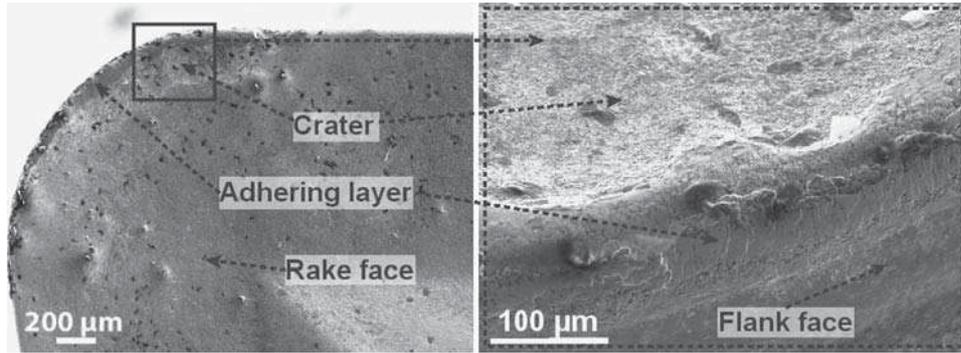
Fig. 5. SEM image of the tool rake/flank face after 20 min of machining in the finishing configuration with 100 bars.

leading to wear by adhesion [10]. Alternatively, with HPWJA, a loss of material on the tool rake face and the formation of a crater can be seen. Damage in these areas is more important at a pressure of 250 bars. In this case, it seems that the most important wear mechanism is adhesion accompanied by abrasion and erosion.

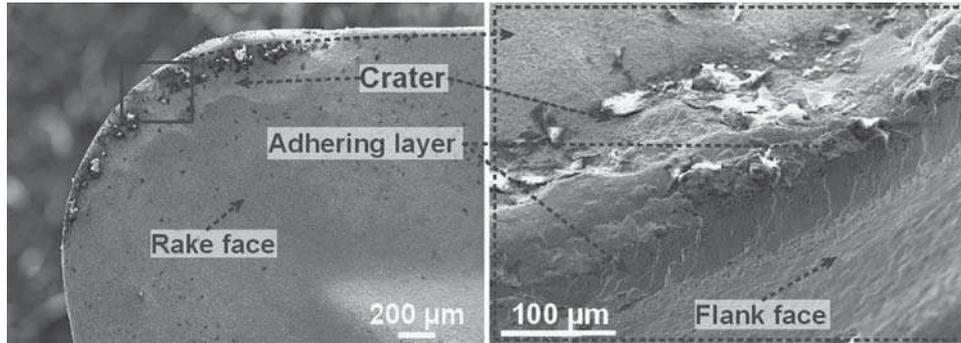
Fig. 6. SEM image of the tool rake/flank face after 20 min of machining in the finishing configuration with 250 bars.

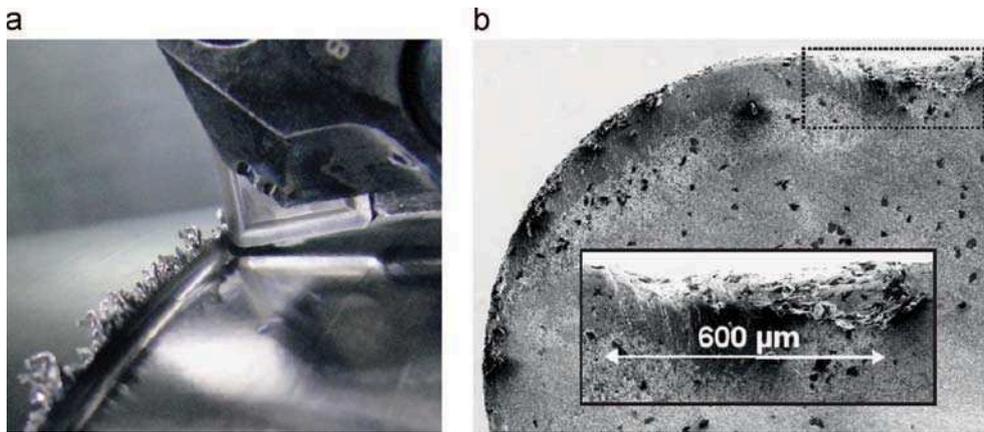
Fig. 7. (a) Formation of burr on the work-piece and (b) notch wear after 20 mm of finishing machining with conventional lubrication.

For conventional lubrication conditions, burrs are formed on the work-piece during machining, as shown in Fig. 7. At the height corresponding to these burrs, significant notch wear (VBn) is formed. The width of the notch is around 600  $\mu\text{m}$  after 20 min of machining. However, no burrs and no notch wear are visible under high-pressure water jet assistance. The specific effort has a slow and gradual evolution, but it is slightly lower in HPWJA.

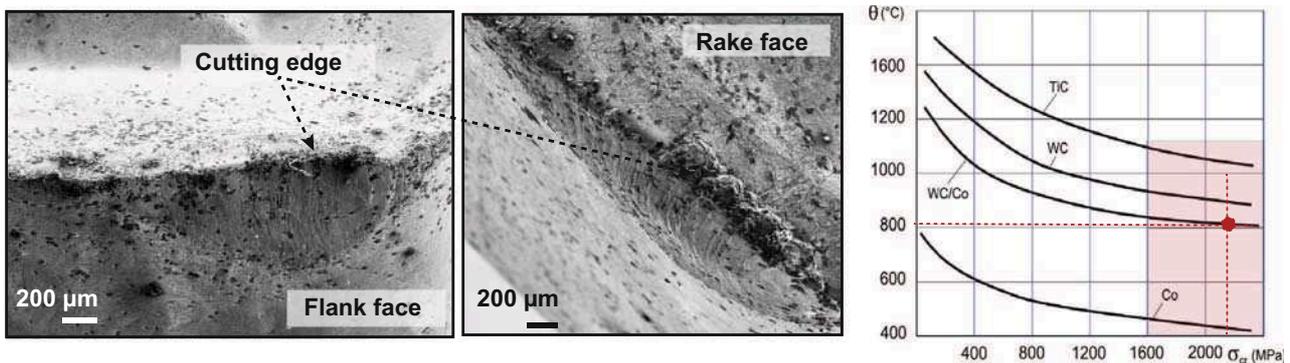
Fig. 8. (a) Image of the cutting edge after 75 s of roughing machining with conventional lubrication and (b) creep resistance [12].

pressure  $K_C$  (about 2100 MPa). Fig. 8(a) shows tool rake and flank faces after 75 s of roughing machining.

The measurement of the cutting force reveals that the average specific pressure is around 2100 MPa in conventional machining. Fig. 8(b) shows that, to avoid creep in the tool when exposed to a contact pressure of 2100 MPa, the cutting temperature must not exceed 900  $^{\circ}\text{C}$  for the WC and 800  $^{\circ}\text{C}$  for the WC/Co inserts. However, these temperatures correspond to those obtained when machining titanium [13–15]. This result confirms the degradation mode of the cutting edge by creep in conventional machining.

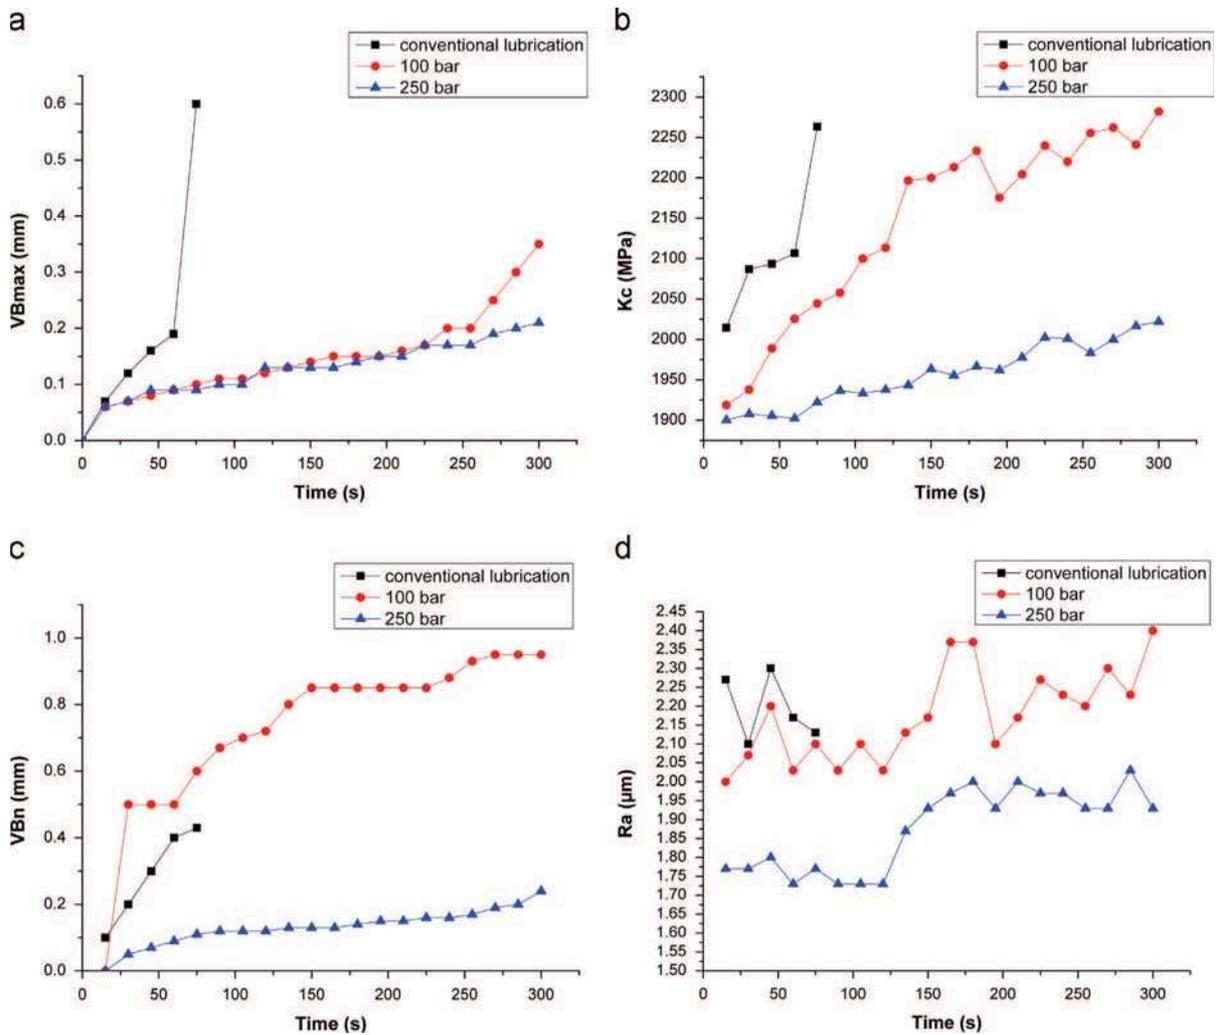
Fig. 9. Evolution of (a) flank wear, (b) specific cutting pressure, (c) notch wear, and (d) surface roughness.

By contrast, for the case of high-pressure water jet assistance, this degradation mode is no longer dominant, the cutting edge does not collapse. This can be explained by the fact that the high-pressure lubrication can greatly reduce the temperature in the cutting zone [16–18]. In addition, the cutting pressure decreases slightly to a value of approximately 1950 MPa. Fig. 9(a) shows that flank wear progresses very quickly under conventional lubrication with rapid collapse of the tool. Under HPWJA, the evolution of flank wear increases slowly and steadily.

This evolution is the same for both assistance pressures. However, from 4 min of machining, wear is accelerated at 100 bars. For a machining time of 5 min, flank wear is around 0.35 mm at 100 bars and around 0.21 mm at 250 bars. For a tool wear criterion set to 0.2 mm, tool life is less than 1 min in conventional machining and about 5 min at 250 bars; so, tool life is multiplied by a factor of 5.

The notch wear, VBn was also observed. Fig. 9(c) shows the evolution of notch wear for the three lubrication configurations in the roughing condition. With conventional lubrication, the notch size increases significantly with machining time. It reaches a value of 0.4 mm when the tool cutting edge collapses. Therefore, the tool degradation mode is the collapse of the cutting edge by plastic deformation, not by notch wear. With water jet assistance at 100 bars, a relatively large notch (0.5 mm) is present from the start of the test and progresses constantly until it reaches 0.95 mm after

Fig. 9(b) shows the evolution of the specific cutting pressure versus machining time. The specific cutting pressure seems to increase with increasing tool wear. It can also be noticed that the cutting force under HPWJA is lower than in conventional machining. Indeed, with a pressure of 250 bar, the specific cutting pressure  $K_c$  is about 10% lower than in conventional machining for an unworn tool. This could be due to a decrease in the friction coefficient. Indeed, the lubricant jet is inserted between the chip and the tool, which may change the coefficient of friction. The cooling is mainly localized at the tool and the tool–chip interface. The primary shear zone does not seem significantly cooled.

Fig. 9(d) shows the evolution of the surface roughness. For the three configurations,  $R_a$  is generally stable despite a slight tendency to increase over time.

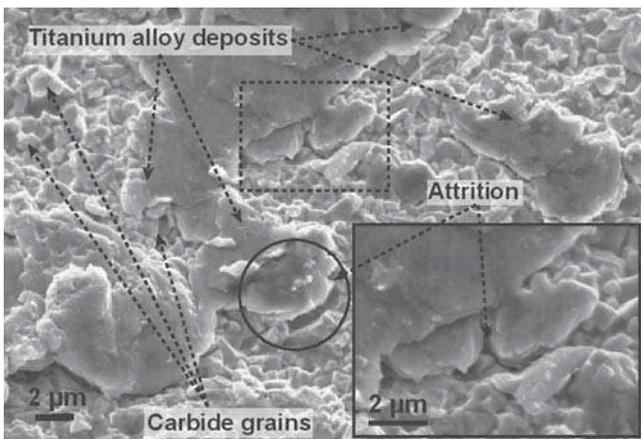
Fig. 10. Adherent layers on the tool rake face after 5 min of roughing machining at a pressure of 100 bars.

Fig. 10 shows material deposits sticking to tungsten carbide grains. Furthermore, it shows the attrition or loss of carbide grains. Fig. 11 shows that the areas with material deposits are protected and are not subjected to damage.

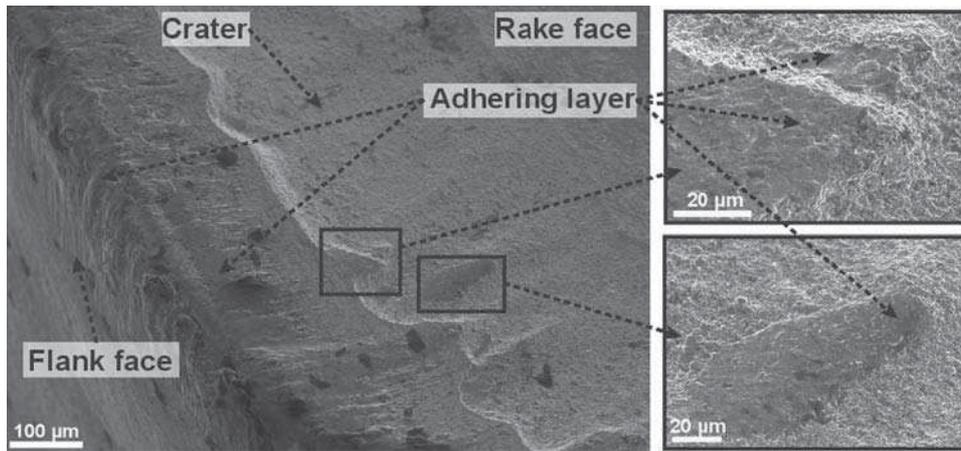
Fig. 11. Adherent layers on the tool rake face after 5 min of roughing machining at a pressure of 250 bars.

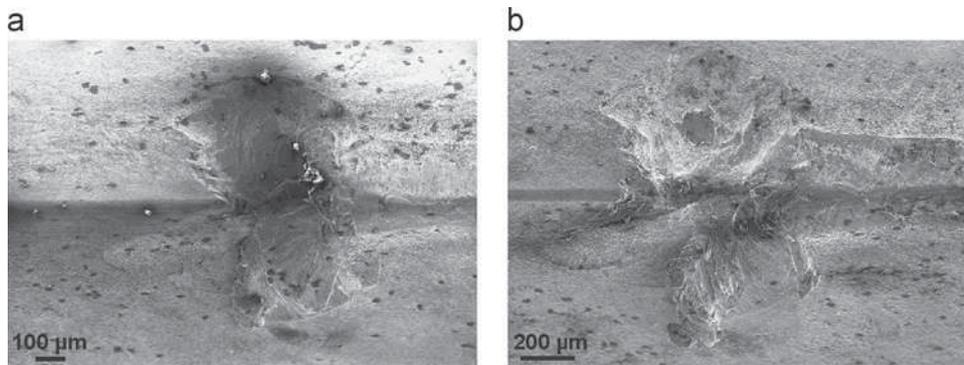
Fig. 12. Evolution of notch wear in roughing condition: (a) 4 min and (b) 5 min.

Fig. 12(a), taken after 4 min of machining, shows layers adhering to the notch. After 1 min of additional machining, the same notch is observed. Fig. 12(b) shows that the previously observed layers are pulled out, leaving a larger notch. Indeed, significant material loss was noted in the areas where material deposits were located. These observations confirm the wear mechanism by tearing-off of adhering layers.

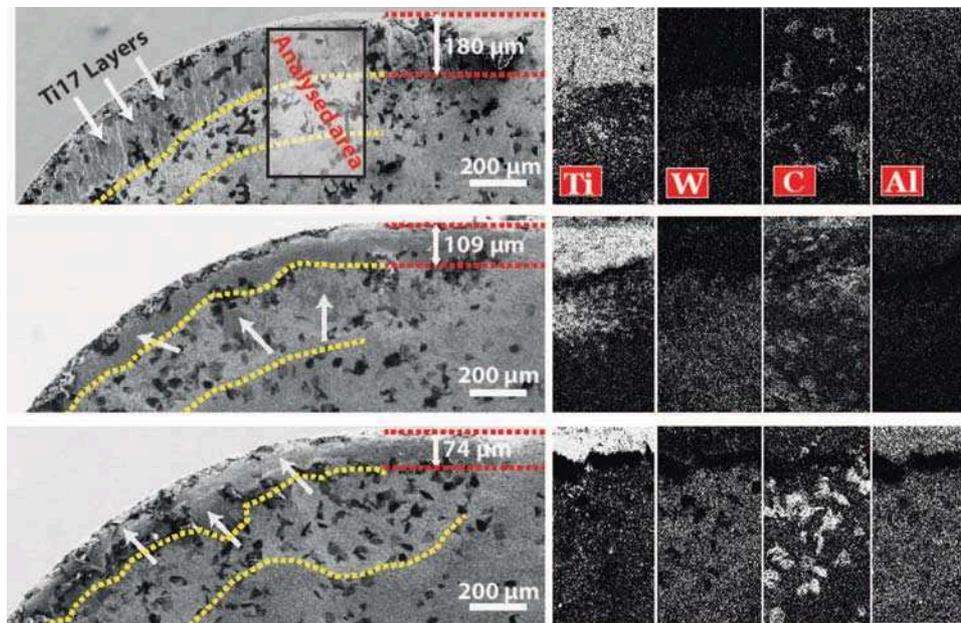
Fig. 13. Analysis of material deposits on the rake face after 15 min of finishing machining: (a) conventional machining, (b) 100 bars and (c) 250 bars.

operation, the control and analysis interval was reduced to 30 s. Fig. 13 shows the results of the qualitative analysis. Three zones can be distinguished.

- The first is formed by Ti17 layers. This is the sticking and adhesion zone;

- The second is an area of material abrasion and tearing-off, characterized by localized loss of material (and formation of a crater);
- The last zone is the area that remains intact.

In addition, the EDS analyses show the distribution maps of the elements forming the tool and the titanium alloy. The distribution maps of the elements Ti, W, C, Al are presented in Fig. 13. It can be seen that increasing the water jet pressure results in a reduction of the adherent layers zone. This reflects a decrease of the zone of strong adhesion and sticking of the chip on the tool rake face. This zone can be related to the tool/chip contact length (LC). Hence, these observations show a decrease in the tool/chip contact length with increasing pressure. The contact length decreases from 180 μm in conventional lubrication, to 74 μm under high-pressure water jet assistance (at 250 bars). In fact, for HPWJA, the fluid infiltrates between the chip and the tool. It has therefore the tendency to separate the chip from the tool rake face, thus decreasing the contact length, LC, and reducing friction between the tool and the chip.

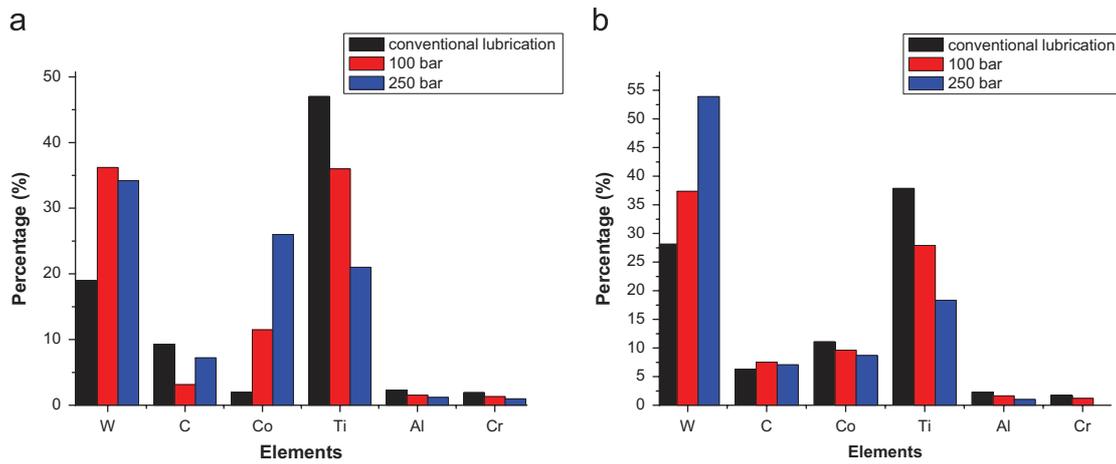
Fig. 14. Elements percentage: (a) roughing (2 min) and (b) finishing (15 min).

The same measurements have been made for the roughing condition. Fig. 14 shows the results of the analysis. Note that for the conventional lubrication condition the results are recorded after 75 s of machining. For both the roughing and the finishing conditions an increase in the jet pressure leads to a decrease in the

size of the adherent layers. For example, the percentage of the alloying elements is reduced from 45% for conventional lubrication to 21% at 250 bars for the finishing condition. In all tested conditions, the deposit rate of titanium decreases by about 25% with a pressure of 100 bars and by about 55% with a pressure of 250 bars.

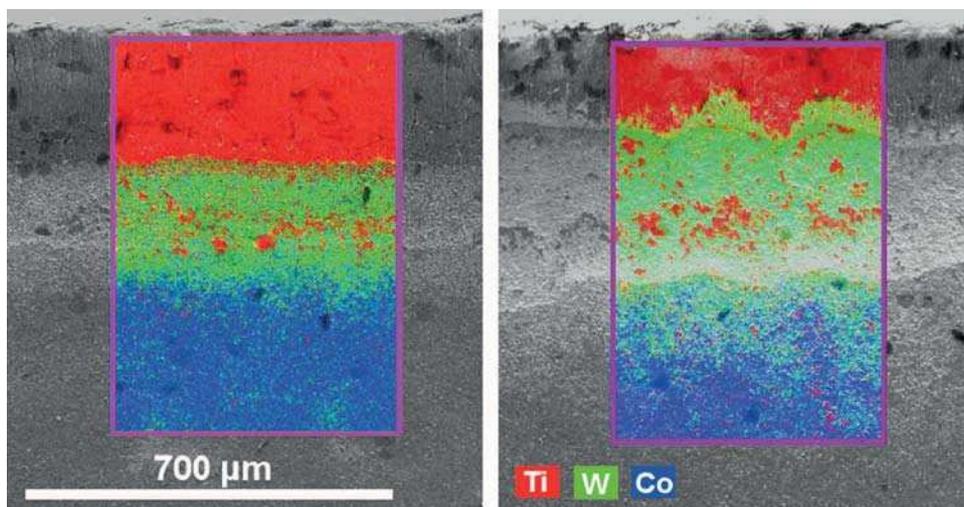
Fig. 15. EDS analysis after 4 min of roughing machining (100 bars and 250 bars, respectively).

Fig. 15 shows the tool rake face of two inserts after 4 min of roughing machining at 100 bars and 250 bars, respectively. It can be seen that the area of the adherent layers becomes smaller when the pressure is increased from 100 bars to 250 bars. In fact, the order of magnitude of the contact length is close to that found in the finishing condition.

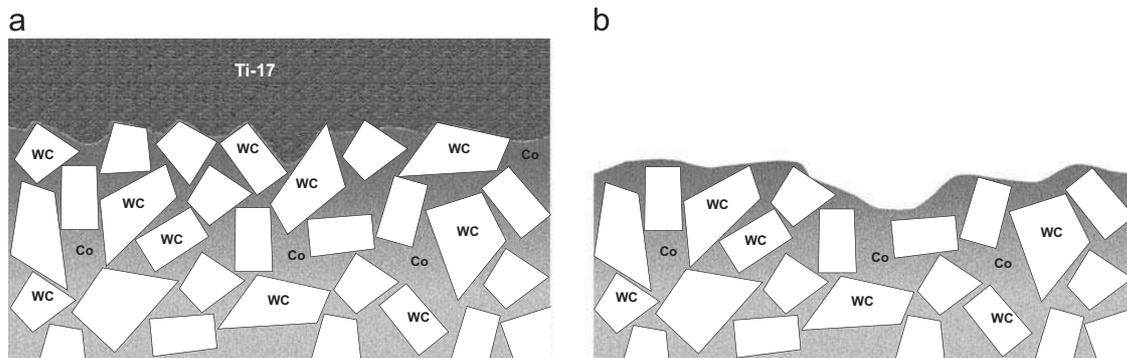
Fig. 16. Mechanism of adhesive wear.

Fig. 16 illustrates wear by adhesion. In fact, during the tool/chip contact, an interfacial layer of titanium is formed. Combined with the high temperature and high contact pressure, this layer reacts chemically with the tungsten carbide and adheres to the surface of the insert [8,11]. Thus, an increase in the cutting temperature promotes the diffusion between the tool and the chip. This deposited layer seems to protect the tool since the chip is no longer directly in contact with the carbide tungsten. However, after a period of time, the deposit may become unstable and so can be torn off by the chip. In this case, it tears fragments of the tool material leading to wear by adhesion. These findings confirm the results of other studies on adhesive wear of nickel-based alloys. Devillez et al. [19] and Bhatt et al. [11] show via SEM pictures and EDS analysis the formation of a sticky layer; it is to be noted that when this layer is pulled-out, it causes the adhesive wear.
