Vanessa RODRIGUEZ, Jacob SUKUMARAN, Yeczain PEREZ DELGADO, Mariana STAIA, Alain IOST, Patrick DE BAETS - Scratch evaluation on a high performance polymer - Mechanical Engineering Letters - Vol. 9, p.76-84 - 2013

Scratch evaluation on a high performance polymer

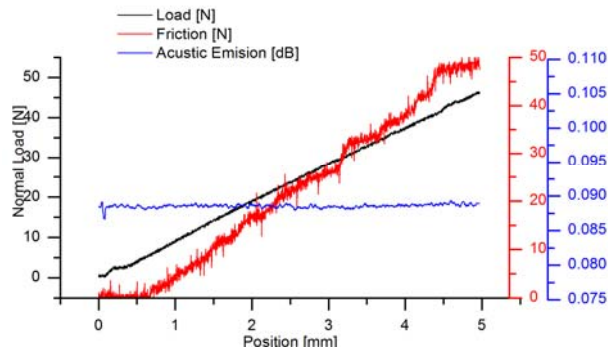
The figure 2 is a typical testing curve for polymers under progressive load scratch test of the PEEK-E02 sample, where the tangential force curves show small magnitude of fluctuations at the beginning and at the middle of the test due to the inertial effects of instantaneously accelerating the scratch head to the designated scratch speed. But after this, the tangential force increase slightly and in a digressive manner to its final level, influences at the end by the movement of the indenter.

Figure 2. Typical course of the scratch loads versus scratch length measure in PEEK-E02 with a progressive load of 50N

Various properties were observed in this study such as penetration depth, tangential force, surface damage as a function of load, there are plotted in the figure 2 and 5 for the two PEEK filled with composites were shows the experimental results of scratching test. In both figure, it can be observed that the scratch force is increased as the load increased. From the Coulomb's law, it is evident that there is a linear relationship between scratch force and applied load. In previous investigations by Sujeet Sinha (Sinha and Lim 2006) finds that the scratch forces for all polymers that their investigated such as polypropylene,

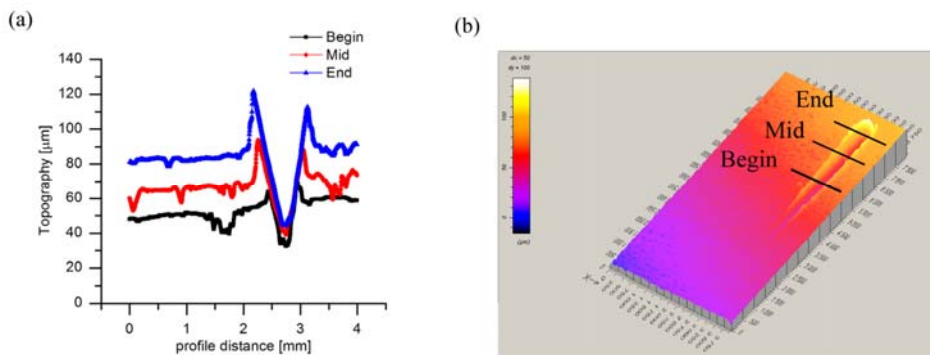
Figure 3. Profilometer results of a typical scratch on a PEEK-E02 surface: (a) depth profile with clear evidence of the scratch with different positions of the scratch; beginning, middle and end) 3D view of the scratch test

An evaluation of the scratch produced using profilometry leads to the profiles shown in figure 3 (a) the penetration depth with less material deformation at the beginning and a progressively increasing residual scratch towards the end of the scratch. At this position the scratch depth is also slightly deeper from the normal scratch course, due to the back-movement of the scratch head. In the figure 3(b) a corresponding a 3D view of the scratch following the original scratch direction, so that the deeper valley and the pushed-up hills at the rim of the scratch are more visible.

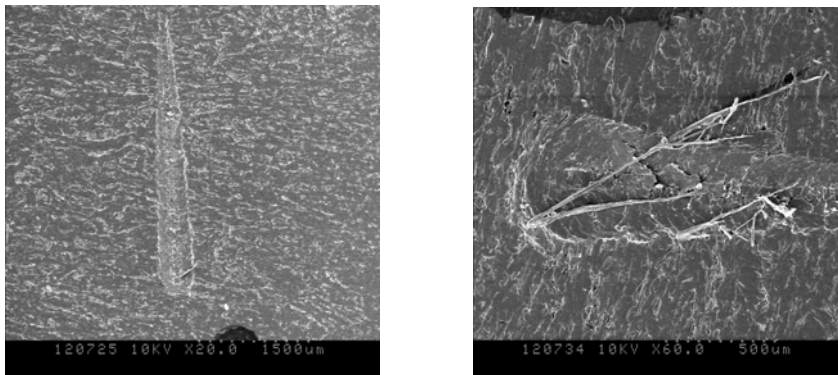
In figure 4, the sample of PEEK polymer filled with carbon fibers, graphite fibers and PTFE shows that the surface deforms with the formation of noticeable cracks, microcracks, materials removal and some detached debris particles within the scratch zone for PEEK-E02 material. In some cases depending upon the type of the materials and the severity of the contact, the material deformation can take place around the scratch tip with or without wear debris formation (Rajesh and Bijwe 2005).

Figure 4. The scratch surface damage observed using scanning electron micrographs on PEEK-E02 under the scratching load of 50N and scratching velocity of 10mm/min

Additionally a few analysis of scanning electron microscopy images for the PEEK-E02 polymer figure 4 and figure 7 for PEEK-S01, were performed to understand how material deformation and removal processes take place during scratching. This has indications in the understanding of abrasive wear process for polymers because abrasive wear mechanism takes places by hard asperities or loose debris particles.

Observing the SEM micrographs of the scratches on the material illustrates cracks, microcraks, material removal and debris in the contour of the scratch zone for both types of polymers.

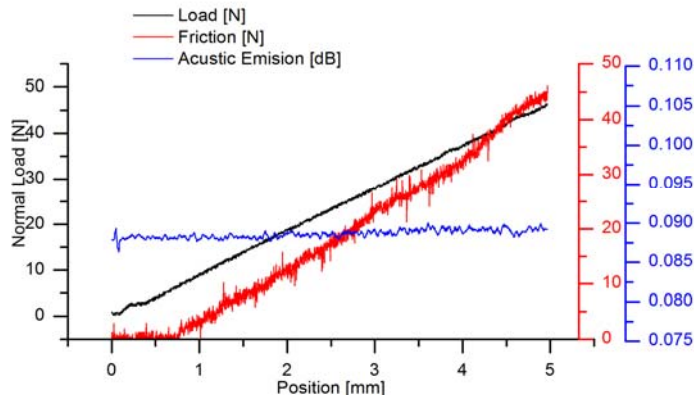
For the PEEK-S01 material filled with carbon fibers, graphite fibers shows smaller differences in the curve under the progressive load of the scratch test compared with the PEEK-E02 polymer as it can be seen in the testing curve under load scratch test figure 5, the appearance of the scratches on the both materials is rather similar but in this case with less fluctuations and smooth changes during the scratching test. The scratch frictional force, and contact zone size increased almost linearly with applied load.

Figure 5. Typical course of the scratch loads versus scratch length measure in PEEK-S01 with a progressive load of 50N.

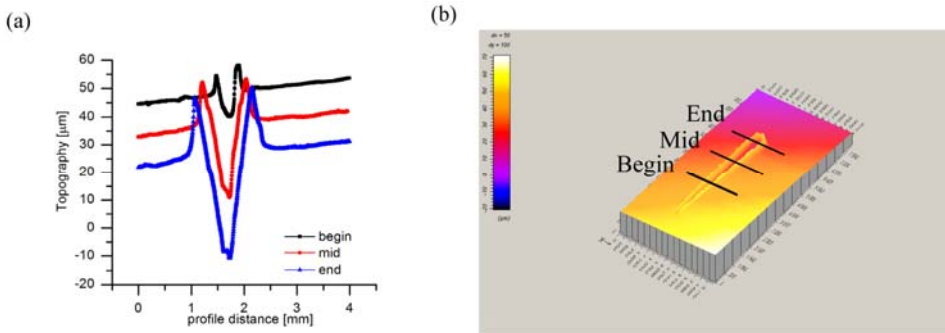
The depth profilometry allows obtaining more precise information on the remaining penetration depth during scratching test. In the figure 6 (a) we can see the variation of the penetration in the bulk of polymer for the PEEK-S01 filled with carbon fibers and graphite it can be seen how is slightly deeper and smoothly in the beginning until the end of the scratch test. And it can be notice in the figure 6 (b) the 3D images and the penetration depth and the grooves formation during the scratching test in the material tested.

Figure 6. Profilometer results of a typical scratch on a PEEK-S01 surface: (a) depth profile with clear evidence of the scratch with different positions of the scratch; beginning, middle and end (b) 3D view of the scratch test.

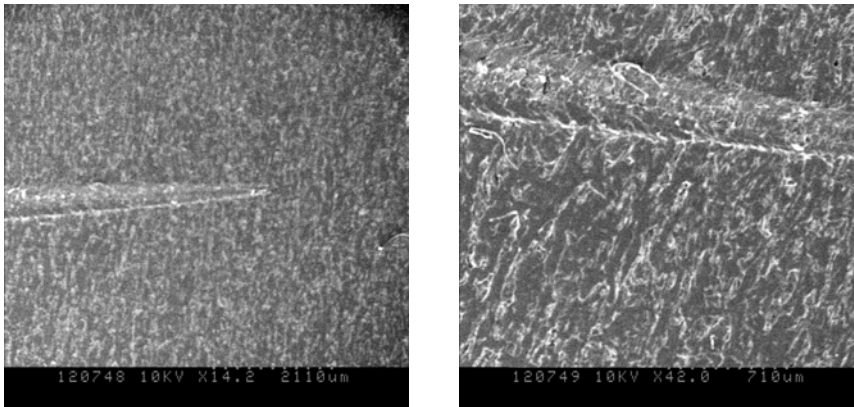
Also, by scanning electron microscopy (SEM) of the PEEK-S01 polymer in the figure 7 we can see the contour of the scratched surface when the load was further increased. The PEEK-S01 surface deforms with the formation of noticeable cracks within the scratch. A regular crack formation was seen, which can be due to surface stresses that the microstructure in the semi-crystalline polymer were subjected. Comparing SEM images of the PEEK-S01 with the

material PEEK-E02 it can be observed there is not clear formation of debris of the PEEK-S01 than in the SEM images of the PEEK-E02. A well-defined edge on the two sides of the scratch groove and a smooth scratch surface are formed after scratch pattern.

Figure 7. The scratch surface damage observed using scanning electron micrographs on PEEK-S01 under the scratching load of 50N and scratching velocity of 10mm/min
