Aliasghar BEHNAMGHADER, D. NAJJAR, Alain IOST, Stéphane BENAYOUN - Mechanical behavior study of plasma sprayed hydroxyapatite coatings onto Ti6Al4V substrates using scratch test - Materials Science Forum - Vol. 638-642, p.641-646 - 2010

Mechanical behavior study of plasma sprayed hydroxyapatite coatings onto Ti6Al4V substrates using scratch test

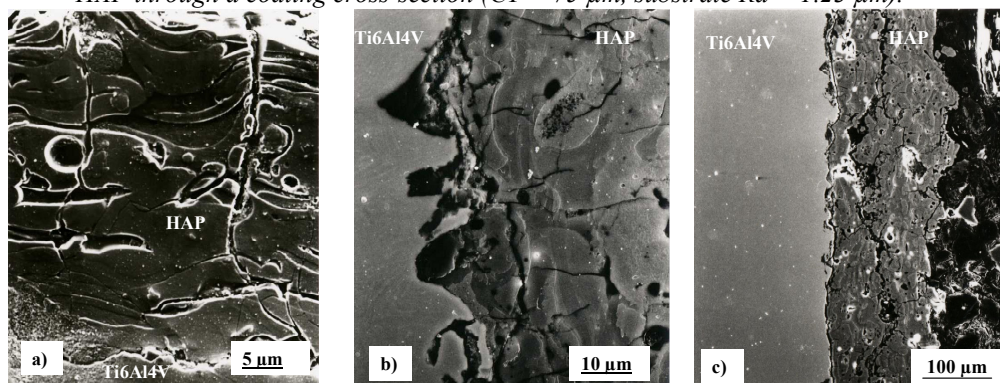
Figure 2: HAP coating cross sections showing: a) large perpendicular cracks emerging at the top surface ($CT = 50 \mu\text{m}$, substrate $Ra = 1.23 \mu\text{m}$), b) fine perpendicular cracks ($CT = 165 \mu\text{m}$, substrate $Ra = 2.29 \mu\text{m}$), c) interfacial and interlamellar cracks ($CT = 150 \mu\text{m}$, substrate $Ra = 2.29 \mu\text{m}$).

The lamellar microstructure arising from the accumulation of the well-flattened molten splats contains also partially melted particles and various cracks. Some of the cracks are normal and others are parallel to the coating/substrate interface. Two kinds of normal cracks can be detected: large ones that emerge and open on the top surface of coating in the molten areas (Fig. 2a) and fine ones localized near the coating/substrate interface (Fig. 2b). It must be mentioned that the density of fine normal cracks increases when thickness of the coating increases. The parallel cracks are either localized in the interfaces of melted splats (interlamellar cracks) or in the interface between the coating and the substrate (interfacial cracks). For coatings deposited on the substrate having the

higher arithmetic average roughness parameter, cracks propagating in the interface are always detected when thickness is above $105 \mu\text{m}$ (Fig. 2c) and a good interfacial bonding is obtained when thickness is less or equal to $90 \mu\text{m}$. Coatings deposited on the substrate having the lower arithmetic average roughness parameter R_a generally show the worse bonding quality with an increasing interfacial cracking propensity when thickness increases. It must be outlined that pores and cracks lower the coating mechanical performance on one hand but support the ingrowth of the tissue into the ceramic material on the other hand.

If the existence of pores can be related to entrapped gases, poorly melted particles and poor bonding between adjacent splats, cracking is the result of relaxation of the residual stresses developed in the ceramic coating during the deposition process [14-16, 18]. In this study, while the largest cracks normal to the coating/substrate interface are very probably the result of the relaxation of the residual tensile stresses [16], the parallel cracks are mainly promoted by in plane compressive stresses producing induced through-thickness tensile stresses [19, 20]. Finally, since the thermal expansion of HAP is above that of Ti-6Al-4V, the finest perpendicular cracks detected near the coating/substrate interface is thought to be the result of tensile stresses due to the thermal expansion mismatch. As mentioned by Yang et al. [20], the mechanism of residual stress generation and the impact of these residual stresses are so complicated that only few works are devoted to the quantitative prediction of the magnitude stress.

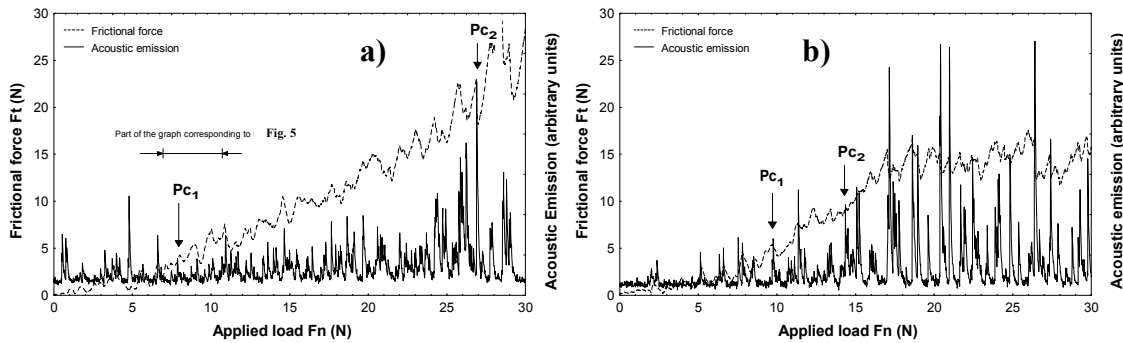
Figure 4: Typical acoustic emission and frictional force variations during a scratch test in the case of: a) a thick coating ($CT = 105 \mu\text{m}$, substrate $Ra = 1.23 \mu\text{m}$), b) a thin coating ($CT = 50 \mu\text{m}$, substrate $Ra = 1.23 \mu\text{m}$).

Determination of the critical load P_{c1} for crack initiation was delicate. In fact, it is impossible to estimate directly and thoroughly P_{c1} considering only the graph of the frictional force or the graph of the acoustic emission because no significant change in these curves is observed (Fig. 4). Indeed, the frictional force does not change significantly for this critical load since cracks are produced behind stylus according to the Hertz theory [9]. As to the acoustic emission, microcracks initiating at P_{c1} produce only short single peaks hidden in the noisy background. The critical load P_{c1} was finally determined from numerous and attentive scanning electron microscopy observations of all coatings. These observations based on a comparative study of crack length revealed that the normal load value, for which a microcrack reaches a length of 50% of the scratch track width, may be a satisfactory criterion to evaluate P_{c1} . An example of the microcracks formed in a range of applied loads near the P_{c1} value is presented on Fig. 3b.

emission curves combined simultaneously with a local sharp decrease of the frictional force at high loads (Fig. 4a). However, secondary pulses especially on acoustic emission curves may prevent to find the true peak and hence to estimate precisely P_{c2} . The secondary pulses appear at high loads and are mainly due to local coating failures that occur when the stylus interacts with pores or preexisting thermal cracks due to the plasma-spraying process. Sometimes, the stylus can cross over the largest defects associated with large and sharp discontinuities of surface topography resulting in significant sharp pulses on frictional force without significant effect on acoustic emission signal. The presence of such secondary pulses hampers the precise estimation of P_{c2} directly from the acoustic emission or the frictional force curves. This fact emphasizes the very usefulness of microscopic observations even if the lack of sufficient contrast of imaging between the coating and the substrate can be also an obstacle. In fact, the major problems encountered to estimate thoroughly P_{c2} , due either to the interaction between stylus and initial flaws generated during the plasma-spraying process in the coatings or to the lack of sufficient contrast of imaging, have been already mentioned by other authors [10, 12, 21].

Fig. 4b presents a typical graph of frictional force evolution and acoustic emission of a thin coating tested in this work. In this case, the higher critical load was assessed from microscopic observations and corresponds to the normal load for which the contact between the stylus and the substrate occurs. At first sight, it seems that the normal load value P_{c2} determined by these microscopic observations is not so far as the abscissa corresponding to the inflexion point on the frictional force graph. However, as mentioned by Stephanopoulos et al. [22], such a behavior is more representative of the interaction between the stylus and the substrate after the occurrence of contact rather than coating/substrate adhesion. As a consequence, it can be suspected that our experimental conditions of scratching may be no longer probing to predict adhesion of the HAP coatings which thickness is less or equal to 90 μm .
