Aliasghar A BEHNAMGHADER, Denis D NAJJAR, Alain IOST, Stéphane S BENAYOUN -
Mechanical behavior study of plasma sprayed hydroxyapatite coatings onto Ti6Al4V substrates
using scratch test - Materials Science Forum - Vol. 638-642, p.641-646 - 2010

Mechanical behavior study of plasma sprayed hydroxyapatite coatings onto Ti6Al4V substrates using scratch test

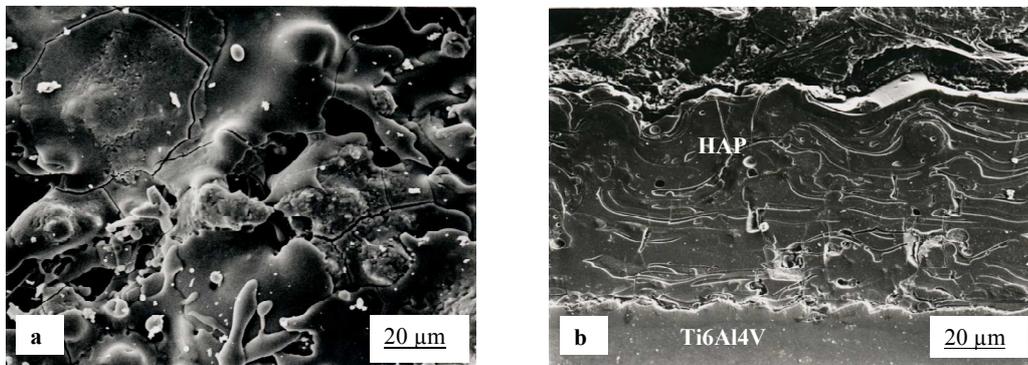
Figure 1: SEM micrographs showing: a) a typical top view of an HAP coating surface produced by air plasma spraying (coating thickness $CT = 105 \mu\text{m}$, substrate $Ra = 2.29 \mu\text{m}$), b) a typical microstructure of the plasma-sprayed HAP through a coating cross-section ($CT = 75 \mu\text{m}$, substrate $Ra = 1.23 \mu\text{m}$).

Microstructure. In a preliminary study, the X-ray diffraction reveals that HAP is the principal phase of coatings [8]. SEM observations of the plasma-sprayed coatings reveal typical features presented in numerous other studies [13-17]. The as-sprayed coating surface is characterized by unmelted or partially melted particles, fully molten splats, pores and emerging cracks that propagate in the molten areas (Fig. 1a). A lamellar microstructure with an orientation closely parallel to the coating/substrate interface is observed on cross-sections (Fig. 1b).

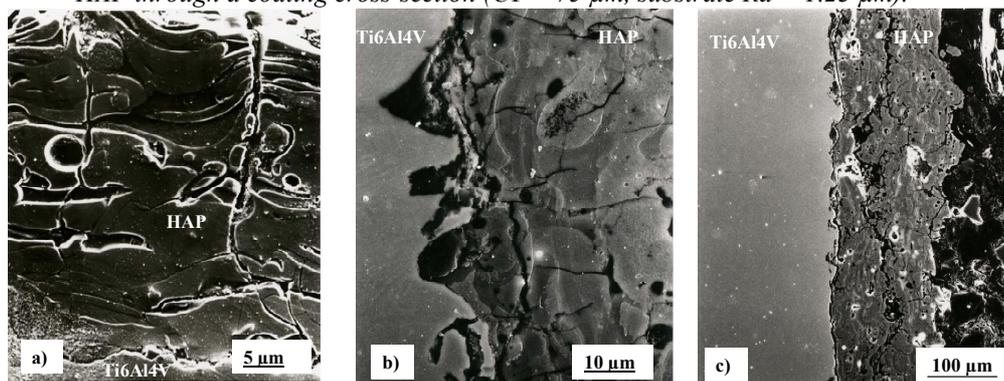
Figure 2: HAP coating cross sections showing: a) large perpendicular cracks emerging at the top surface ($CT = 50 \mu\text{m}$, substrate $Ra = 1.23 \mu\text{m}$), b) fine perpendicular cracks ($CT = 165 \mu\text{m}$, substrate $Ra = 2.29 \mu\text{m}$), c) interfacial and interlamellar cracks ($CT = 150 \mu\text{m}$, substrate $Ra = 2.29 \mu\text{m}$).

The lamellar microstructure arising from the accumulation of the well-flattened molten splats contains also partially melted particles and various cracks. Some of the cracks are normal and others are parallel to the coating/substrate interface. Two kinds of normal cracks can be detected: large ones that emerge and open on the top surface of coating in the molten areas (Fig. 2a) and fine ones localized near the coating/substrate interface (Fig. 2b). It must be mentioned that the density of fine normal cracks increases when thickness of the coating increases. The parallel cracks are either localized in the interfaces of melted splats (interlamellar cracks) or in the interface between the coating and the substrate (interfacial cracks). For coatings deposited on the substrate having the

higher arithmetic average roughness parameter, cracks propagating in the interface are always detected when thickness is above $105 \mu\text{m}$ (Fig. 2c) and a good interfacial bonding is obtained when thickness is less or equal to $90 \mu\text{m}$. Coatings deposited on the substrate having the lower arithmetic average roughness parameter R_a generally show the worse bonding quality with an increasing interfacial cracking propensity when thickness increases. It must be outlined that pores and cracks lower the coating mechanical performance on one hand but support the ingrowth of the tissue into the ceramic material on the other hand.

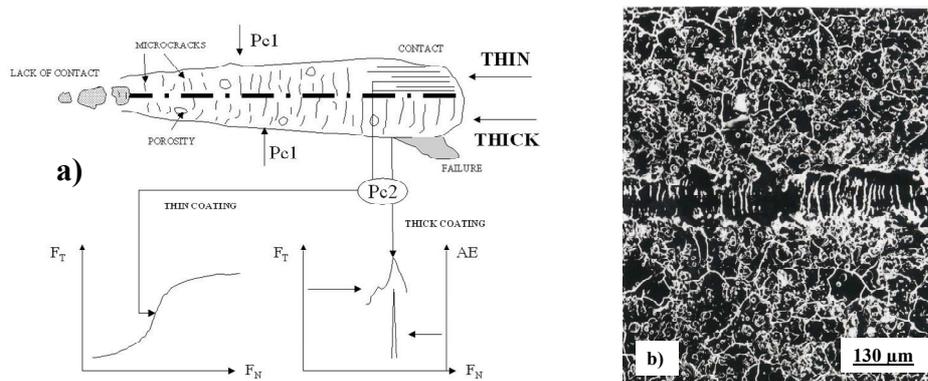
Figure 3: a) Synoptic of the events occurring on a typical scratch track under progressive loading and determination methodology of the critical loads for thick and thin coatings. P_{c1} : Normal load at which a microcrack reaches 50 % of the scratch track width. P_{c2} : Normal load (F_N) corresponding either to the inflexion point of the frictional force (F_T) graph for thin coating or to a sharp pulse on the acoustic emission signal (AE) combined with a sudden decrease of the frictional force for a thick coating, b) Example of microcracks formed during the scratch test in the range of applied loads near the P_{c1} value. This top view is related to the part of the graph indicated in Fig. 4.

An instantaneous adhesive spalling observed by visual inspection occurs generally before the contact between stylus and substrate, mainly in thick coating at high loads. This instantaneous spalling arises probably from the lateral crack propagation in the coating/substrate interface. On the other hand, for thin coatings, stylus can reach the substrate at intermediate loads without any instantaneous coating spalling ahead of the moving stylus. All these events are summarized on a synoptic of a typical scratch track in Fig. 3a. This figure presents also schematically how critical loads P_{c1} and P_{c2} were approximately determined.

Determination of the critical load P_{c1} for crack initiation was delicate. In fact, it is impossible to estimate directly and thoroughly P_{c1} considering only the graph of the frictional force or the graph of the acoustic emission because no significant change in these curves is observed (Fig. 4). Indeed, the frictional force does not change significantly for this critical load since cracks are produced behind stylus according to the Hertz theory [9]. As to the acoustic emission, microcracks initiating at P_{c1} produce only short single peaks hidden in the noisy background. The critical load P_{c1} was finally determined from numerous and attentive scanning electron microscopy observations of all coatings. These observations based on a comparative study of crack length revealed that the normal load value, for which a microcrack reaches a length of 50% of the scratch track width, may be a satisfactory criterion to evaluate P_{c1} . An example of the microcracks formed in a range of applied loads near the P_{c1} value is presented on Fig. 3b.

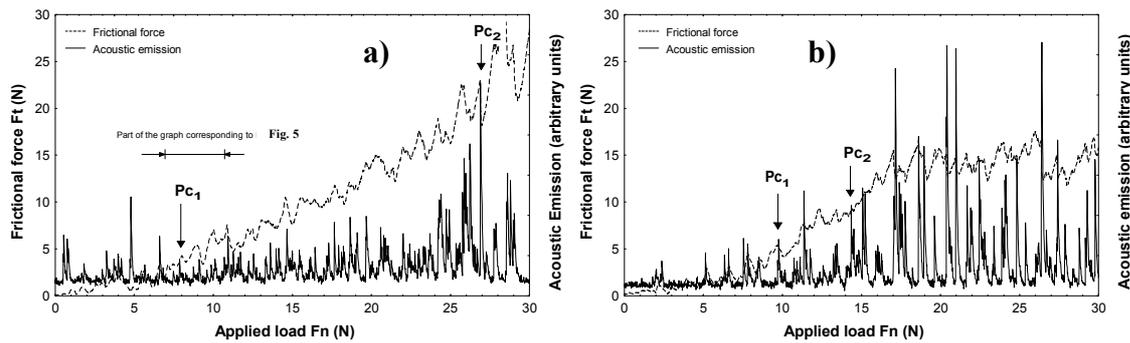
Figure 4: Typical acoustic emission and frictional force variations during a scratch test in the case of: a) a thick coating ($CT = 105 \mu\text{m}$, substrate $Ra = 1.23 \mu\text{m}$), b) a thin coating ($CT = 50 \mu\text{m}$, substrate $Ra = 1.23 \mu\text{m}$).

Generally used in comparative evaluation of adherence, the higher critical load P_{c2} was estimated in this study as the normal load which corresponds either to the instantaneous spalling of the coating or to the contact beginning between the stylus and the substrate. For thick coatings, the observation of instantaneous spalling can be correlated with the occurrence of intense peaks on acoustic

emission curves combined simultaneously with a local sharp decrease of the frictional force at high loads (Fig. 4a). However, secondary pulses especially on acoustic emission curves may prevent to find the true peak and hence to estimate precisely P_{c2} . The secondary pulses appear at high loads and are mainly due to local coating failures that occur when the stylus interacts with pores or preexisting thermal cracks due to the plasma-spraying process. Sometimes, the stylus can cross over the largest defects associated with large and sharp discontinuities of surface topography resulting in significant sharp pulses on frictional force without significant effect on acoustic emission signal. The presence of such secondary pulses hampers the precise estimation of P_{c2} directly from the acoustic emission or the frictional force curves. This fact emphasizes the very usefulness of microscopic observations even if the lack of sufficient contrast of imaging between the coating and the substrate can be also an obstacle. In fact, the major problems encountered to estimate thoroughly P_{c2} , due either to the interaction between stylus and initial flaws generated during the plasma-spraying process in the coatings or to the lack of sufficient contrast of imaging, have been already mentioned by other authors [10, 12, 21].

Fig. 4b presents a typical graph of frictional force evolution and acoustic emission of a thin coating tested in this work. In this case, the higher critical load was assessed from microscopic observations and corresponds to the normal load for which the contact between the stylus and the substrate occurs. At first sight, it seems that the normal load value P_{c2} determined by these microscopic observations is not so far as the abscissa corresponding to the inflexion point on the frictional force graph. However, as mentioned by Stephanopoulos et al. [22], such a behavior is more representative of the interaction between the stylus and the substrate after the occurrence of contact rather than coating/substrate adhesion. As a consequence, it can be suspected that our experimental conditions of scratching may be no longer probing to predict adhesion of the HAP coatings which thickness is less or equal to 90 μm .

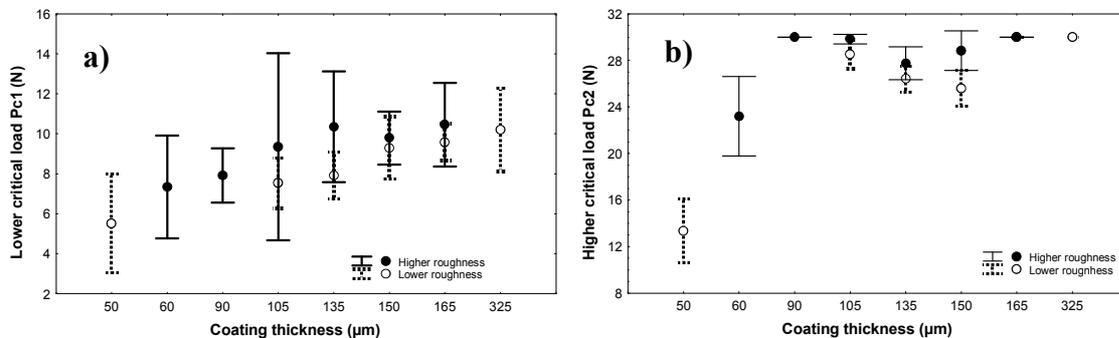
Figure 5: Lower (Left) and higher (Right) critical loads P_{c1} and the associated standard errors as a function of coating thickness for the two studied substrate roughness. Results correspond to 5 and 8 measurements whatever the experimental conditions.

Critical load P_{c1} is plotted versus coating thickness in Fig. 5 for the two values of the arithmetic average roughness of the substrate considered in this study. Whatever the substrate roughness, the mean of this lower critical load increases with thickness. This result can be explained taking into consideration the observed increasing propensity of microcracking that occurs during the cooling process when coating thickness increases. Since microcracking is considered to be the main relaxation process of residual stresses during cooling of plasma sprayed coatings, short cracks due to the scratch testing may be expected to initiate more easily in the studied thin coatings. Moreover, for a given coating thickness, Fig. 5 reveals a trend showing that the substrate having the higher arithmetic average roughness parameter induces a better coating resistance to microcrack initiation since the mean of the lower critical loads recorded are higher than that of the substrate having the lower arithmetic average roughness parameter.

P_{c2} critical load values versus coating thickness are plotted in Fig. 5b for the two values of the arithmetic average roughness of the substrate considered in this study. It must be noted that it was not possible to determine the higher critical load for some of the thick coatings because of the upper experimental device loading limit (30 N). The higher P_{c2} values for specimens having the substrate roughness R_a of 2.29 μm can be related to a better adherence. It must be outlined that the scratch test do not allow to obtain an absolute measure of coating adhesion because numerous extrinsic and intrinsic parameters influence the testing results [12].
