Nasser Eddine BELIARDOUH, Kheireddine BOUZID, Brahim TLILI, Michael J. WALOCK, Corinne NOUVEAU - Tribological and electrochemical performances of Cr/CrN and Cr/CrN/CrAIN multilayer coatings deposited by RF magnetron sputtering - Tribology International - Vol. 82, p.443-452 - 2015

# Tribological and electrochemical performances of Cr/CrN and Cr/CrN/CrAlN multilayer coatings deposited by RF magnetron sputtering

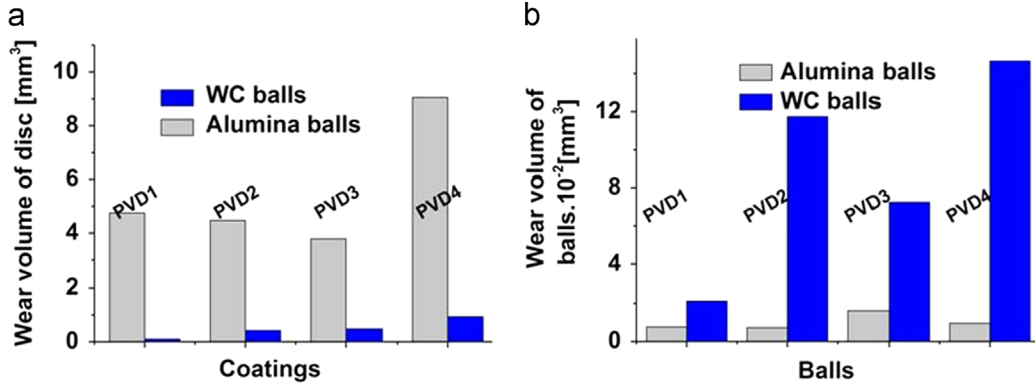
Fig. 6. Estimated wear volume of (a) multilayer coatings and (b) balls.

The estimated wear volume for each couple (PVDi/ball) is presented in Fig. 6. The results can be summarized as follows:

- For the coatings, the alumina balls produced the highest amount of wear, with the extreme (i.e. worst) being the (Cr/CrAlN)-PVD4/alumina couple. The WC balls produced the lowest wear, with the extreme (i.e. best) being the (Cr/CrN/CrAlN)-PVD1/WC couple.
- For the counterparts, the coatings produced the least amount of wear damage on the alumina balls, and the highest wear damage on the WC balls. This may be related to the higher hardness of the alumina balls compared to the WC balls.
- It is interesting to note that the (CrN/CrAlN)-PVD4/alumina couple presented the highest sample/disc wear volume, and the (CrN/CrAlN)-PVD4/WC couple presented the highest counterpart wear volume.

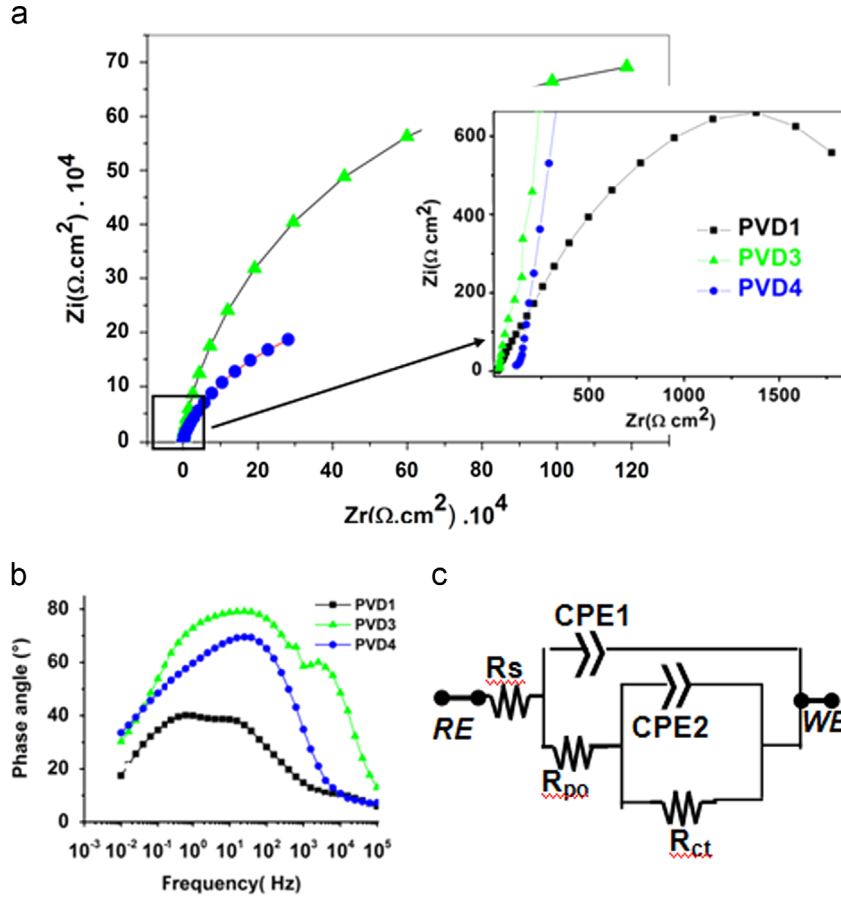
**Fig. 8.** AC impedance measurements of the multilayer coatings (a) Nyquist impedance diagrams (inset image shows the Nyquist plots at high frequencies), (b) bode plots and (c) the equivalent circuit model used to fit impedance EIS data.

The different Nyquist diagrams are presented in Fig. 8(a). It is obvious that the (Cr/CrN/CrAlN)-PVD3 coating presents the best corrosion resistance followed by (CrN/CrAlN)-PVD4. All of the Nyquist plots show two time constants, with a capacitive loop of smaller diameter followed by another capacitive loop of larger diameter. Bode plots, of the phase angle as a function of the frequency (semi logarithm scale) are shown in Fig. 8(b) and confirm the Nyquist data. From the above mentioned results, it is confirmed that there are effectively two time constants in the experimental frequency bandwidth. Consequently, the EIS data indicates the existence of two different interfacial reactions that may be related to the coating/solution interface and substrate/solution interface, respectively.

The experimental results were interpreted through the development of typical impedance models for the electrode surfaces, and curve fitting on the basis of an equivalent circuit (using the Zview impedance program). A circuit model was proposed to ascribe the two sub-electrochemical interfaces that are generally used in such cases [32,33,36,37]. The equivalent circuit (Fig. 8(c)) consists of the following elements:  $R_s$  corresponds to the solution resistance of the electrolyte test between the working electrode (WE) and reference electrode (RE).  $CPE1$  and  $R_{po}$  elements were used in parallel to replace the coatings' dielectric properties.  $CPE2$
