Héloïse ROLLAND, Nicolas SAINTIER, Gilles ROBERT - Damage mechanisms in short glass fibre reinforced thermoplastic during in situ microtomography tensile tests - Composites Part B: Engineering - Vol. 90, p.365-377 - 2016

Damage mechanisms in short glass fibre reinforced thermoplastic during *in situ* microtomography tensile tests

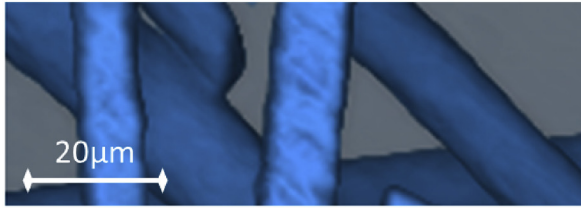
Fig. 11. Local stress thresholds to break (tensile direction is vertical).

The interest is then to have a better understanding of what happens leading to the failure of a fibre in the material. First, stress values, before and after the failure of the fibre illustrated in Fig. 11, have been identified at the macroscopic scale. Thanks to homogenisation computation, it is possible to have a first estimation of the stress at the micro scale. The Mori-Tanaka's homogenisation scheme [19] has been used considering an ellipsoidal approximation for fibre geometry. The obtained values for the stress in the fibre phase are $\sigma_{MT}^{local} = 168.0 \text{ MPa}$ before fibre failure and $\sigma_{MT}^{local} = 291.1 \text{ MPa}$ after fibre failure, illustrated in Fig. 11(a) and (b). These stress values are far beyond the 2030 MPa reported for E glass fibre tensile ultimate stress [20].
