# Isothermal fatigue damage mechanisms at ambient and elevated temperature of a cast Al-Si-Cu aluminium alloy

Pablo Wilson<sup>a,b</sup>, Nicolas Saintier<sup>a,\*</sup>, Thierry Palin-Luc<sup>a</sup>, Sebastien Bergamo<sup>b</sup>

## ABSTRACT

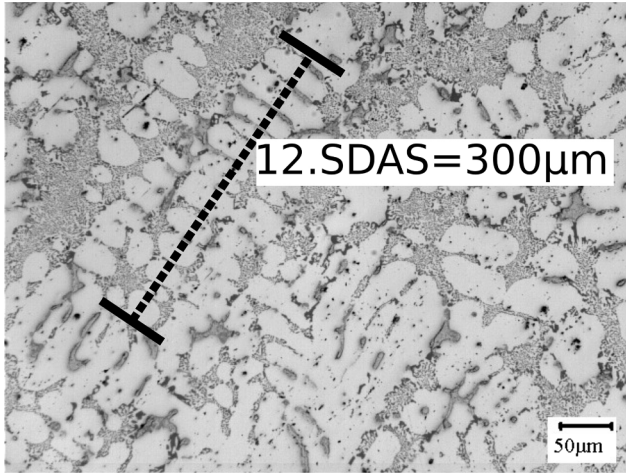
**Fig. 1.** Optical microstructure of specimen and SDAS measurement.

The microstructure exhibits dendritic solidification shown in Fig. 1. The secondary dendritic arm spacing (SDAS) is measured over 1 mm<sup>2</sup> in the center of the round bar, corresponding to the fatigue tested zone. Table 2 shows the observed mean SDAS value equal to 24 µm (measured on 102 values), which is among the values observed in the literature for similar casting process [16]. The casting process of the bars was specifically tailored in order for the SDAS to be relatively low and reproduce high cooling rates locations in components.

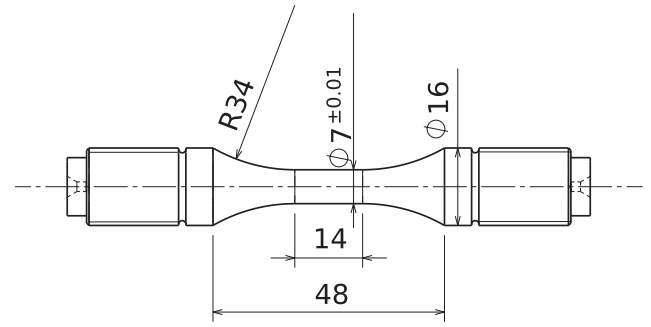
**Fig. 2.** Specimen geometry for low-cycle fatigue test.

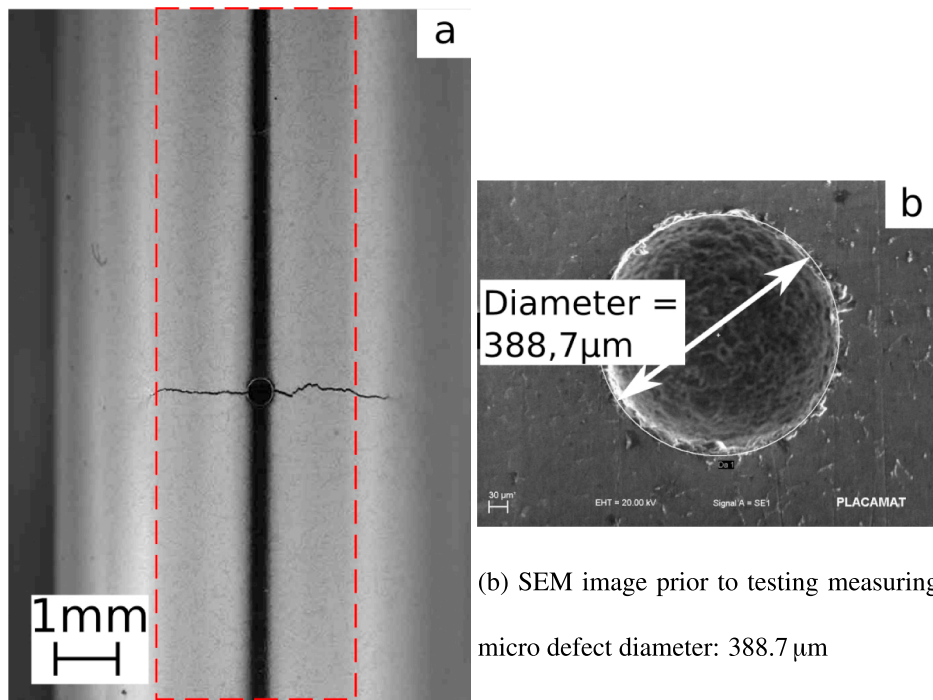
(a) Digital picture of specimen with microdefect

Fig. 3. Test setup of crack monitoring specimens.

Artificial microdefects were machined at the surface of some specimens to follow crack propagation more easily. An hemisphere of 400 µm was machined by electro discharge. Fig. 3(a) shows micro defect in the middle part of a test specimen, while Fig. 3(b) shows SEM image used to measure the micro defect diameter before fatigue testing. All diameters are in the interval [359–401 µm]. For later crack propagation calculations, the measured value is used avoiding part of the bias caused by the scatter in the microdefect sizes.

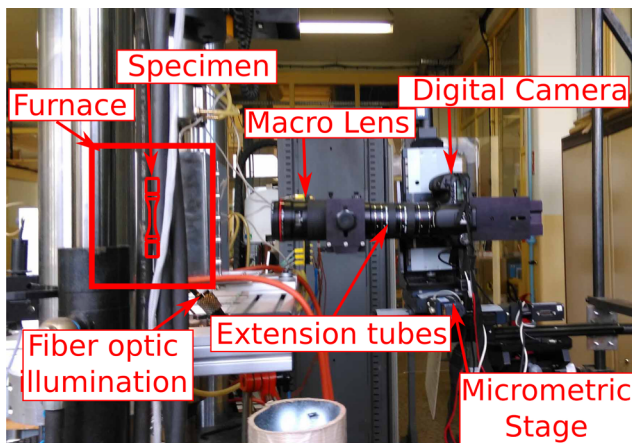
Fig. 4. Crack propagation monitoring setup.

To monitor the crack propagation, the digital camera was synchronized with the test rig and a picture was taken for each cycle at the maximum load, therefore maximizing the crack opening (see Fig. 4). Special care is taken as to obtain high quality pictures during crack propagation over a large surface of the cylindrical specimen. While standard direct illumination can be used to observe flat area, such as for SENT specimens, indirect illumination is here used and allows us to monitor crack propagation on standard LCF cylindrical specimens: the walls of the furnace are illuminated, and the reflection of the walls on the specimen are captured by the camera. Compared to direct illumination, this method avoids a glare effect caused by the specimen curvature. The camera settings are set to minimize the motion blur while maximizing signal to noise ratio (Canon EOS 40D, Canon EF 180 mm f/3.5L Macro USM Macro lens,  $f/8$ ,  $1/13\text{s}$ , iso 1000). An image treatment is then applied. Firstly, all the pictures are registered to the first one thereby eliminating slight translations between pictures. Secondly, an averaging is done over sequential images: considering time (i.e. cycles) as the third dimension, a Gaussian filter of standard deviation 6 time unit (i.e. 6 cycles) is applied. The image enhancement obtained can be seen in Fig. 5: the crack path can clearly be identified with respect to the microstructure. For the last cycles, when the crack tip propagation is too fast and image averaging causes blur, the raw data images are considered. The observation setup allows for microstructure observation of an approximate area of 33 mm<sup>2</sup> (the 11 mm height is limited by the sensor size, whereas the 3 mm width is limited by the depth-of-field).

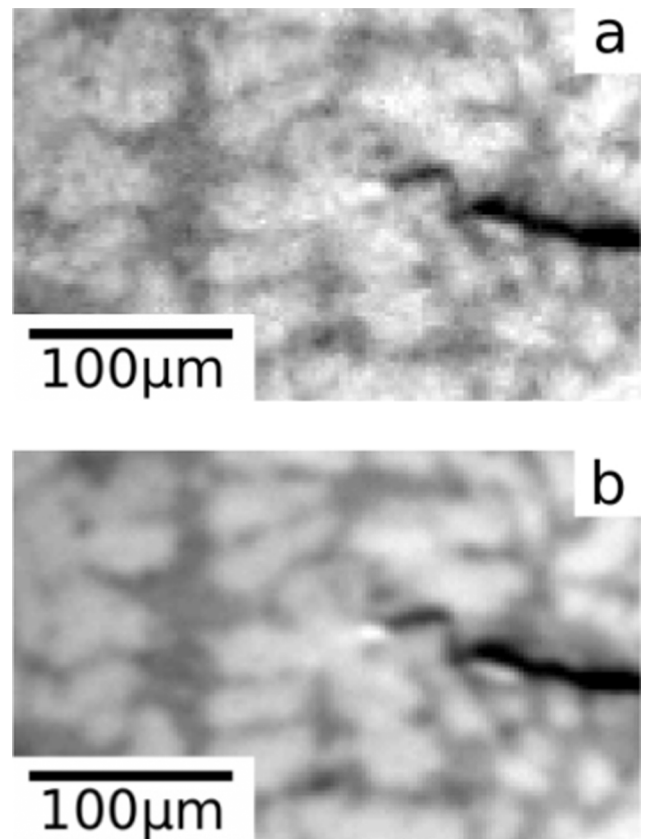
Fig. 5. Image treatment of crack propagation monitoring (a) raw image, (b) after image processing.

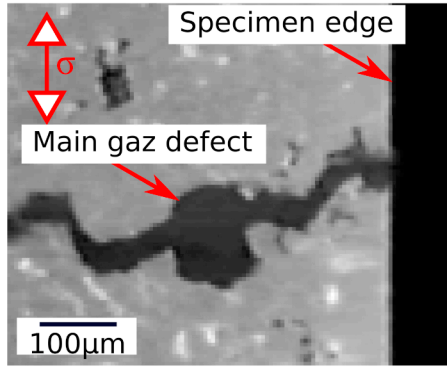
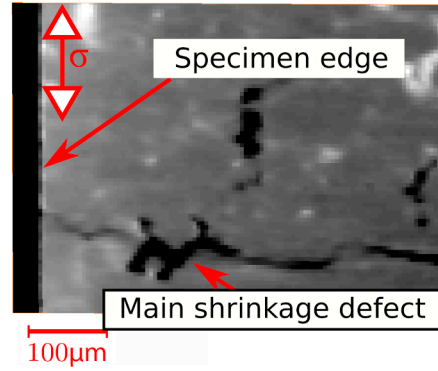
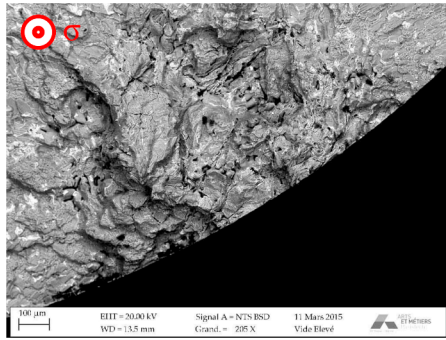
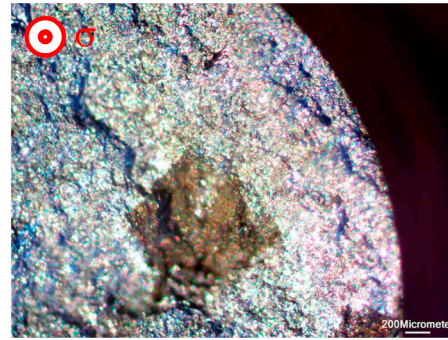
Fig. 6. Crack initiation on defects: classification.

(a) Spherical gas porosity identified by micro-tomography (specimen 62T5,  $\Delta\epsilon/2 = 0.3\%$ ,  $250^\circ\text{C}$ ,  $R_\epsilon = -1$ ,  $N_f = 2089$  cycles)

(b) Shrinkage defect identified by micro-tomography (specimen 130T5,  $\Delta\epsilon/2 = 0.3\%$ ,  $150^\circ\text{C}$ ,  $R_\epsilon = -1$ ,  $N_f = 2443$  cycles)

(c) SEM-BSE image of defect cluster (specimen 22T5,  $\Delta\epsilon/2 = 0.3\%$ ,  $20^\circ\text{C}$ ,  $R_\epsilon = -1$ ,  $N_f = 2689$  cycles)

(d) Optical microscopy: large oxide (specimen 4T5,  $\Delta\epsilon/2 = 0.4\%$ ,  $20^\circ\text{C}$ ,  $R_\epsilon = -1$ ,  $N_f = 257$  cycles)

- Gaz porosity: large gaz porosities ( $>100\mu\text{m}$ ) were are close to the specimen surface. Fig. 6a shows such a defect identified by microtomography, revealing the crack initiates around the mid plane of the defects, where the stress concentration factor is the highest.
- Casting shrinkage: large shrinkages ( $>100\mu\text{m}$ ) are also found close to the specimen surface (see Fig. 6(b)). The convolutions caused by the shrinkage imply a lower defect sphericity and high acuteness.
- Defect cluster: also located close to the specimen surface, they appear larger than isolated defects ( $>500\mu\text{m}$ ). Fig. 6(c) displays a cluster of defects that caused the main crack initiation. In this case, rigorous measurement of the defect size cannot be achieved (the frontiers of the cluster being unclear).
- Large oxides: in three cases, large oxides are revealed on the fracture

surface by optical microscopy (see Fig. 6(d)). No special test condition (imposed strain or temperature) reveals this type of initiation. These oxides are a consequence of the casting process (no oxide filter is used before casting, whereas these filters are present for real component casting). Therefore, these tests are not taken into account for the rest of this study.

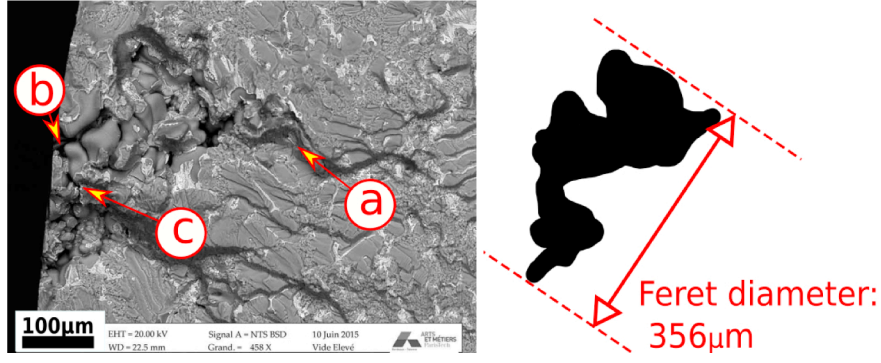
(a) Raw SEM image of initiating defect. (b) Manually binarized defect identification

(2D Feret diameter: 356 µm)

**Fig. 7.** Manual identification of defects. (specimen 87T5,  $\Delta\epsilon/2 = \pm 0.30\%$ , 20 °C,  $R_\epsilon = -1$ ,  $N_f = 2904$ ).

In order to systematically measure defects size, SEM images are manually binarized. Fig. 7 shows such an example of image processing. While more robust, automatized treatments are here unable to identify defects, hence a manual process is used.

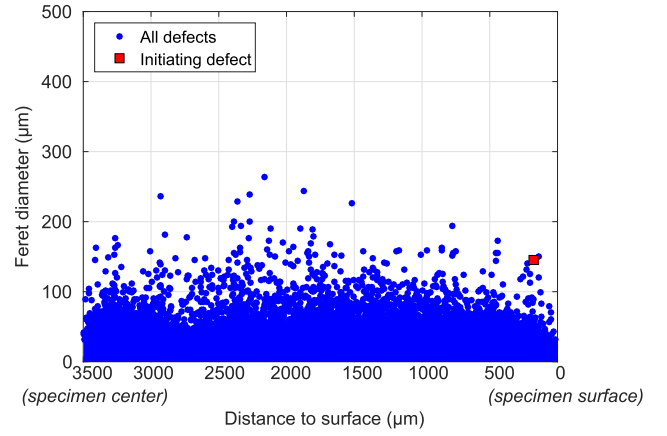
**Fig. 8.** Defect population of cycled specimens: the crack-initiating defect is not the largest in the whole volume (Specimen 130T5:  $\Delta\epsilon/2 = \pm 0.3\%$ , 150 °C,  $R_\epsilon = -1$ ,  $N_f = 2396$  cycles).

Beside the defect size, the defect location with respect to the specimen surface is known to have an impact on fatigue life (see for example [17] for LCF and [18] for multiaxial high-cycle fatigue). In order to assess the effect of the distance of the defect to the specimen surface, a fatigue test was interrupted before final failure and observed by tomography. The critical defect size was compared to the total population of defects. Given the small crack opening, the crack initiating defect could be identified and the 3D Feret diameter still be measured (see example in Fig. 6(b)). Distance to the surface was measured from the closest edge of the defect to the specimen surface (see Fig. 9). Using this method, the distance to the surface of a defect intersecting the specimen surface is equal to 0. Results are shown in Fig. 8 where the critical defect is highlighted compared to the global defects population. Even though the crack initiating main defect is amongst the largest ones (150 µm), other defects located further from the specimen surface are

larger in size illustrating the fact that the defect size is not the critical parameter to identify the crack initiating defect: both size and defect location have to be considered.

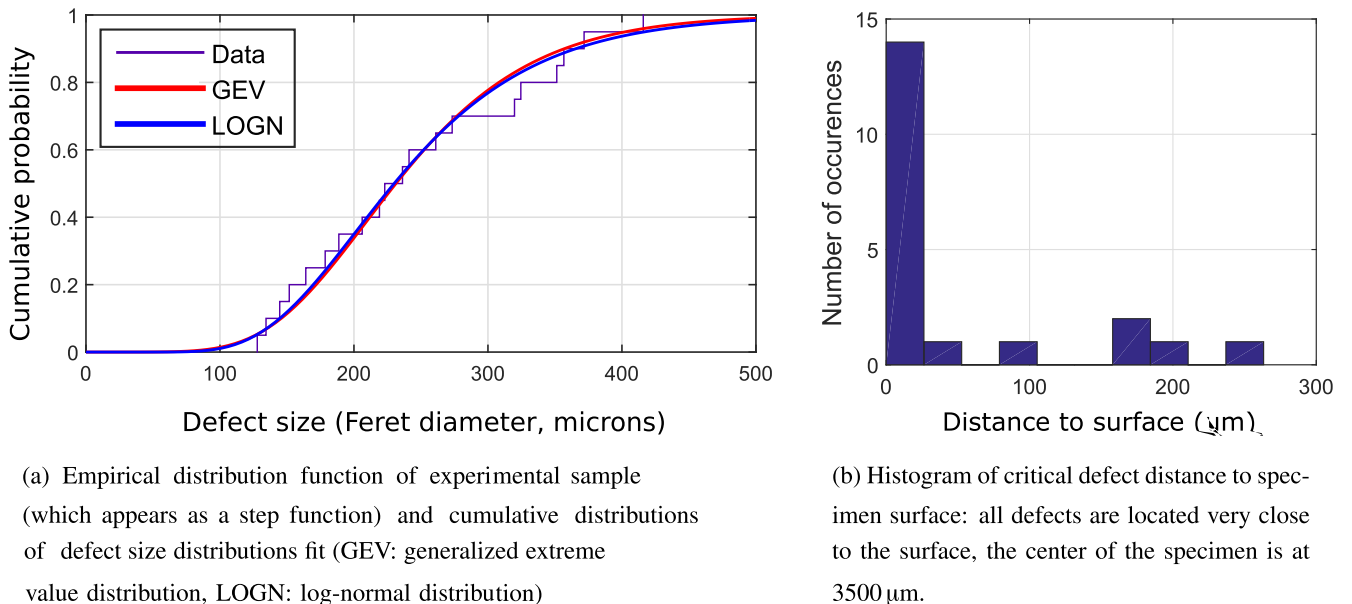
Fig. 9. Distance of critical defects to the surface.

Despite those difficulties, the Feret diameter is here considered as representative of the defect size and measured for each crack initiating defect. For all defects both SE and BSE images were used to unambiguously identify defects limits. Feret diameters (for gas and shrinkage porosities) are between  $127$  and  $415\ \mu\text{m}$  (see Table 4). The empirical cumulative defect size distribution is presented in Fig. 9a

The criticality of defect location is confirmed by observing fracture surfaces of all LCF tests. Histogram 9b shows distance to surface for identified defects (gas, shrinkage and cluster defects). 13 of the 20 initiation defects occur at or very close to specimen surface, and all are less than 260 µm from the specimen surface, confirming previous observation from tomography data: defect size and location (noticeably with respect to the free surface) combined analysis has to be done in order to assess the defect criticality.

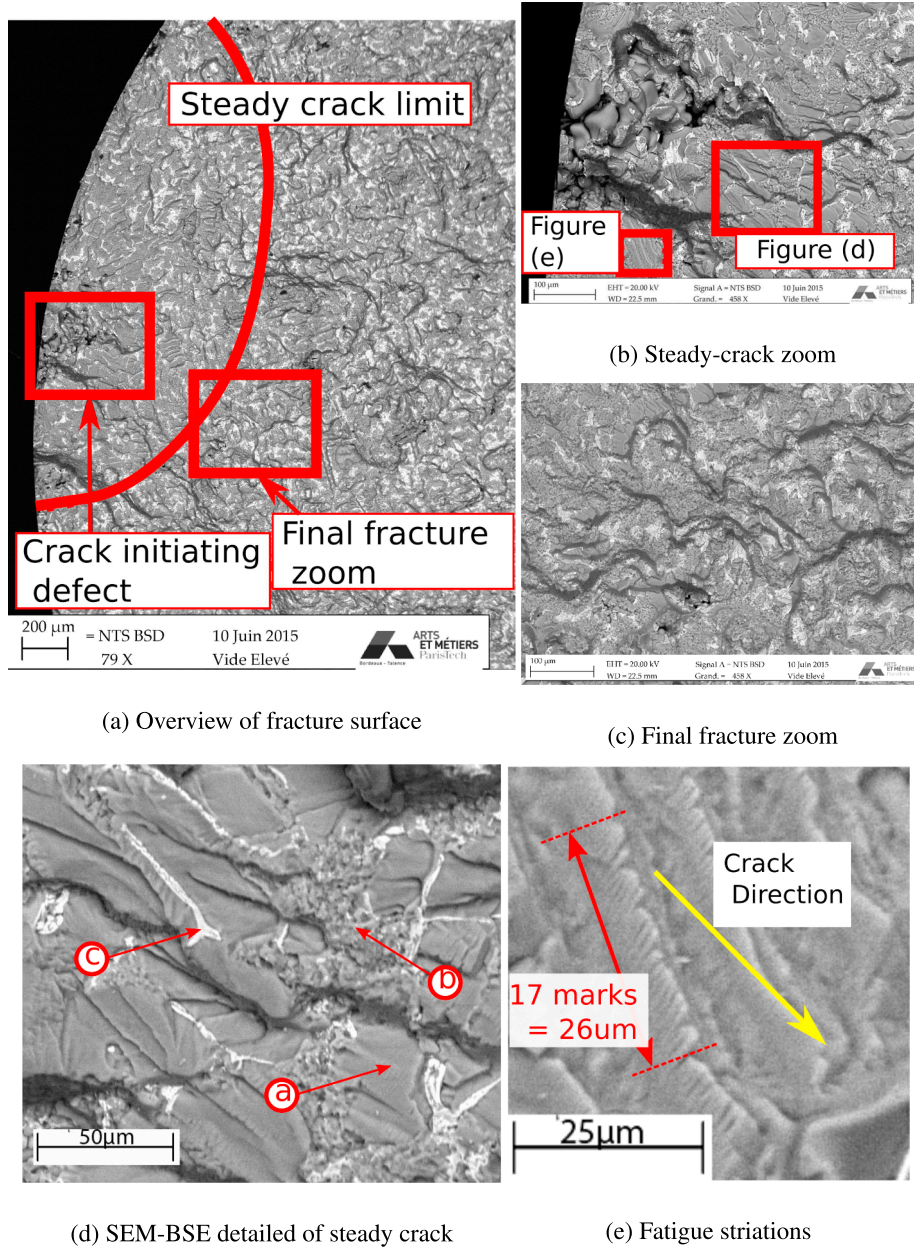
**Fig. 10.** Crack propagation fracture surface (Specimen 87T5:  $\Delta\epsilon/2 = \pm 0.3\%$ ,  $20^\circ\text{C}$ ,  $R_\epsilon = -1$ ,  $N_f = 2904$  cycles).

Fatigue crack propagation features are detailed depending on crack propagation regime. Detailed mechanisms are illustrated on specimen 87T5 ( $\Delta\epsilon/2 = \pm 0.3\%$ ). Firstly, Fig. 10a gives us an overview of the fracture surface by SEM.

**Crack initiation** (Fig. 10b). While unclear at higher temperatures, relatively lower temperature tests show a first propagation stage that can be differentiated from the subsequent steady-crack propagation. During this first crack initiation, several cracks develop along the regions of highest stress concentrations around large defects (as was seen in [14] or [19]). However, these regions of high stress concentration are not necessarily in the same horizontal plane (i.e. the plane

**Steady-crack propagation** (Fig. 10d). The initiating porosity defect appears on the left side, and large flat areas perpendicular to the loading direction appear, corresponding to mode I crack propagation. These can better be seen in Fig. 10d where 3 morphological features appear: label (a) corresponds to flat regions perpendicular to loading, corresponding to crack propagation in the aluminium dendrites; label (b) is typical of the propagation in the eutectic region; label (c) shows a sliced intermetallic. The propagation in the aluminium dendrites leads to the development of fatigue striations as is indicated in Fig. 10e, and confirms observations proposed in [20].

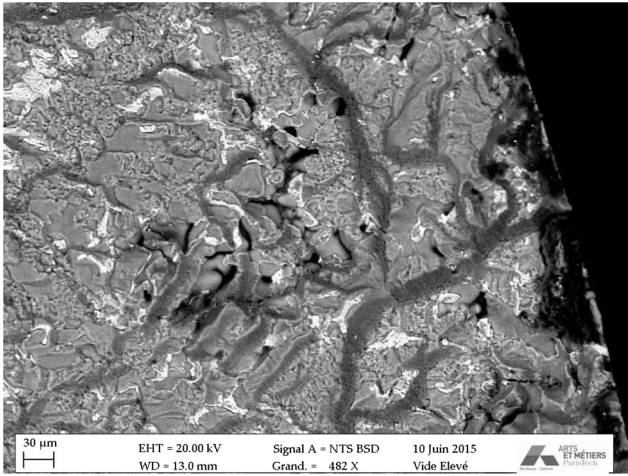
Fig. 11. SEM-BSE of fracture surface (Specimen 71T5:  $\Delta\epsilon/2 = \pm 0.3\%$ , 200 °C,  $R_\epsilon = -1$ ,  $N_f = 2622$  cycles).

In comparison with Fig. 10d, which is on a specimen tested at 20 °C, Fig. 11 displays the steady-crack region for a higher test temperature (200 °C) with an identical imposed total strain amplitude ( $\Delta\epsilon/2 = \pm 0.3\%$ ). A detailed observation shows the crack propagation occurs in pure mode I at ambient temperature: the crack path is only slightly modified by the microstructure. At higher temperature, as is observed in [21], more tear ridges appear on the fracture surface, these tear ridges occurring mostly in the eutectic regions. This shift in mechanisms could be attributed to the increased plasticity levels at the crack tip caused by the higher temperatures. Indeed, in front of the crack, strain incompatibility cause the brittle particles (such as eutectic silicon and intermetallics) to fracture. The crack path is then later modified and tends to propagate through these fractured particles (see [14]).

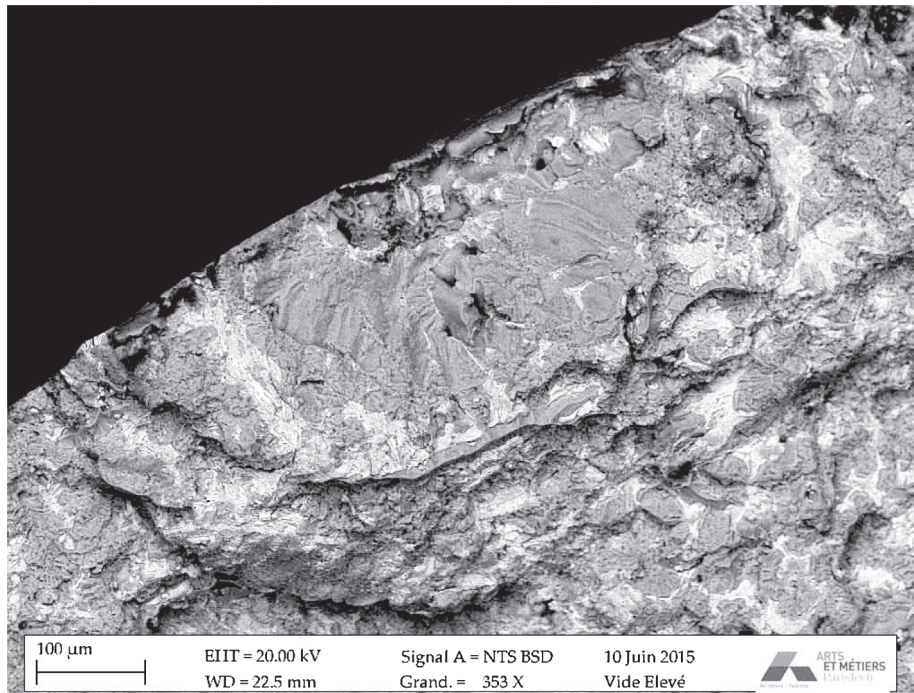
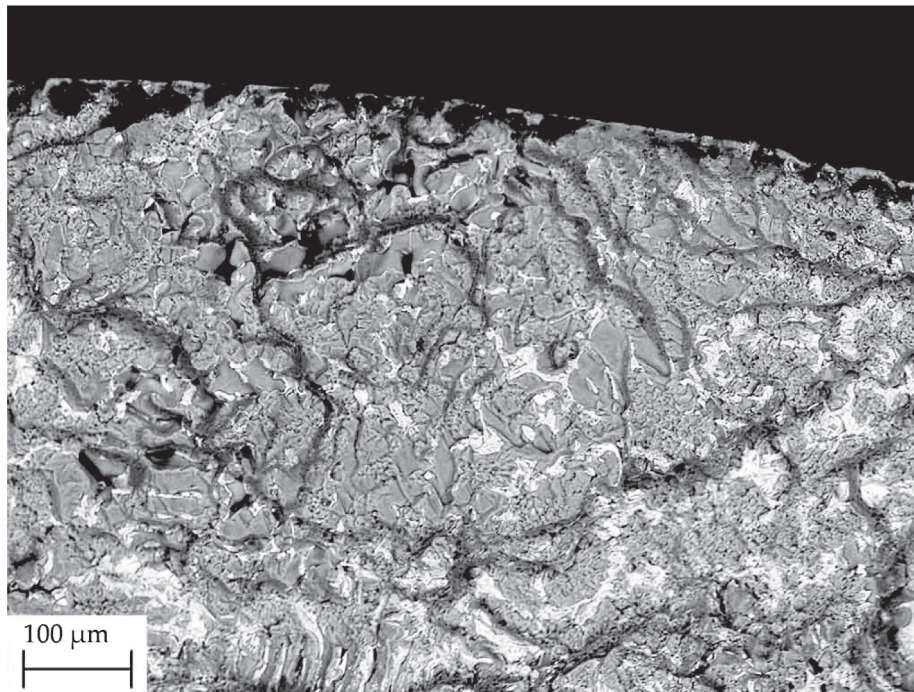
(a) SEM-BSE of fracture surface (Specimen 87T5:  $\Delta\varepsilon/2 = \pm 0.3\%$ , 20 °C,  $R_\varepsilon = -1$ ,  $N_f = 2904$  cycles)

(b) SEM-BSE of fracture surface (Specimen 71T5:  $\Delta\varepsilon/2 = \pm 0.3\%$ , 200 °C,  $R_\varepsilon = -1$ ,  $N_f = 2622$  cycles)

**Fig. 12.** Effect of temperature on steady-crack propagation at 20 °C and 200 °C: small cracks (note that both figures use the same scale).

The same comparison can be emphasized in Fig. 12 where two short fatigue cracks are illustrated. These fatigue cracks probably developed slower than the main crack, observed elsewhere, and show the first stages of crack propagation. The fatigue crack displayed in Fig. 12a, at ambient temperature, shows much more aluminium matrix than at higher temperature, where the fracture surface consists mostly of eutectic and intermetallic particles (as is shown in Fig. 12b). These observations suggest that the temperature significantly modifies the nature of the plastic deformation in the crack tip zone. It is also noteworthy despite the different mechanisms, the total fatigue life ( $N_f$ ) only slightly decreases with temperature increase for identical imposed total strain.

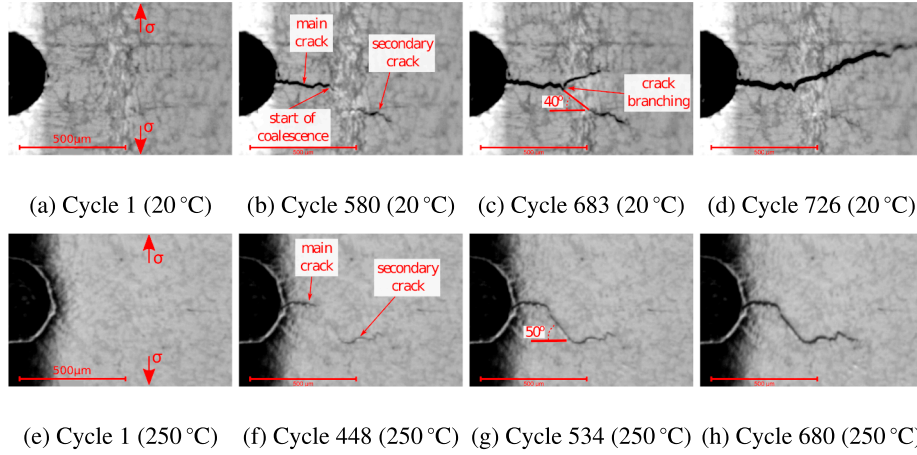
**Fig. 13.** Crack propagation monitoring. Figures (a)–(d): branching crack mechanism (Specimen 76T5:  $\Delta\epsilon/2 = \pm 0.4\%$ , 20 °C,  $R_\epsilon = -1$ ,  $N_f = 734$  cycles). Figures (e)–(h): coalescence crack mechanism (Specimen 89T5:  $\Delta\epsilon/2 = \pm 0.4\%$ , 250 °C,  $R_\epsilon = -1$ ,  $N_f = 701$  cycles).

In order to better show the temperature effect on the short crack propagation, surface observations were performed on short fatigue cracks initiated from artificial defects. Figs. 13a–d illustrates the case of crack propagation at ambient temperature (Specimen 76T5:  $\Delta\epsilon/2 = \pm 0.4\%$ , 20 °C,  $R_\epsilon = -1$ ,  $N_f = 734$ ) while Figs. 13e–h illustrates the high temperature case (Specimen 89T5:  $\Delta\epsilon/2 = \pm 0.4\%$ , 250 °C,  $R_\epsilon = -1$ ,  $N_f = 701$ ).

In both cases, secondary crack is observed ahead of the initial crack. For low temperature test, despite some localisation of the deformation

between the two fatigue cracks, the initial crack does not coalesce with the secondary one and propagates through the aluminium matrix resulting in a rather flat fracture surface. The final images (such as is seen in Fig. 13d) clearly indicate that, later in the test, the secondary crack closes due to the stress shielding effect induced by the main crack propagation. In the case of high temperature tests however, the artificial defect induced fatigue crack quickly coalesce with the secondary crack through a mode II transition (see Fig. 13c). For the high temperature test, two reasons may explain the different observed mechanisms. Firstly, a significant change in the cyclic plastic zone at the crack tip that could induce a larger interaction range with secondary cracking. Similar crack tip interactions and strain localization at high temperature can be seen in [19]. In addition, this localization may be favoured by a shift in plastic deformation mechanisms with higher temperature: Al-Si-Cu alloys (high-stacking fault energy) are known to exhibit dynamic softening mechanisms, such as dynamic recovery during deformation at elevated temperatures. Cyclic plastic deformation ahead the crack tip may trigger such softening mechanisms and

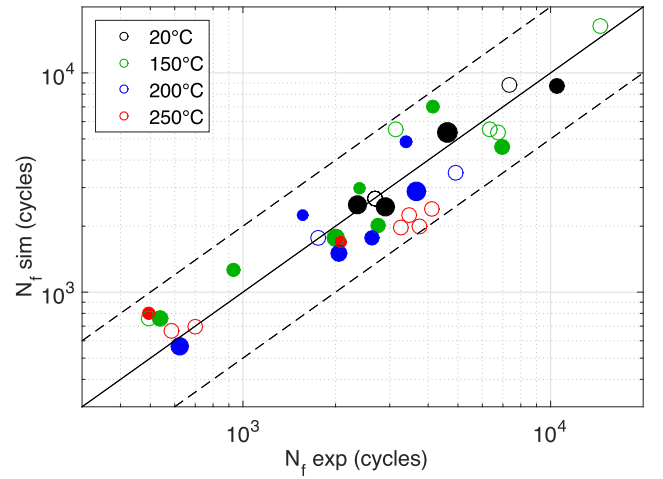
**Fig. 15.** Numerically predicted fatigue life as a function of experimentally measured for all specimens. Marker area is proportional to Feret diameter, the marker in the legend corresponding to 100  $\mu\text{m}$ . Full markers are used for model identification while empty ones are used for validation for unmeasured defects.

The results are presented in Fig. 15 (empty markers). The model provides good fatigue life estimations for all the temperatures and imposed strains. However, for the highest temperature (250 °C), the model does not seem to capture the propagation kinetic and mechanism. This could be caused by the shift in propagation mechanism, with the increased plasticity effect, and the lack of measured defects. Indeed, only 2/8 specimens initiating defects are identified at this temperature, causing them to have small impact on the optimized parameters.

For most of the data points, the use of the median defect size allows for a conservative prediction of fatigue life.

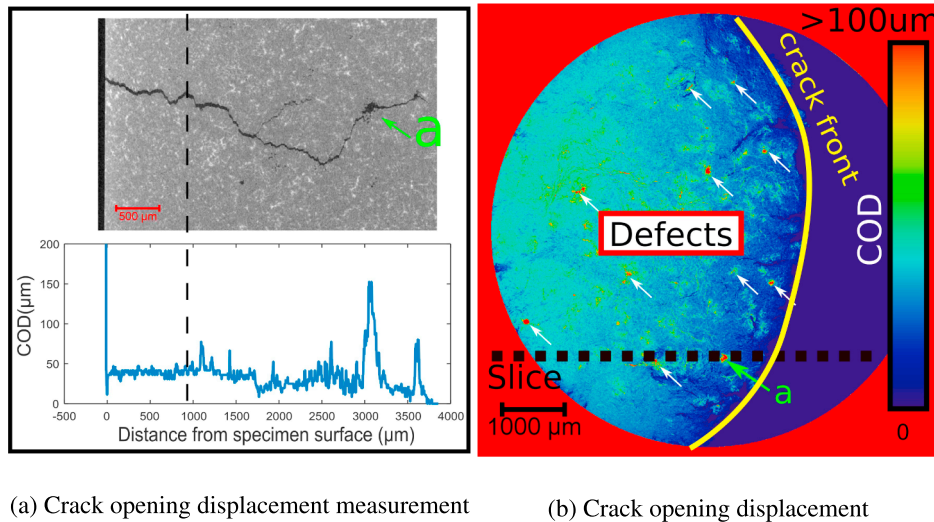
**Fig. 14.** Crack opening displacement and defect interaction. (specimen 62T5,  $\Delta\epsilon/2 = \pm 0.3\%$ , 250 °C,  $R_\epsilon = -1$ ,  $N_f = 2089$  cycles).

By analysing a specimen interrupted before final failure by tomography, defect interaction with crack can be seen in Fig. 14 for a high temperature test. The method applied is similar to that in [22]: the crack is thresholded and the crack opening displacement (COD) measured by counting the number of voxels belonging to the crack per vertical line  $l$  and converting using voxel resolution (see Fig. 14a). It must be noted the opening displacement is measured after testing, implying the specimen is not under tensile loading. In presence of defects, the measured displacement is the sum of COD and defect height, causing defects to appear red<sup>1</sup> on the map. Several defects can be seen for all crack advances. Especially, for the latter stages of crack propagation, defects influence the crack path at larger scales ( $\approx 1$  mm). This can be seen on the slice (see Fig. 14a) which displays a defect (label (a) in Fig. 14) that strongly influences the crack path.

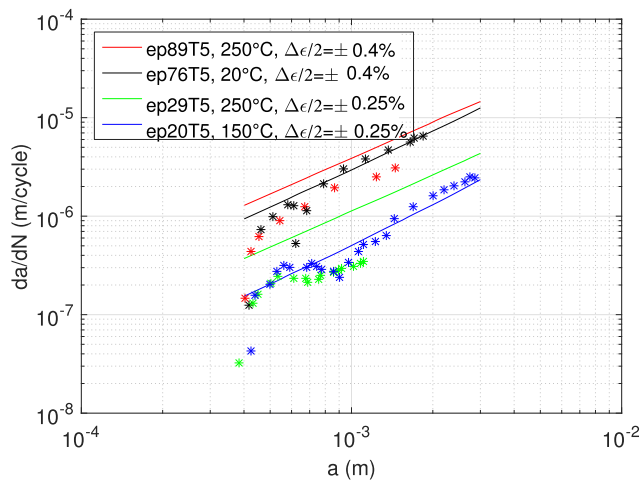
**Fig. 16.** Experimental (markers) and model (lines) crack propagation rates versus crack length.

Lastly, the results of the crack propagation monitoring experiments are compared to the model. Results are presented in Fig. 16. As is

observed previously, high temperature (250 °C) crack propagation rate is overestimated by the model for two specimens (89T5 and 29T5), but it still captures the right order of magnitude and appears to be conservative, making the model suitable for design purposes. For the two

other specimens (76T5 and 20T5) at ambient temperature, the crack propagation rate is accurately predicted.

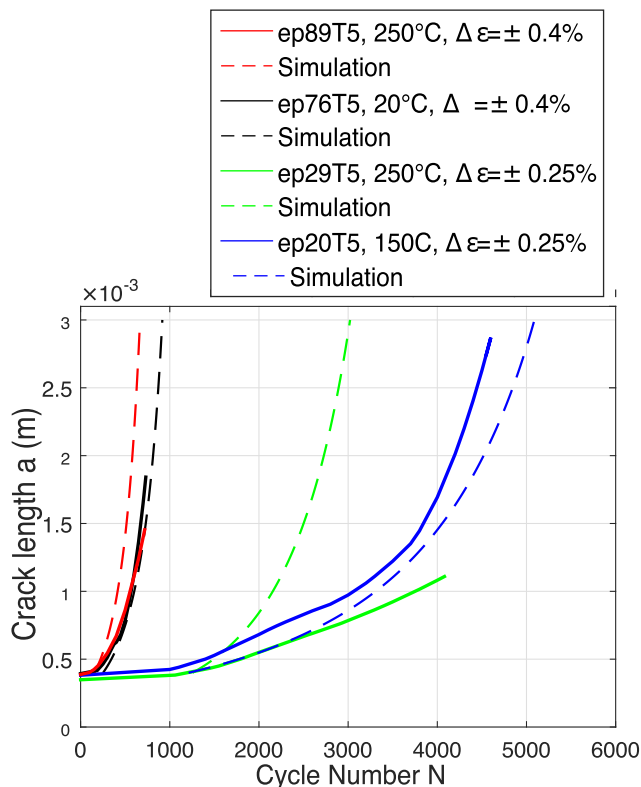
**Fig. 17.** Experimental (full line) and simulated (dashed line) crack length as a function of the number of cycles.

Crack length simulation is shown in Fig. 17. The initial defect length is taken as the measured hemispherical defect diameter (around 400  $\mu\text{m}$ ). The crack propagation model does not take into account the initiation period, and the experimental measured values of cycles to initiation ( $N_{init}$ ) are therefore used for both simulated and experimental crack propagation data (i.e. the simulated crack propagation only starts at ( $N_{init}$ ) in Fig. 17). The simulated crack length are in good agreement with the observed data except for the high-temperature (250 °C) low strain ( $\Delta\epsilon/2 = \pm 0.25\%$ ) experiment, which still remains conservative.
