Maxime SAGNARD, Romain ECAULT, Laurent BERTHE, Kay BRUNE - Development of the symmetrical laser shock test for weak bond inspection - Optics and Laser Technology - Vol. 111, p.644-652 - 2019

# Development of the symmetrical laser shock test for weak bond inspection

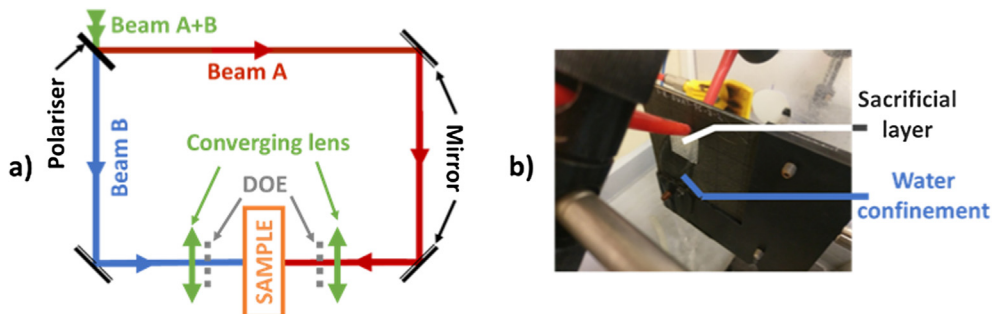
Fig. 3. (a) Schema of the experimental setup. (b) Close up on the sample setup.

A Nd:Yag laser is used to generate a pulse of 7 ns which can deliver up to 2x7J. To create a symmetrical shot, the Gaïa laser used on the Hephaïstos platform is composed of two lasers which beams are polarised by 90° from one another. Thanks to a polariser, two distinct beams, referred to as Beam A and Beam B, are created and transported through optics to both sides of the tested sample (Fig. 3(a)).

Prior to the shot, the tested area was protected using an aluminium adhesive tape, and the zone was confined using a water trickle to make sure at least 1 mm of water covered the sample during the test (Fig. 3(b)).

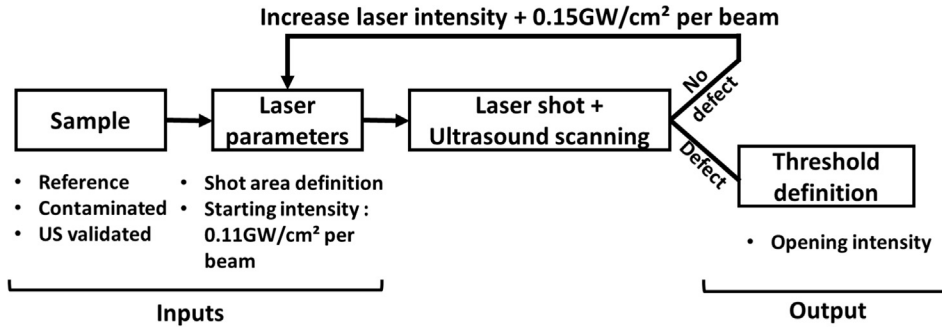
Fig. 6. Block scheme of the experimental procedure.

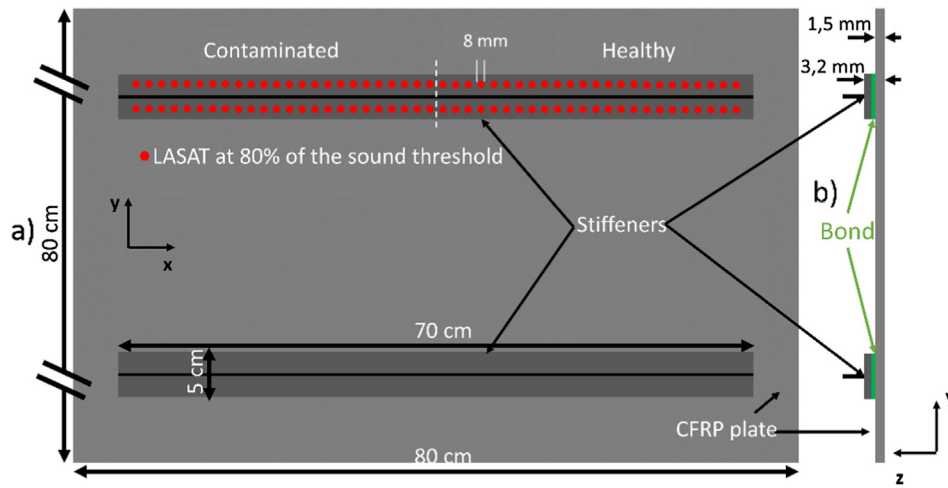
Fig. 10. Production panel: (a) front view with laser shot position and (b) side view with specified thicknesses.

A350 panels have been produced/recovered to test the technique using real parts. The production sample is an  $800 \times 800 \times 1.5$  mm CFRP plate on which two  $700 \times 50 \times 1.7$  CFRP stiffeners were bonded (Fig. 10). The plate is made of 14 prepreg layers with the following lay-up:  $[+45/90/0/90/+45/0/90]_s$ . On one half, the stiffeners have been bonded without contamination, and on the other half of the plate both the de-icing fluid and the finger print solution have been applied on the stiffeners' surface before the bond. The goal will be to assess the quality of the bond holding the stiffeners to the CFRP plate. Only the upper stiffener has been tested.

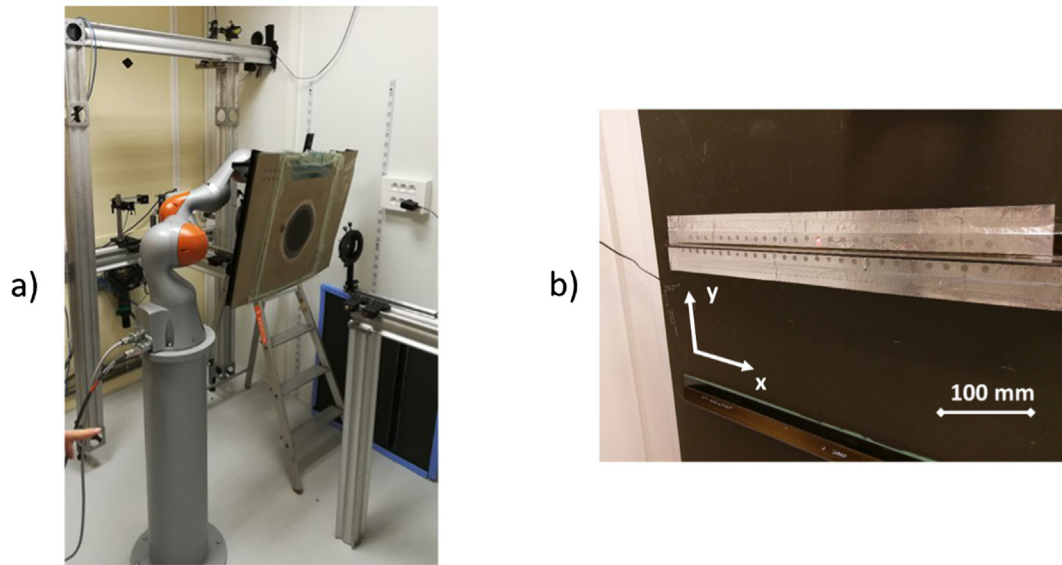
Fig. 12. (a) New experimental setup with the repair panel placed on the robot and (b) one of the stiffener of the production panel after laser shots.

They are covered by the transparent confinement tape. The “dots” are areas that have been test using S-LASAT. This panel is ready to undergo a full ultrasonic scan to find the opened areas.

These parts were too big to fit into the initial experimental setup. A robot has been installed to move the piece around, and the optics had to be rearranged (Fig. 12(a)). The water confinement was not feasible either. Instead, a solid constraining material in the form of a thick transparent adhesive layer was used. Its confinement capabilities are comparable to the water in the intensity range  $0-3 \text{ GW/cm}^2$ . Tests on the coupon sample have also validated this choice. The sacrificial layer is the same as before. Fig. 12(b) is a picture of the production panel. Two bands of sacrificial aluminium tape were placed on the stiffener.
