Yessine AYED, Guénaël GERMAIN - High-pressure water-jet-assisted machining of Ti555-3 titanium alloy: investigation of tool wear mechanisms - International Journal of Advanced Manufacturing Technology - Vol. 96, n°1-4, p.845-856 - 2018

High-pressure water-jet-assisted machining of Ti555-3 titanium alloy: investigation of tool wear mechanisms

Abstract

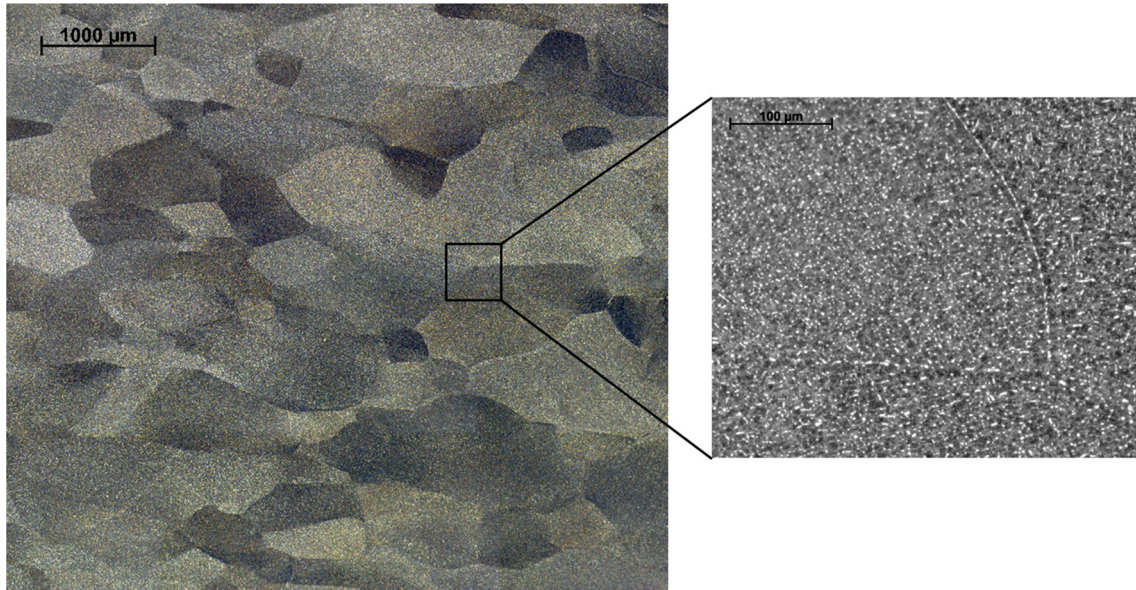
Fig. 1 Microstructure of the Ti555-3 alloy

The Ti555-3 near-beta titanium alloy was selected for this study. It has improved mechanical properties compared to the Ti-10V-2Fe-3Al alloy and is mainly intended for landing gear and other aeronautical structural components. It also has high hardenability, high fracture toughness and a good strength to weight ratio [28, 29]. The microstructure of the as-delivered material, etched with Kroll's reagent, is shown in Fig. 1. It displays a two-phase microstructure: lamellar and globular α phase within the β matrix.

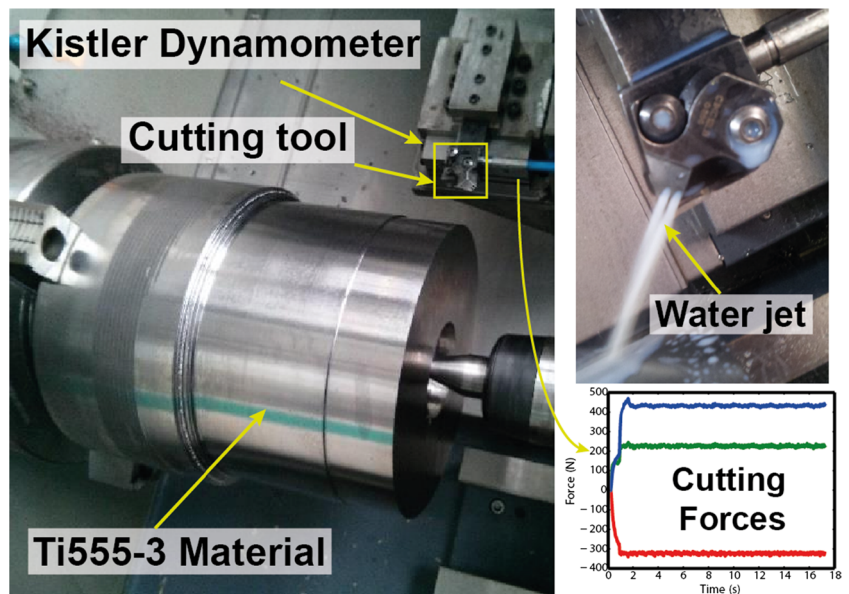
Fig. 2 Experimental setup

Longitudinal turning tests have been carried out on Leadwell LTC25iL CNC turning lathe supplying a maximum power of 24 kW. Based on the recommendations from previous studies [5] and due to the high chemical reactivity of titanium alloys, uncoated tungsten carbide inserts (ISO designation CNMG 12 04 12-23 H13A) have been used. An emulsion-based cutting fluid (5% concentration) has been used for the conventional lubrication tests and HPWJA tests at 100 bar (15 l/min) and 250 bar (26 l/min). Instrumented experiments have been carried out to track and to analyse tool wear evolution. A Kistler dynamometer (9257B) has been used to measure the evolution of the cutting forces. Flank wear has been measured using a stereo microscope on the basis of the standard ISO3685. The tool wear rejection criterion used is $VB = 0.3$ mm (VB represents the average flank wear). For a more comprehensive investigation of the tool wear mechanisms, a SEM and a 3D profilometer have been used. Figure 2 illustrates the experimental procedure.

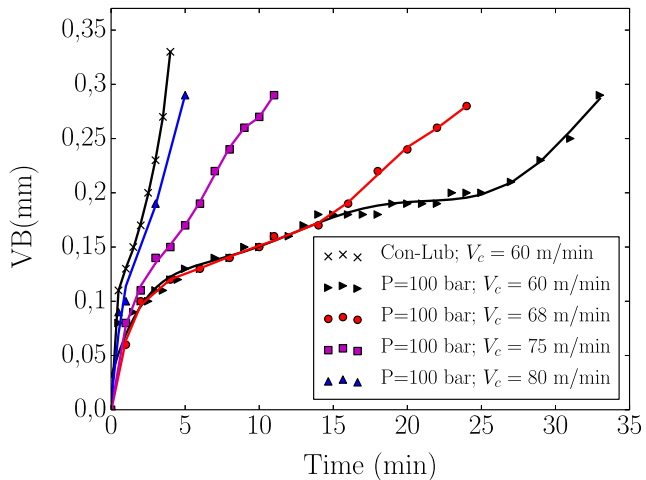
Fig. 3 Influence of the cutting speed and the high-pressure water-jet assistance on tool life ($a_p = 1.5$ mm, $f = 0.1$ mm/rev)

Figure 3 demonstrates that the cutting speed could be further increased to 75 m/min while maintaining an acceptable tool life of up to 11 min. Beyond this speed, HPWJA is no longer efficient. The acceleration of wear as a consequence of an increase in cutting speed is mainly related to the activation of different tool wear mechanisms. During the cutting process, heat is generated in the cutting zone due to plastic deformation and friction. The amount of heat generated is increased by an increase in the cutting speed. As reported by Moura et al. [10],

First of all, in order to highlight the impact of the water-jet assistance on tool life, the cutting conditions were fixed ($V_c = 60$ m/min, $a_p = 1.5$ mm and $f = 0.1$ mm/rev). Two tests were carried out under conventional and HPWJA conditions ($P = 100$ bar). As showed by Fig. 3, the contribution of HPWJA can be clearly observed with an increase in tool life of up to a factor of 8 (from 4 to 34 min). Based on these results, a significant gain in terms of productivity could be obtained by improving the cutting conditions. To this end, a slight increase in the cutting speed

at the cutting edge, the temperature may reach 1000 °C. Hence, the high temperature levels accelerate diffusion and adhesion (plucking mechanism) [10]. In the case of HPWJA, the lubricant jet insures good cooling of the cutting zone, thereby slowing tool wear evolution. However, the progressive increase of the cutting speed leads to a rapid temperature increase that the lubricant jet cannot evacuate quickly. This finally leads to a reduction of the HPWJA efficiency (80 m/min).

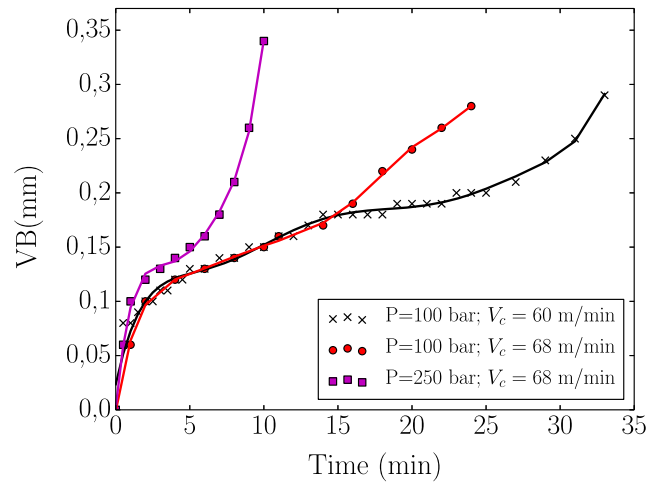
Fig. 4 Influence of the cutting speed and coolant pressure on tool life ($a_p = 1.5$ mm, $f = 0.1$ mm/rev)

This part of the study has been achieved by a comparative analysis of the impact of the lubricant-jet pressure on tool life. Figure 4 illustrates the evolution of the tool wear curves. It shows that a pressure increase causes a considerable decrease in tool life.

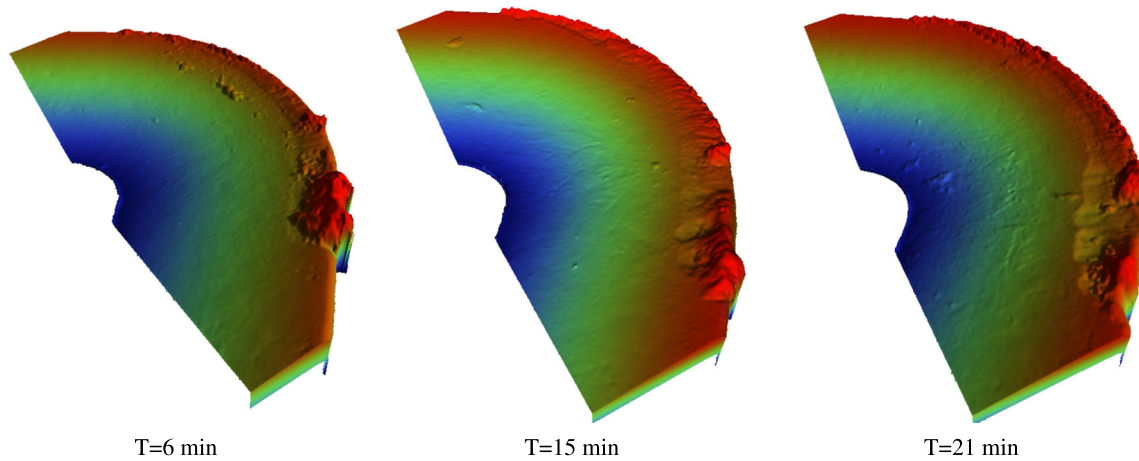
Fig. 5 Tool wear evolution ($P = 100$ bar)

For both cases, observations of the tool using a stereo microscope revealed the formation of a crater at the cutting face. To get more information about tool wear evolution and mechanisms, cutting tools have been analysed using a 3D profilometer and a SEM. Figures 5 and 6 show different stages of crater formation.

For a pressure of 100 bar, tool wear evolves gradually and crater wear takes place only after 15 min of machining. However, for a pressure of 250 bar, excessive tool wear

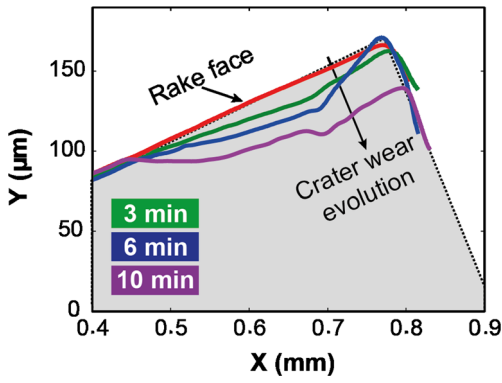
Fig. 7 Crater wear evolution ($P = 250$ bar)

is seen, notably at the level of the tool rake face. The crater becomes larger and deeper as shows by Fig. 7. The progressive formation of the crater weakens the cutting tool. Hence, machining up to 10 min has caused the cutting edge to break and substantial material chipping.

Under these cutting conditions, crater wear becomes more pronounced with the increase of the lubricant-jet pressure. Generally, the crater formation mechanism is often related to the activation and the acceleration of diffusion at high cutting temperatures [10, 30]. Optimum cutting conditions and an effective lubrication must avoid overheating of the cutting zone and thus slowdown crater formation. However, this hypothesis is inconsistent with the results found. Hence, it could be concluded that the formation of crater wear in HPWJA must be due to another mechanism. Similar results have been obtained when machining the Ti17 titanium alloy under the same lubrication conditions [26, 27]. It seems that crater formation in this case is due to an adhesion/plucking mechanism. Indeed, during machining, adherent layers are

formed and stick to the surface of the tool under the action of the high contact pressure and temperature. The mechanical action of the water jet causes the tearing off and plucking of these adherent layers. The increase of the water-jet pressure intensifies this phenomenon; the tool/chip contact length is more and more reduced.

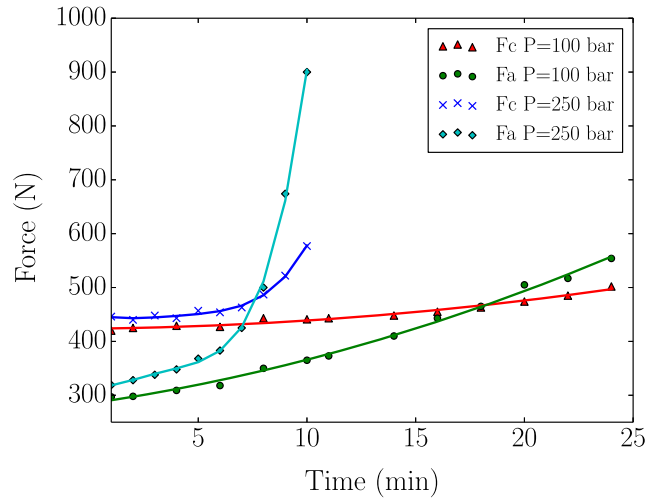
Fig. 10 Evolution of the cutting forces

The evolution of the mean arithmetic (average value) cutting force and the axial force (F_c , F_a) during machining is presented in Fig. 10. It can be seen that for 100 bar, the cutting force evolves gradually. However, for 250 bar, a sharp and rapid evolution can be observed. This could be linked to flank wear, crater wear and material chipping at the cutting edge which causes a local change of the tool geometry, cutting angles and contact length.

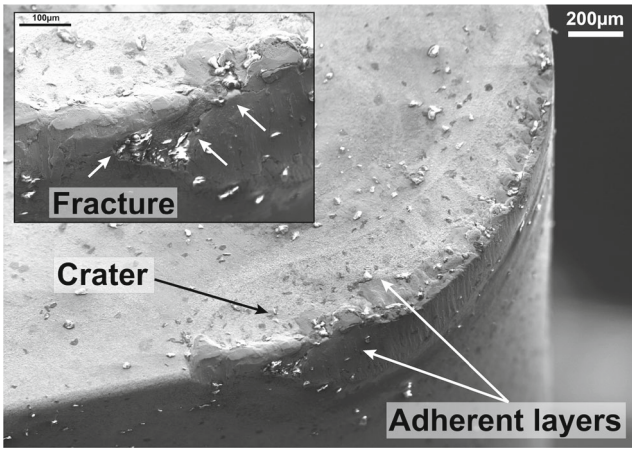
Fig. 8 SEM observation of tool wear ($P = 250$ bar, $T = 9$ min)

The SEM observations, illustrated in Fig. 8, show the existence of adherent layers on the tool rake and flank faces. The parallel scratches on the tool flank face are a sign of abrasion wear. Micro-cracks have also been detected and they are mainly due the combination of tool stiffness degradation and high cutting forces.

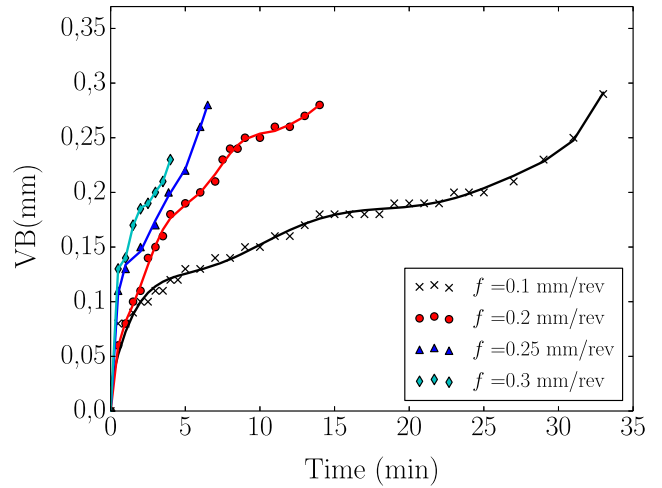
Fig. 11 Feed rate influence ($a_p = 1.5$ mm, $V_c = 60$ m/min, $P = 100$ bar)

At a cutting speed of 60 m/min and a pressure of 100 bar, the feed rate has been varied from 0.1 to 0.3 mm/rev. The experimental results are plotted in Fig. 11. It shows a sharp decrease in tool life (at least 50%); tool life does not exceed 4 min at 0.3 mm/rev. Also, for high feed rates, a large notch occurs and weakens the tool insert. In this context, it is necessary to point out that under these conditions and with conventional lubrication, machining of the Ti555-3 alloy is almost impossible (only 5 min at 0.1 mm/rev). Machining is accompanied by high temperature generation and smoke that ends by the collapse of the cutting edge after a few seconds.

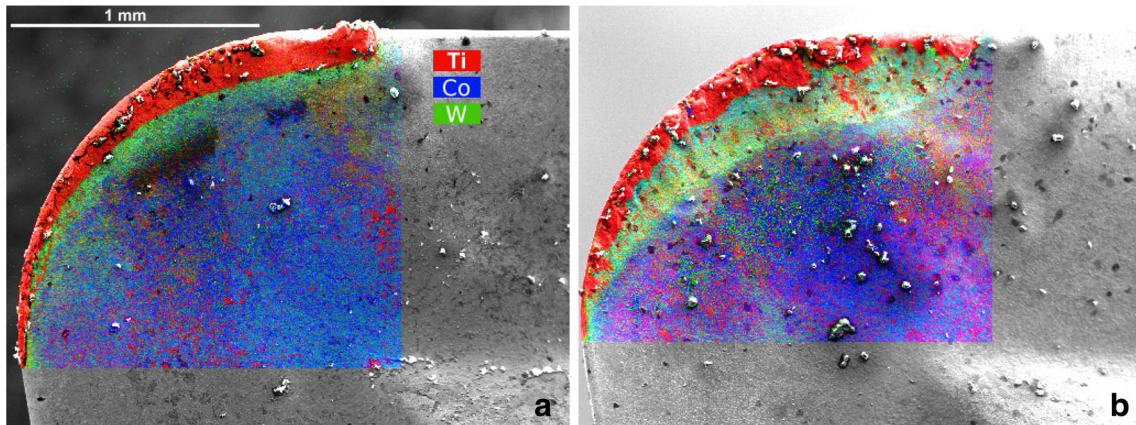
Fig. 9 SEM observation of tool wear: **a** Conventional lubrication, $T = 4$ min; **b** $P = 250$ bar, $T = 9$ min

An EDS examination of the adherent layers has confirmed the activation of an adhesion mechanism by the detection of titanium on the tool rake face as illustrated by Fig. 9. For the case of conventional machining, titanium deposits are uniformly distributed along the contact area. However, for the case of high-pressure water-jet assistance, the amount of these deposits has been greatly reduced which is mainly due to the reduction of the tool/chip contact length.

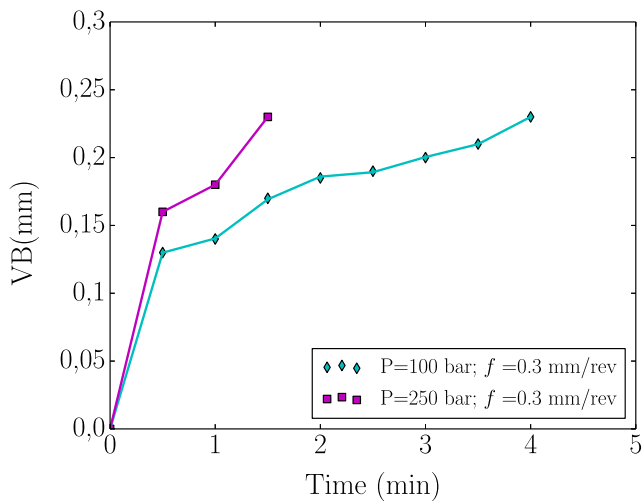
Fig. 12 Feed rate and pressure influence ($a_p = 1.5$ mm, $V_c = 60$ m/min)

Figure 12 emphasizes the influence of the water-jet pressure at 100 bar and 250 bar. Tests have been stopped at $VB = 0.23$ mm to preserve the highly damaged cutting edge for further analysis. As well as the last tests, the increase of pressure leads to a more degradation of the tool.

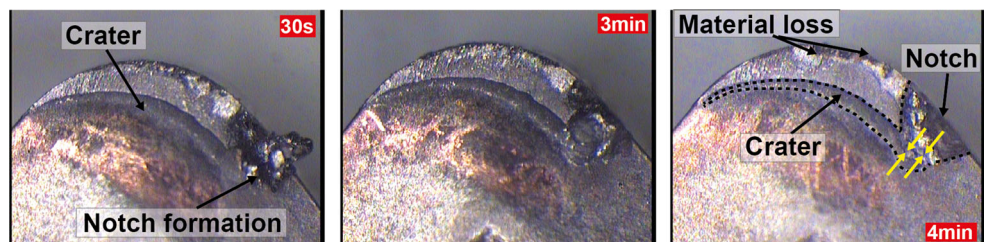
Fig. 13 Observation of tool wear evolution on the tool rake face ($a_p = 1.5$ mm, $f = 0.3$ mm/rev, $V_c = 60$ m/min, $P = 100$ bar)

Monitoring of tool wear evolution using a stereo microscope is illustrated in Fig. 13. It shows that after only 30 s, severe wear has taken place. A notch and a crater have been formed; material chipping has been observed on

the cutting edge. Over time, tool wear evolves rapidly; the notch becomes larger and reaches the crater. At this point, the tool tip becomes very fragile and it could collapse under the action of the increasing cutting forces, even if the flank wear remains stable.

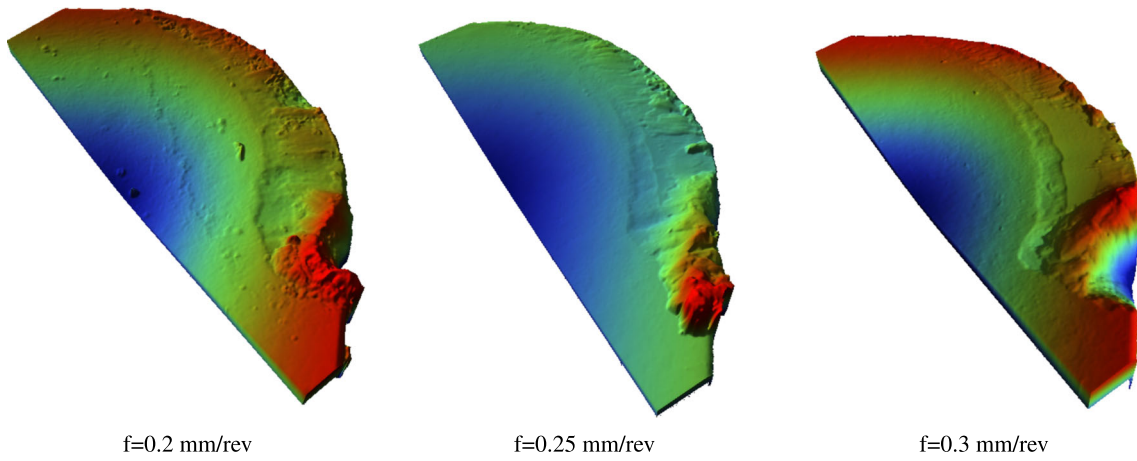
Fig. 14 Tool wear at the end of tool life ($a_p = 1.5$ mm, $V_c = 60$ m/min, $P = 100$ bar)

For a more exhaustive tool wear analysis, tool inserts have been observed using a SEM and scanned using a 3D profilometer. Figure 14 shows the scanned surfaces of the cutting tools at the end of the tool life. Figures 15 and 16 show the SEM observations of the worn tools.

These analysis have permitted a closer view of the damaged areas. Material deposits (adherent layers) and material chipping are clearly distinguishable ($f = 0.2$ mm/rev and $f = 0.3$ mm/rev) on the flank face, the rake face and the notch. For a feed rate of 0.3 mm/rev, the tool seems to have undergone very severe thermo-mechanical loads, given the significant deterioration of the cutting edge. Indeed, a large notch of approximately 400 μ m wide and material chipping along the cutting edge have occurred in only 4 min.

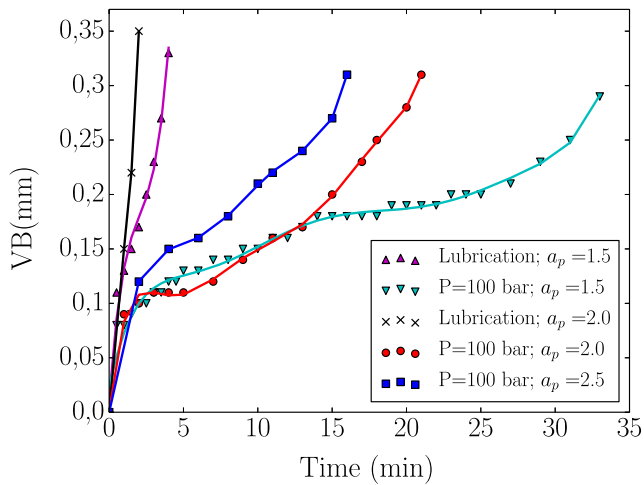
Fig. 17 Depth of cut impact ($f = 0.1$ mm/rev, $V_c = 60$ m/min)

A final series of tests have been carried out in order to investigate the impact of the depth of cut on tool wear using HPWJA. The depth of cut has been varied from 1.5 to 2.5 mm ($f = 0.1$ mm/rev, $V_c = 60$ m/min). The results of these tests are presented in Fig. 17.

First of all, it could be noted that the Ti555-3 titanium alloy is almost not machinable under these cutting conditions, using conventional lubrication; the tool life does not exceed 2 min at $a_p = 2.0$ mm. However, the use of the high-pressure water-jet assistance significantly increases tool life. Indeed, for $a_p = 1.5$ mm, tool life has been multiplied by a factor of 8 and for $a_p = 2$ mm, it has been multiplied by a factor of 10 (from 2 to 21 min).

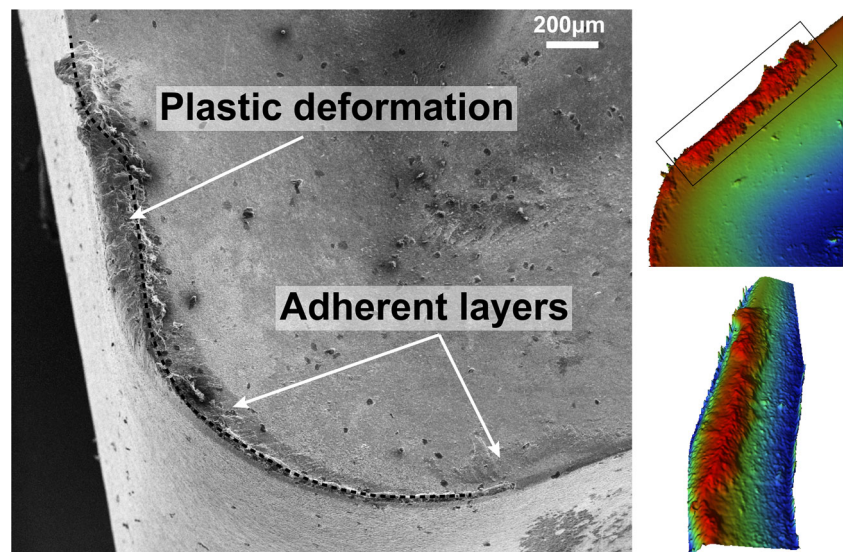
Fig. 18 Plastic deformation of the cutting edge (conventional lubrication, $a_p = 2$ mm, $T = 2$ min)

collapse [34]. This has been confirmed by analyses using the SEM and the 3D profilometer. Figure 18 illustrates the plastic deformation at the cutting edge (conventional lubrication); the cutting edge has been deformed by approximately 0.15 mm.

As the cutting forces increase when the depth of cut increases, it leads to a considerable increase in temperature in the cutting zone. In this very confined zone, which is subjected to very high cutting pressures, the evacuation of heat by the lubricant fluid remains very difficult. Tool wear mechanisms are then accelerated; the combined effect of temperature and mechanical actions will eventually cause plastic deformation of the cutting edge and subsequently its

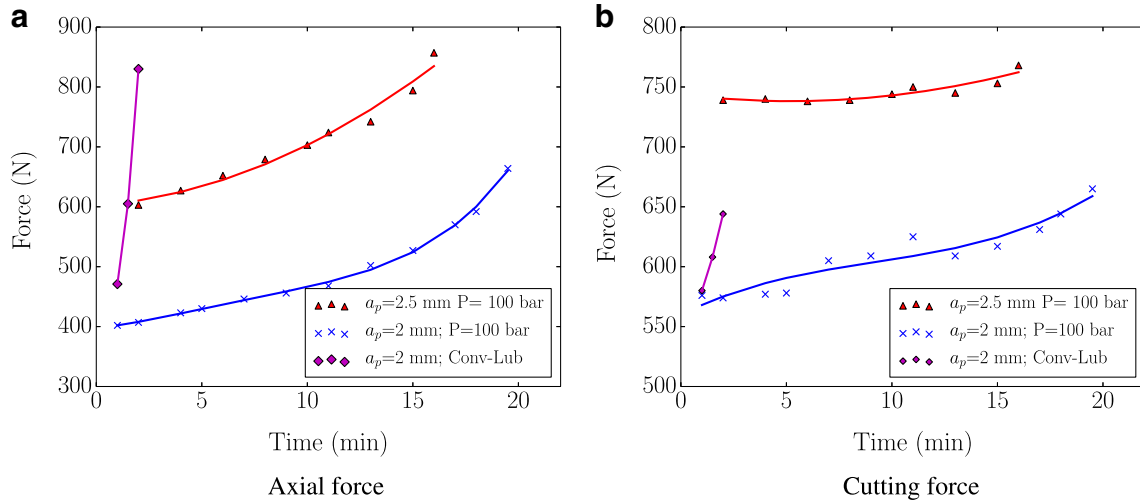
Fig. 19 Cutting force evolution

The evolution of the cutting forces is provided by Fig. 19. Hence, it can be deduced that the initial specific cutting force ($K_c = \frac{F}{a_p f}$) is approximately 2800 MPa and it reaches 3520 MPa at the end of the tool life. This further explains the plastic deformation phenomenon which has occurred. On the bases of the work by Astakhov [34], to prevent thermal softening of tungsten carbide, the temperature should not exceed 800 °C for such a loading level. However, this temperature is far exceeded during machining of titanium alloys even for a lower cutting conditions [35]. In the case of water-jet assistance, a large part of the generated heat is evacuated.

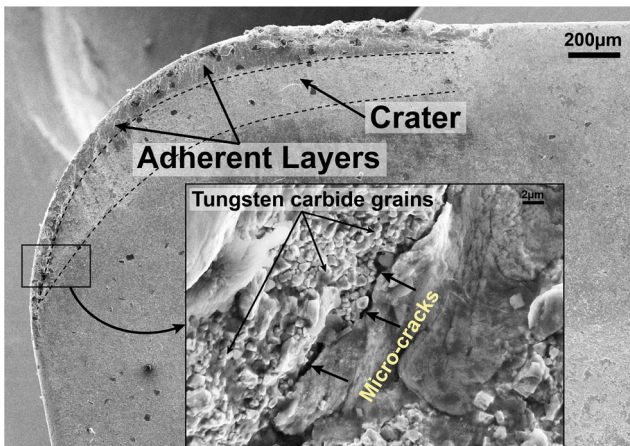
Fig. 20 Tool wear: $a_p = 2$ mm, $P = 100$ bar, $T = 19$ min

The efficient lubrication provided by the high-pressure water jet avoids the plastic deformation wear mechanism. Figure 20 shows the rake face of the tool at the end of the tool life (19 min). It shows the zones of material adhesion and a large crater; it also shows micro-cracks on the border between the crater and the cutting edge. The gradual formation of the crater under the action of the adhesion mechanism (accelerated by the water jet) weakens the tool. Meanwhile, wear on rake and flank faces leads to an increase in the cutting forces. At this time, micro-cracks begin to form; this will end by the rupture of the cutting edge.
