High-pressure water-jet-assisted machining of Ti555-3 titanium alloy: investigation of tool wear mechanisms

Y. Ayed¹ · G. Germain¹

Abstract

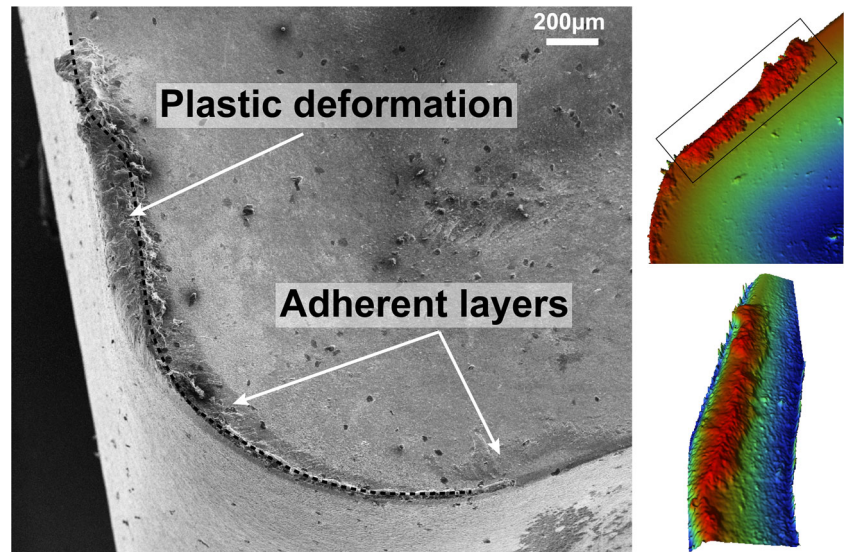
Fig. 18 Plastic deformation of the cutting edge (conventional lubrication, $a_p = 2$ mm, $T = 2$ min)

collapse [34]. This has been confirmed by analyses using the SEM and the 3D profilometer. Figure 18 illustrates the plastic deformation at the cutting edge (conventional lubrication); the cutting edge has been deformed by approximately 0.15 mm.
