Crack path in aeronautical titanium alloy under ultrasonic torsion loading

ABSTRACT. This paper discusses features of fatigue crack initiation and growth in aeronautical VT3-1 titanium alloy under pure torsion loading in gigacycle regime. Two materials: extruded and forged VT3-1 titanium alloys were studied. Torsion fatigue tests were performed up to fatigue life of 10^9 cycles. The results of the torsion tests were compared with previously obtained results under fully reversed axial loading on the same alloys. It has been shown that independently on production process as surface as well subsurface crack initiation may appear under ultrasonic torsion loading despite the maximum stress amplitude located at the specimen surface. In the case of surface crack initiation, a scenario of crack initiation and growth is similar to HCF regime except an additional possibility for internal crack branching. In the case of subsurface crack, the initiation site is located below the specimen surface (about 200 μm) and is not clearly related to any material flaw. Internal crack initiation is produced by shear stress in maximum shear plane and early crack growth is in Mode II. Crack branching is li

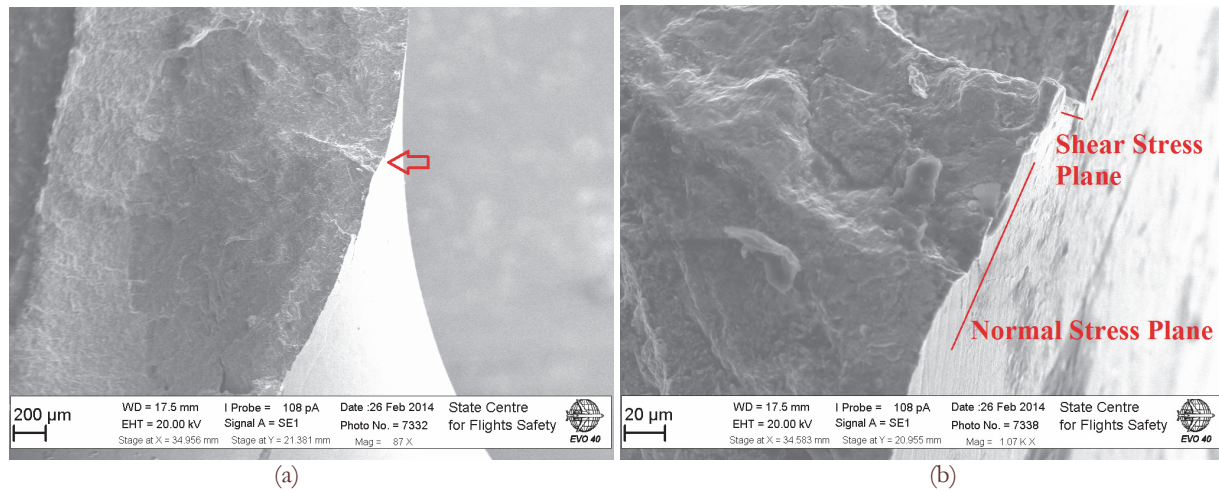
Figure 8: Surface crack initiation in forged VT3-1 under torsion loading (a) overview of torsion crack with initiation site marked by arrow and (b) detailed crack initiation view.

First of all, the comparison of SN-curves for push-pull and torsion loadings (Fig.4 and 5) shows a more important slope of SN-curve in the case of torsion loading. This tendency keeps being the same as for forged, as well for extruded titanium alloy in spite of small difference of SN-curves for these alloys under push-pull fatigue. This means that VT3-1 titanium is more sensitive to shear stress than to normal one. This is typical for ductile metals. However, long crack propagation is observed in planes of maximum normal stress which is typical for more brittle material. Therefore, at the very first stage of fatigue crack initiation, when a crack length is about the same order than the grain size the fatigue behavior of titanium is similar to ductile material and fatigue damage accumulation is due to sliding process. In the case of two-phase $\alpha + \beta$ titanium alloy a higher capacity to accommodate plastic sliding has a hexagonal alpha-phase. Thus, the fatigue resistance of titanium alloy to torsion loading may be related to features of alpha-platelets. In the case of surface torsion crack it can be observed macroscopically at surface in one of two maximum shear stress planes: along or perpendicularly to specimen’s axis. Fig.8b shows an example of first torsion crack growth stage along an axis.

When torsion crack reaches a length of several micrometers, the crack growth turns into a plane of maximum normal stress, Fig. 8b. Typical size of alpha-platelets is very small for the studied titanium alloys and micro-plasticity of alpha-phase is not enough to accumulate fatigue damage at later stage of crack growth that turns fatigue behavior of material to the brittle-mode failure (governed by the normal stress cracking mechanisms). Another reason that can limit the stage of crack growth in shear plane is quite high deformation rate in the case of ultrasonic loading. But anyway, a transition from maximum shear to normal stress plane is typical for torsion cracking at different loading frequencies. In reference [18] fully reversed torsion fatigue tests were carried out on titanium alloy Ti-6Al-4V in HCF regime at a loading frequency of
