Hassen MEFTAH, Sahbi TAMBOURA, Hachmi BENDALY, Abbas TCHARKHTCHI, Joseph FITOUSSI - Thermal aging influence on the damage mechanisms of fully recycled composite-reinforced polypropylene/polyethylene blend - Polymer Composites - Vol. 40, n°8, p.3342-3350 - 2019

Thermal Aging Influence on the Damage Mechanisms of Fully Recycled Composite-Reinforced Polypropylene/Polyethylene Blend

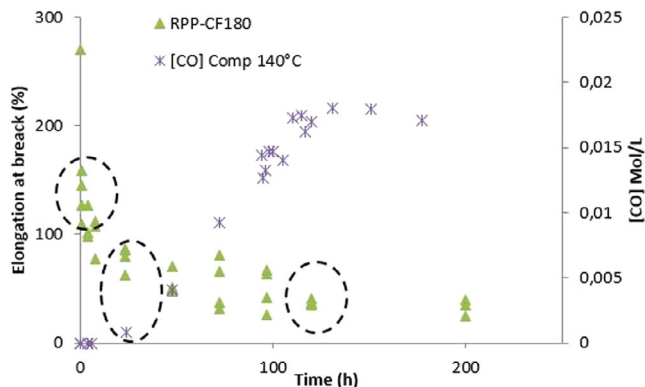
FIG. 2. Elongation at break and carbonyl growth evolutions during thermal aging at 140°C. [Color figure can be viewed at wileyonlinelibrary.com]

The choice of the specimens was made following the elongation at break and the carbonyl build-up evolutions during thermal aging as described in Fig. 2. This mechanic behavior was characterized through tensile tests at quasi-static loading (10^{-2} s^{-1}) on composite specimens taken at different time of aging. These results were obtained in previous work [26] and it has been proven that with the increase of the exposure time, only the elongation at break is affected. Figure 2 shows that from the first moments of exposure (during the induction period) the elongation at break for quasi-static tensile tests drops dramatically by 45%. This important decrease of the elongation at break can be explained by a weakening of the matrix due cross-linking mechanism and chains cut or/and an embrittlement of the composite microstructure more precisely the fiber/matrix interface weakening. Therefore it is important to choose the first aged specimen during this period in order to emphasize the local mechanisms at the origin of the brutal embrittlement occurring just before the beginning of oxidation (t_{iCO}) [13, 14]. The second specimen was taken once the oxidation products start to appear and the third one when the oxidation process begins to stabilize.

As mentioned earlier in Section “Specimen choice and preparation”, the embrittlement in the composite occurs from the first moments of exposure and the elongation at break drops by 45% to reach 90% at the end of oxidation. Thus, in order to identify the mechanisms involved in this embrittlement, SEM analysis of the microstructure were carried out on a virgin sample and other aged samples taken at different times of aging. Figure 4 shows the effect of thermal aging on the fiber/matrix interface of RPP-CF180 at different time

of the damaged. Therefore, final failure occurs faster with increasing thermal aging time as described above in Fig. 2.
