Sana CHAABANI, Pedro José ARRAZOLA, Yessine AYED, Aitor MADARIAGA, Albert TIDU, Guénaél GERMAIN - Comparison between cryogenic coolants effect on tool wear and surface integrity in finishing turning of Inconel 718 - Journal of Materials Processing Technology - Vol. 285, p.116780 - 2020

# Comparison between cryogenic coolants effect on tool wear and surface integrity in finishing turning of Inconel 718

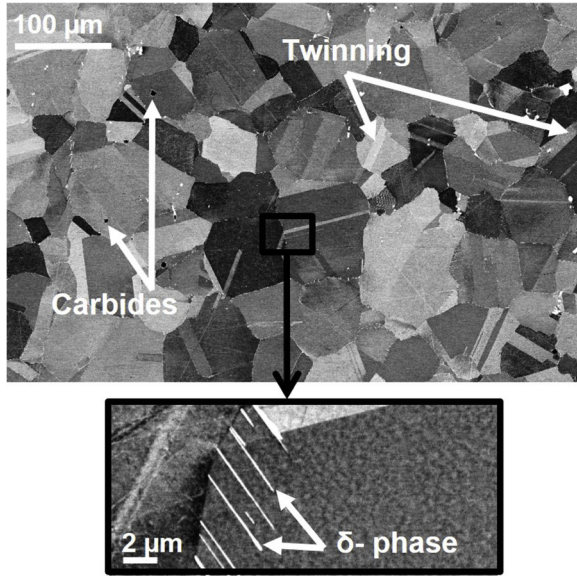
**Fig. 1.** Illustration of Inconel 718 microstructure in the as-received state observed by SEM technique.

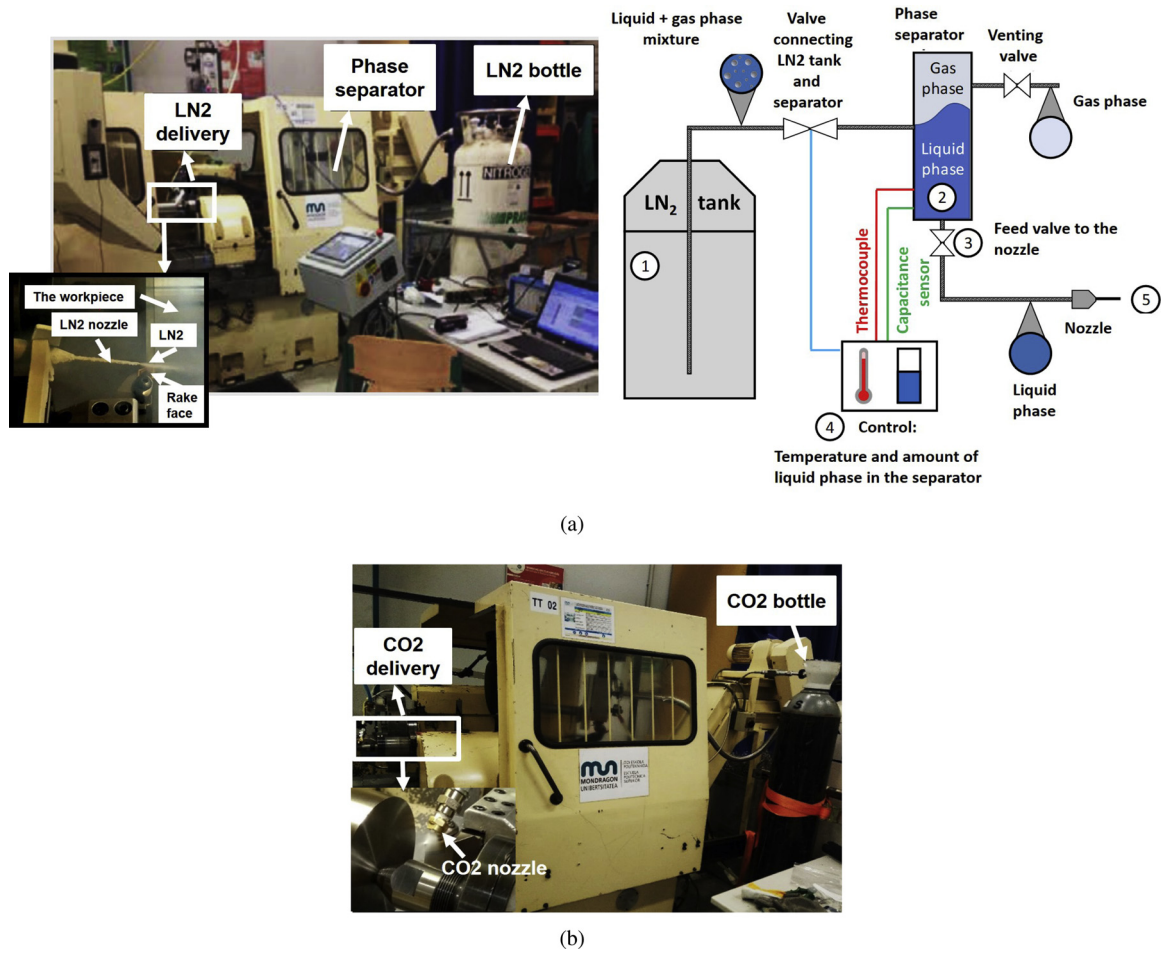
Fig. 2. Experimental set-up for the cryogenic tests: (a) LN<sub>2</sub> set-up; (b) LCO<sub>2</sub> set-up.

nitrogen bottle mounted on the CNC lathe (Fig. 2).

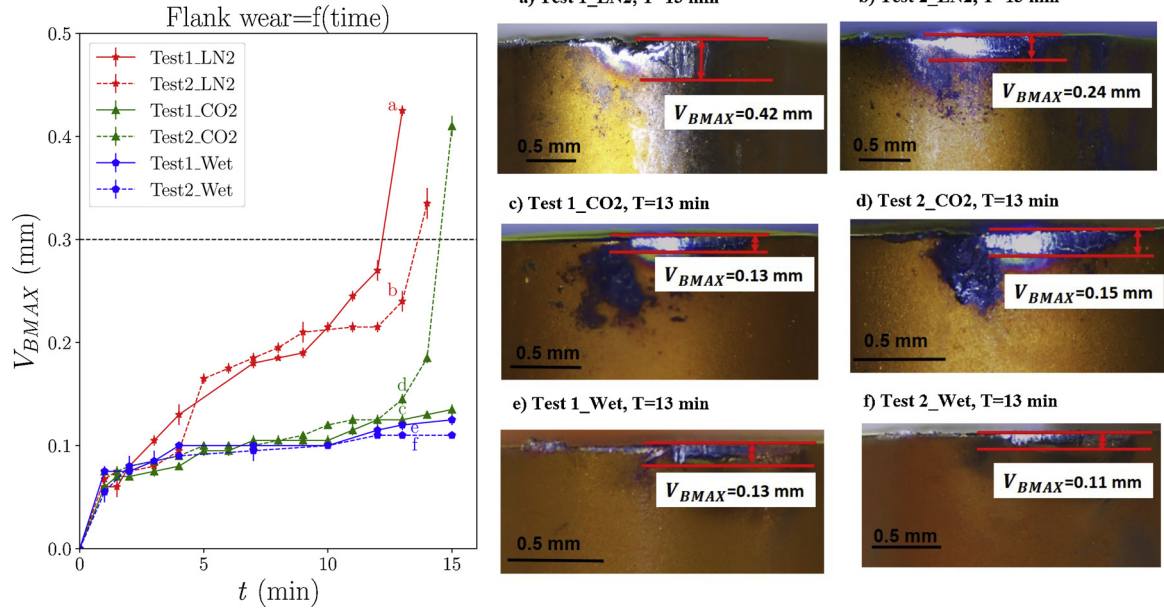
Fig. 3. Tool flank wear evolution under wet, LN<sub>2</sub> and LCO<sub>2</sub> cooling conditions during the tests.

Tool flank wear evolution was measured throughout the turning operations for all cooling methods (conventional and cryogenic conditions). The trials were stopped when reaching 15 min of cutting in conventional lubrication even if the criterion of maximum flank wear namely  $V_{BMAX} = 0.3$  mm was not achieved. Regarding the LCO<sub>2</sub> condition, both tests were stopped at 15 min while the tool flank wear levels were notably different. However, under LN<sub>2</sub> cryogenic condition, the trials were stopped when the criterion of  $V_{BMAX}$  was reached. Focusing on Fig. 3, results indicated that the conventional condition revealed the longest tool life. In fact, the tool flank wear did not surpass 0.12 mm over 15 min of cutting in conventional lubrication. Both repetitions induced the same trend during the cutting process showing a good repeatability.

As for the LCO<sub>2</sub> cooling strategy, a similar evolution has been perceived up to 13 min of cutting. Nevertheless, beyond this duration, the tool flank wear progressed drastically to surpass the criterion at 15 min during the second repetition of LCO<sub>2</sub> experiment. With respect to LN<sub>2</sub> cryogenic condition, tool flank wear increased rapidly from the first 2 and 6 min of cutting during test 1 and test 2 respectively causing reduced tool life. In addition, tool flank wear progress in both cryogenic conditions is quite repeatable at the beginning of the machining process. Nevertheless, a significant variability was observed at 11 min and 13 min respectively in LN<sub>2</sub> and LCO<sub>2</sub> cooling strategies when the tool flank wear increased notably. In conventional cooling approach, a homogeneous tool flank wear evolution was observed even after longer machining times. In contrast, during LN<sub>2</sub> cryogenic machining, wear peaks occurred from the beginning of the turning process, indicating that the cutting process is not performed homogeneously while this parameter showed a steady and slow evolution in LCO<sub>2</sub> cryogenic condition except the last minutes of machining.

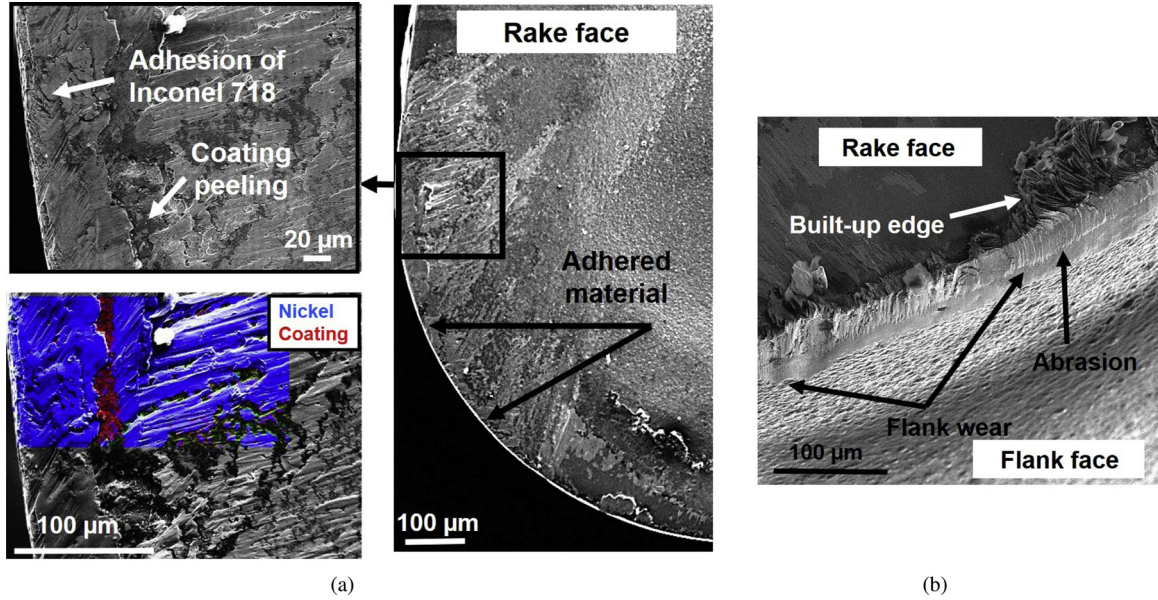
Fig. 4. SEM observations of the tool wear after 15 min of machining in wet condition: (a) rake face/EDS analysis; (b) flank face.

properties are significantly different compared to the one used in the current study. In addition, other factors could be identified consisting in the cutting conditions (cutting parameters as well as the cutting tool geometry). For these reasons, a scientifically rigorous comparison between previous studies and the current job seems to be difficult. Additional analysis have been carried out in order to study the tool wear mechanisms when machining Inconel 718 under conventional lubrication and cryogenic conditions using SEM. Fig. 4 shows the SEM observations of the tool wear state on the rake face as well as the flank face obtained in wet condition after 15 min of cutting.

The main mechanism observed consists in adhesion wear. Effectively, deposits of workpiece material were stuck on the rake face near the cutting edge revealing the chip rubbing. This observation is proved by EDS analysis showing the adhered material consisted in nickel. In fact, as long as machining time increased, adhered layers were formed progressively to establish built-up edges that protect the rake face (Xue and Chen, 2011). However, when achieving stagnation state, the build-up edges are not stable inducing the peeling of tool coating material.

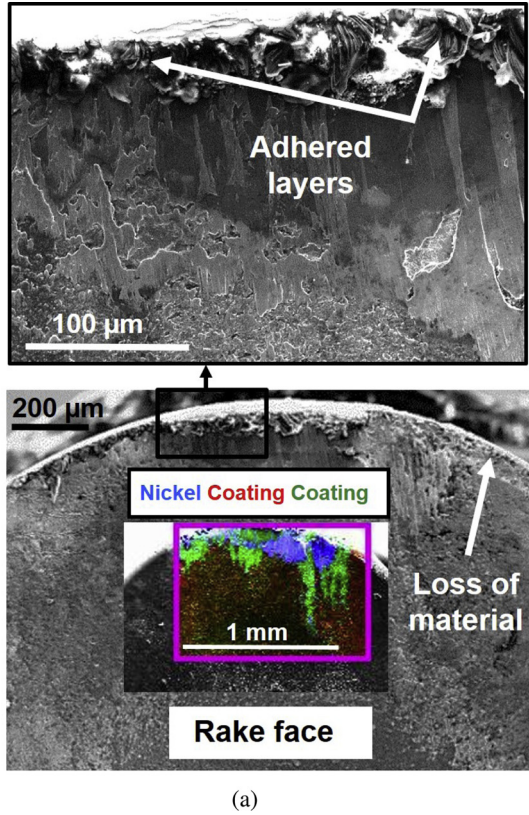
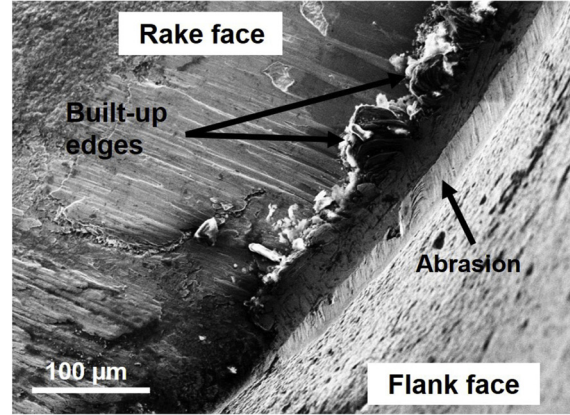
Fig. 5. SEM observations of the tool wear after 15 min of machining in LCO<sub>2</sub> condition during Test 1: (a) rake face/EDS analysis; (b) flank face.

With respect to tool wear mechanisms under LCO<sub>2</sub> condition, the two tests revealed different mechanisms. The first test exhibits the same trend as the conventional lubrication. Indeed, adhered layers are formed during machining as well as abrasion wear that is mainly caused by the hard carbide particles present in the workpiece material. It is worth mentioning that these two wear mechanisms are closely related (Cantero et al., 2013). Effectively, the adherence of the workpiece material inducing the formation of the built-up edge (BUE) leads to tool chipping, because of the instability of BUE that breaks off alternatively tearing out a small lump of the cutting edge (Fig. 5).

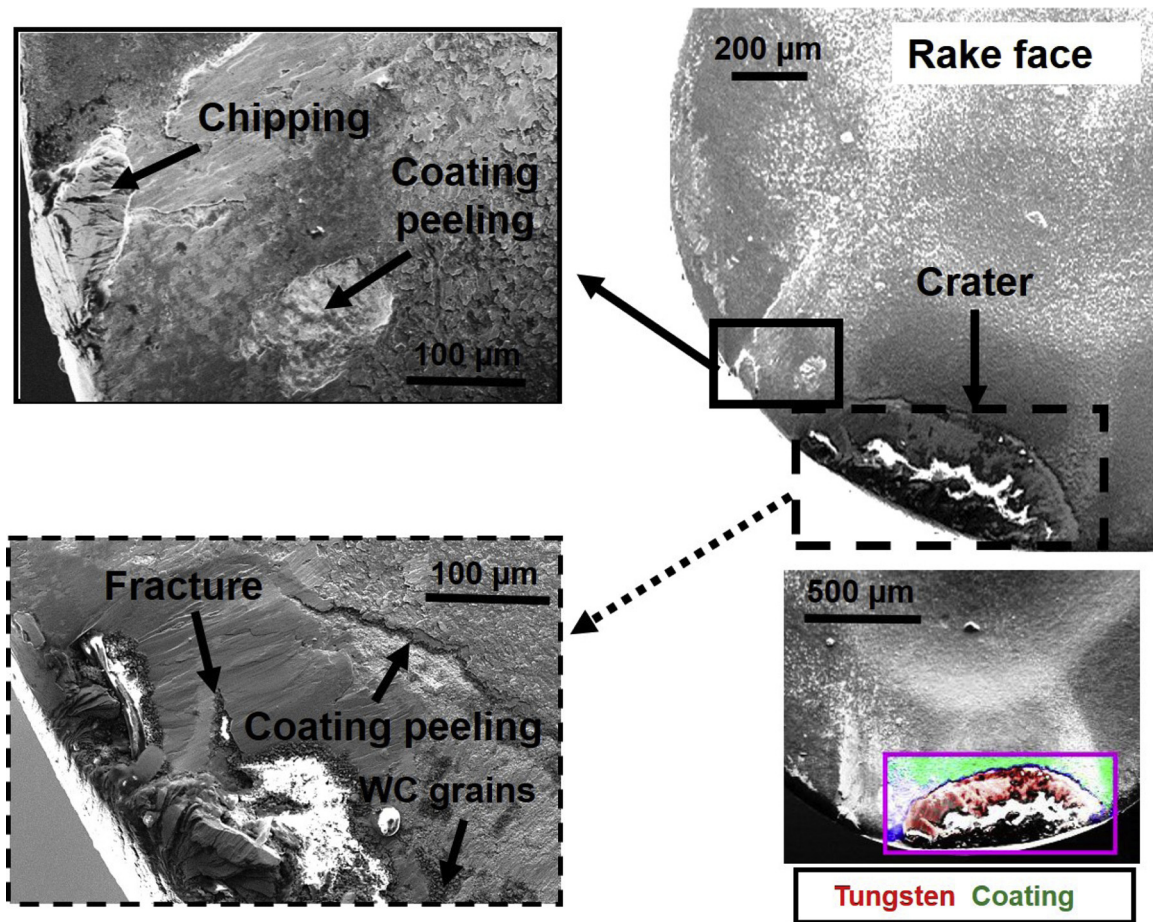
Fig. 6. SEM observations of the tool wear after 15 min of machining in LCO<sub>2</sub> condition during Test 2.

Nevertheless, the tool wear modes and mechanisms occurred during the second test when using LCO<sub>2</sub> are rather different. Besides the flank wear, drastic crater wear took place caused by the plucking out of the tool coating particles as illustrated in Fig. 6.

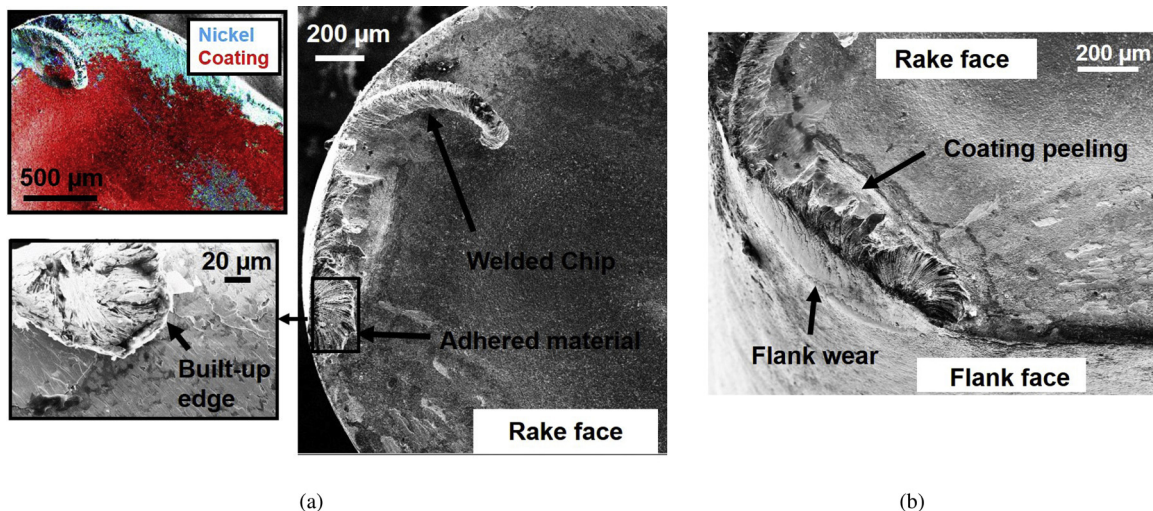
Fig. 7. SEM observations of the tool wear after 13 min of machining in LN<sub>2</sub> condition during Test 1: (a) rake face/EDS analysis; (b) flank face.

Concerning the LN<sub>2</sub> cooling conditions, tool wear mechanisms that have been detected through the SEM observations and the EDS analysis are not far from those obtained during the second test of LCO<sub>2</sub> lubrication. Indeed, during both LN<sub>2</sub> tests, the degradation of cutting tool is primarily caused by adhesion and micro-chipping as depicted in Figs. 7 and 8.

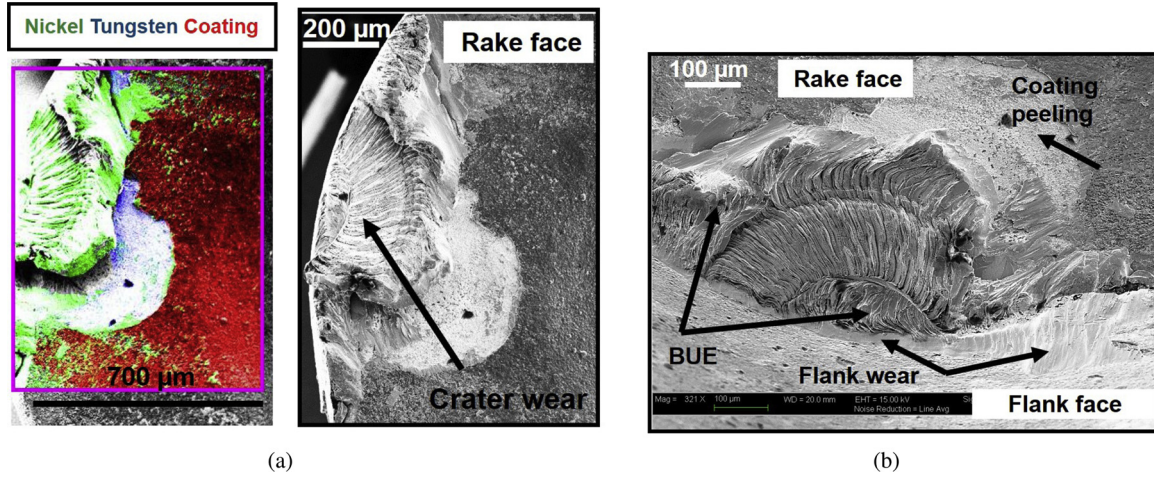
Fig. 8. SEM observations of the tool wear after 14 min of machining in LN<sub>2</sub> condition during Test 2: (a) rake face/EDS analysis; (b) flank face.

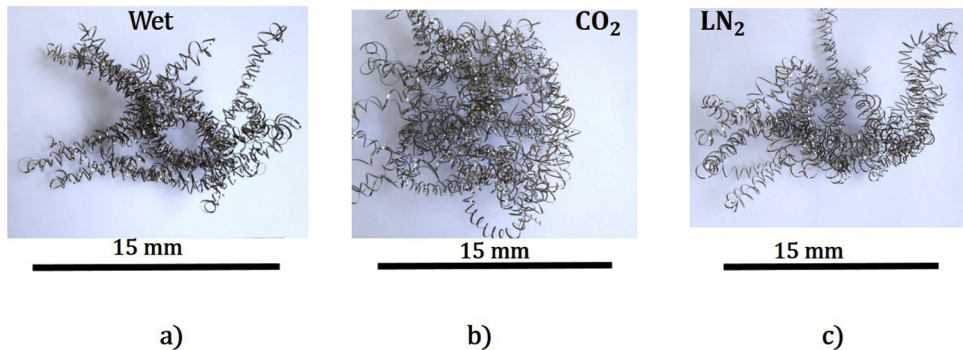
Fig. 9. Chip morphology obtained in the three cooling strategies: (a) wet, (b) CO<sub>2</sub> and (c) LN<sub>2</sub>.

Another aspect should be stated consisting in that when delivering LN<sub>2</sub> cutting fluid on the tool rake face, it seems complicated to avoid cooling the unmachined workpiece. Consequently, the work material deformation behavior as well as the thermal properties could change by the cryogenic temperature (−196 °C). Thereby, the cutting process in this case turns out to be nonhomogeneous affecting the tool wear resistance. Moreover, when examining the chip morphology obtained under all cooling conditions, there is no significant difference; the chips exhibit almost the same morphology as depicted in Fig. 9.

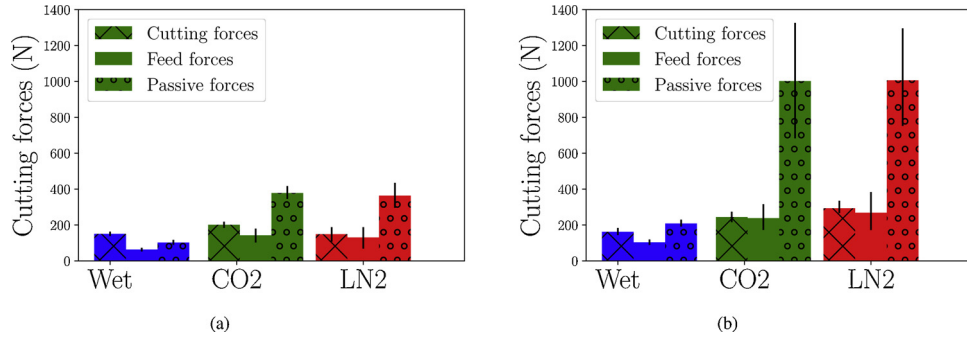
Fig. 10. Comparison between cutting forces components: at the beginning (a); at the end (b) of test.

Results showed that all cutting forces components exhibit lower values in conventional cooling condition than in the case of cryogenic conditions (Fig. 10). Indeed, the cryogenic cutting fluids (LN<sub>2</sub> and LCO<sub>2</sub>) display very low temperature throughout machining time leading to increase the flow stress of the workpiece material. As a result, the machining forces components heighten significantly. For instance, when examining the values of the cutting forces components found in conventional and cryogenic conditions, a strong difference is obtained where the maximum value of cutting forces that has been measured in conventional condition is 180 N. In contrast, in LN<sub>2</sub> and LCO<sub>2</sub> cooling approaches, this variable has exceeded 300 N and 250 N respectively at the end of cutting. Furthermore, the feed forces show the same tendency where the highest values are achieved in LN<sub>2</sub> cryogenic conditions. However, the passive forces revealed the highest values recorded in all cooling environment compared to the cutting and feed forces reaching over 1200 N after 14 min of machining in LN<sub>2</sub> condition.

Cutting forces values are key factors to indicate the tool wear state. Fig. 10 illustrates the cutting forces measurements at the beginning and the end of the cutting process revealing the effect of tool wear evolution. Obviously, over machining time, the tool wear increases relatively to the cooling environment and therefore cutting forces rise as well. In

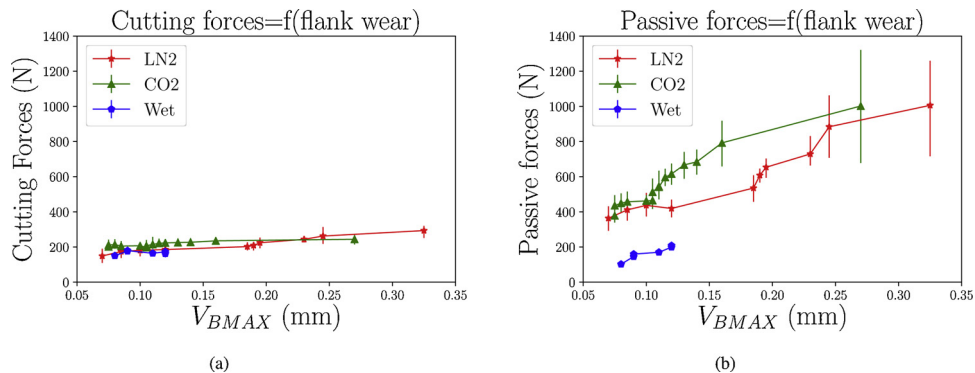
Fig. 11. Correlation between cutting forces components evolution and tool flank wear under Wet, LN<sub>2</sub> and LCO<sub>2</sub> conditions: (a) cutting forces, (b) passive forces.

addition, when comparing between the three components of the cutting forces regardless the lubrication strategy, one could recognize that the passive force measurements showed the highest values, mostly by the end of the machining process where the tool flank wear increased notably (Grzesik et al., 2018). In addition, when comparing between the different cooling methods, one could notice that passive force progress is slow and steady in conventional condition. Nevertheless, under cryogenic conditions, this parameter evolves drastically at the end of machining. This tendency is more pronounced under LN<sub>2</sub> cryogenic condition than under LCO<sub>2</sub> condition. This result may be attributed to the rapid tool flank wear progress in LN<sub>2</sub> cryogenic strategy mentioning that the passive forces are the most sensitive to tool flank wear as depicted in Fig. 11.

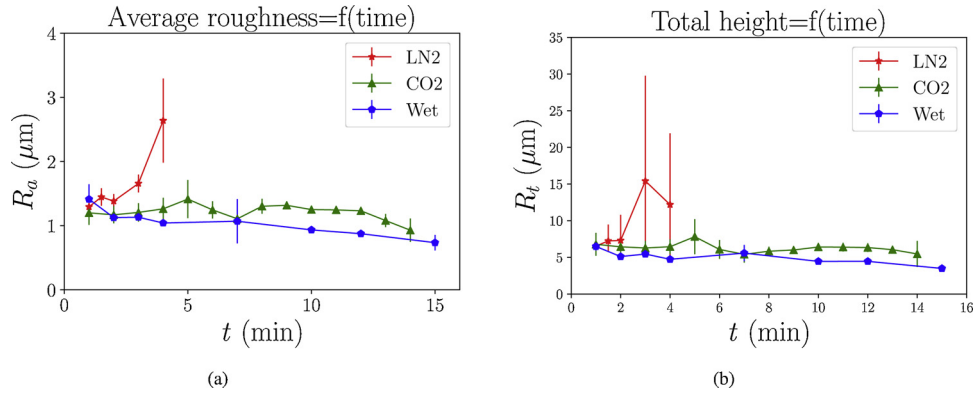
Fig. 12. Surface roughness evolution under wet, LN<sub>2</sub> and LCO<sub>2</sub> cooling conditions: (a) average roughness, (b) total height of the profile.

Surface finish is a crucial parameter that provides good machining performance of machined parts. Fig. 12 illustrates the evolution of surface roughness obtained in conventional and cryogenic conditions. Results showed that conventional coolant tended to enhance significantly the surface finish as it provides the lowest values in terms of the average roughness  $R_a$  as well as the total height of the profile  $R_t$ . Concerning the LCO<sub>2</sub> condition, it induced approximately the same tendency as the conventional strategy. Nevertheless, in LN<sub>2</sub> cryogenic condition, the surface quality exhibited a mediocre state in comparison with wet and LCO<sub>2</sub> conditions. Actually, under LN<sub>2</sub> cryogenic condition, surface roughness has achieved very high values reaching more than 3 µm of  $R_a$  and 20 µm of  $R_t$ . In comparison with LN<sub>2</sub> cryogenic

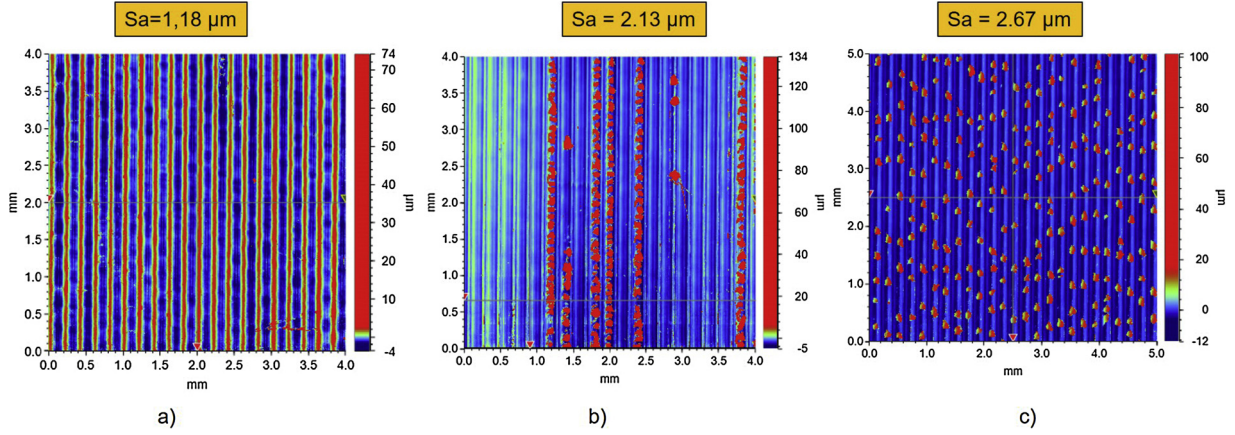
Fig. 13. Surface topography scanned using the Bruker profilometer after machining under LN<sub>2</sub> condition: (a)  $t = 0.5$  min, (b)  $t = 5.5$  min, (c)  $t = 11$  min.

the profilometer in order to characterize the LN<sub>2</sub> surface finish measuring the average areal roughness  $S_a$ . Fig. 13 highlights the increase of  $S_a$  measured at different machining times. Indeed, the scanned surfaces reveal the presence of adhered particles on the machined workpiece surfaces that become more important as the machining time increases. This could be the main reason of the worst surface quality obtained in LN<sub>2</sub> cryogenic condition.

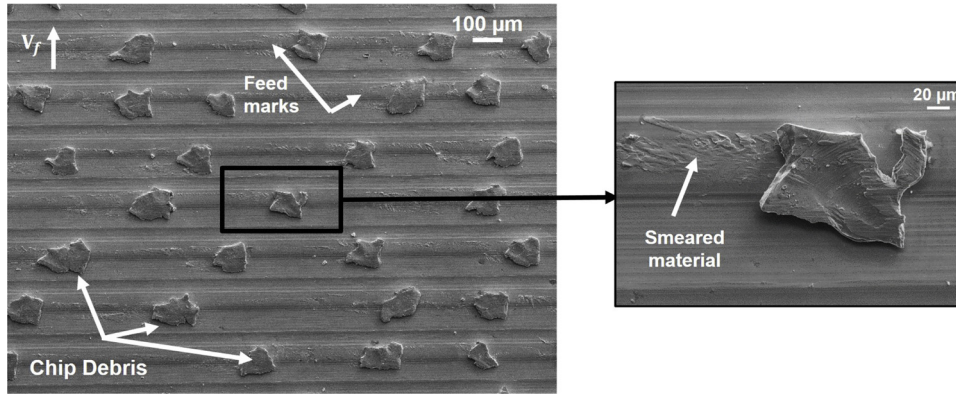
Fig. 14. SEM observations of the surface topography after 11 min of machining under LN<sub>2</sub> condition.

These observations of the machined surface could be explained by the fact that during the chip formation process, the LN<sub>2</sub> cutting fluid did not efficiently evacuate the chip from the cutting zone. Consequently, the chips were stuffed between the cutting edge and the freshly machined surface. Furthermore, the degree of tool wear affects strongly the machined surface quality knowing that thereby the cutting forces and the cutting temperature increase as well when the tool wear evolves. Indeed, these features have been observed in previous work (Zhou et al., 2012). The study pointed out that the chip debris (the adhered chip) is attributed to the increase of the plastic deformation localized at the cutting tool-work material interface. It is worth mentioning that the carbides particles could deteriorate the machined surface quality by generating the smearing of the fresh machined surface as displayed in Fig. 14.

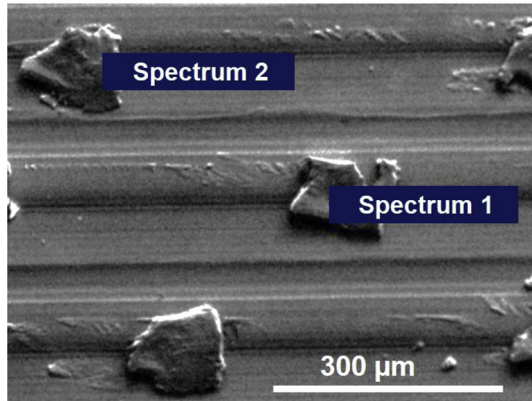
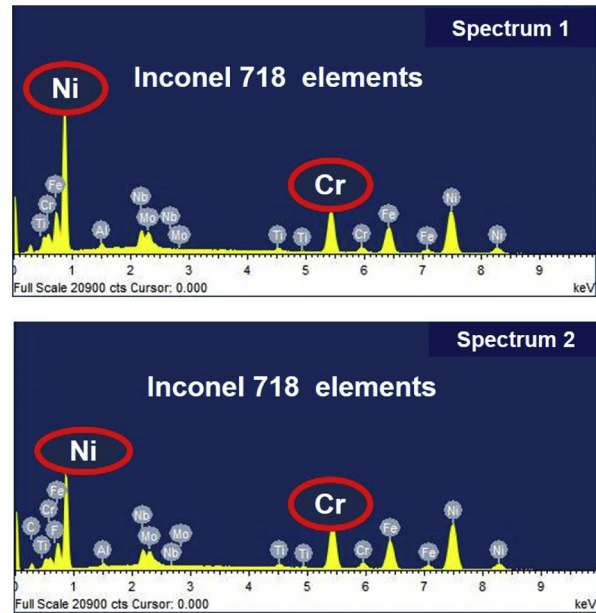
Fig. 15. EDS analysis carried out on the machined surface after 11 min of machining under  $\text{LN}_2$  condition.

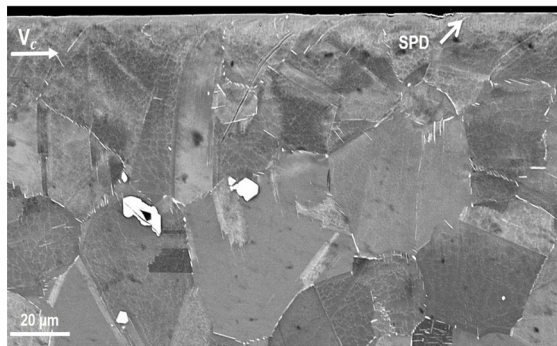
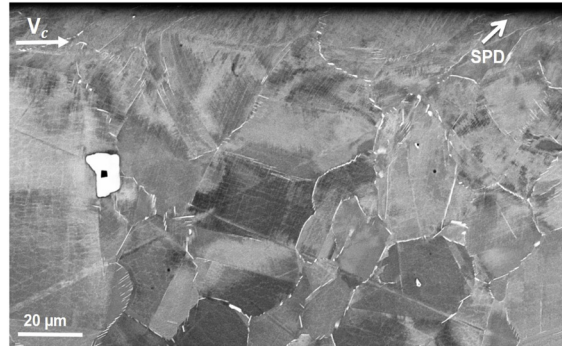
Fig. 16. SEM observations of the machined surfaces in wet condition using new and semi-worn tools: (a) new tool, (b) semi-worn tool ( $V_{\text{BMAX}} = 0.12 \text{ mm}$ ,  $t = 15 \text{ min}$ ).

Figs. 16–18 disclose the machined surfaces and subsurfaces alterations induced by machining under the conventional and cryogenic conditions when using new and worn tools along the cutting direction.

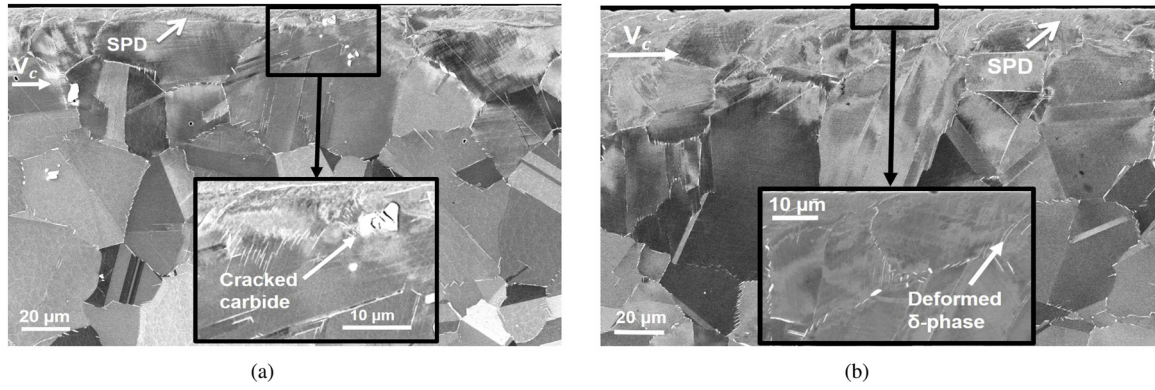
Fig. 17. SEM observations of the machined surfaces in LCO<sub>2</sub> condition using new and semi-worn tools: (a) new tool, (b) semi-worn tool ( $V_{BMAX} = 0.14$  mm,  $t = 15$  min).

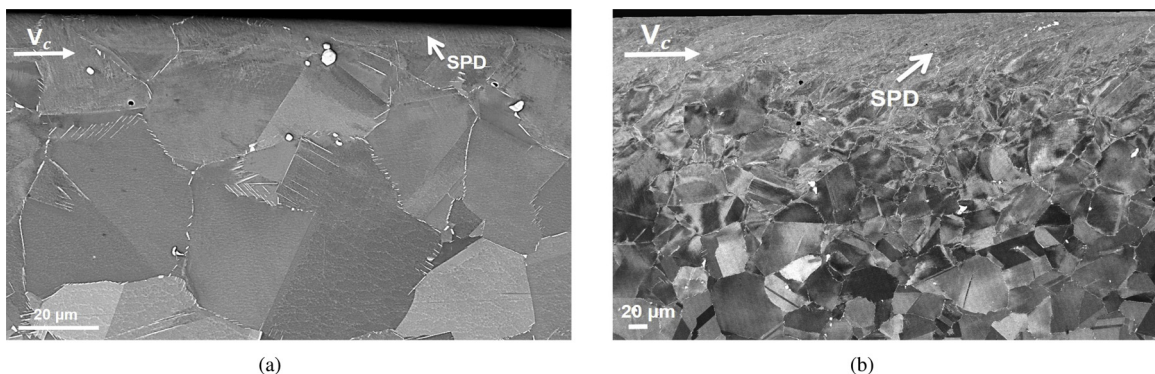
Fig. 18. SEM observations of the machined surfaces in LN<sub>2</sub> condition using new and worn tools: (a) new tool, (b) worn tool ( $V_{BMAX} = 0.35$  mm,  $t = 14$  min).

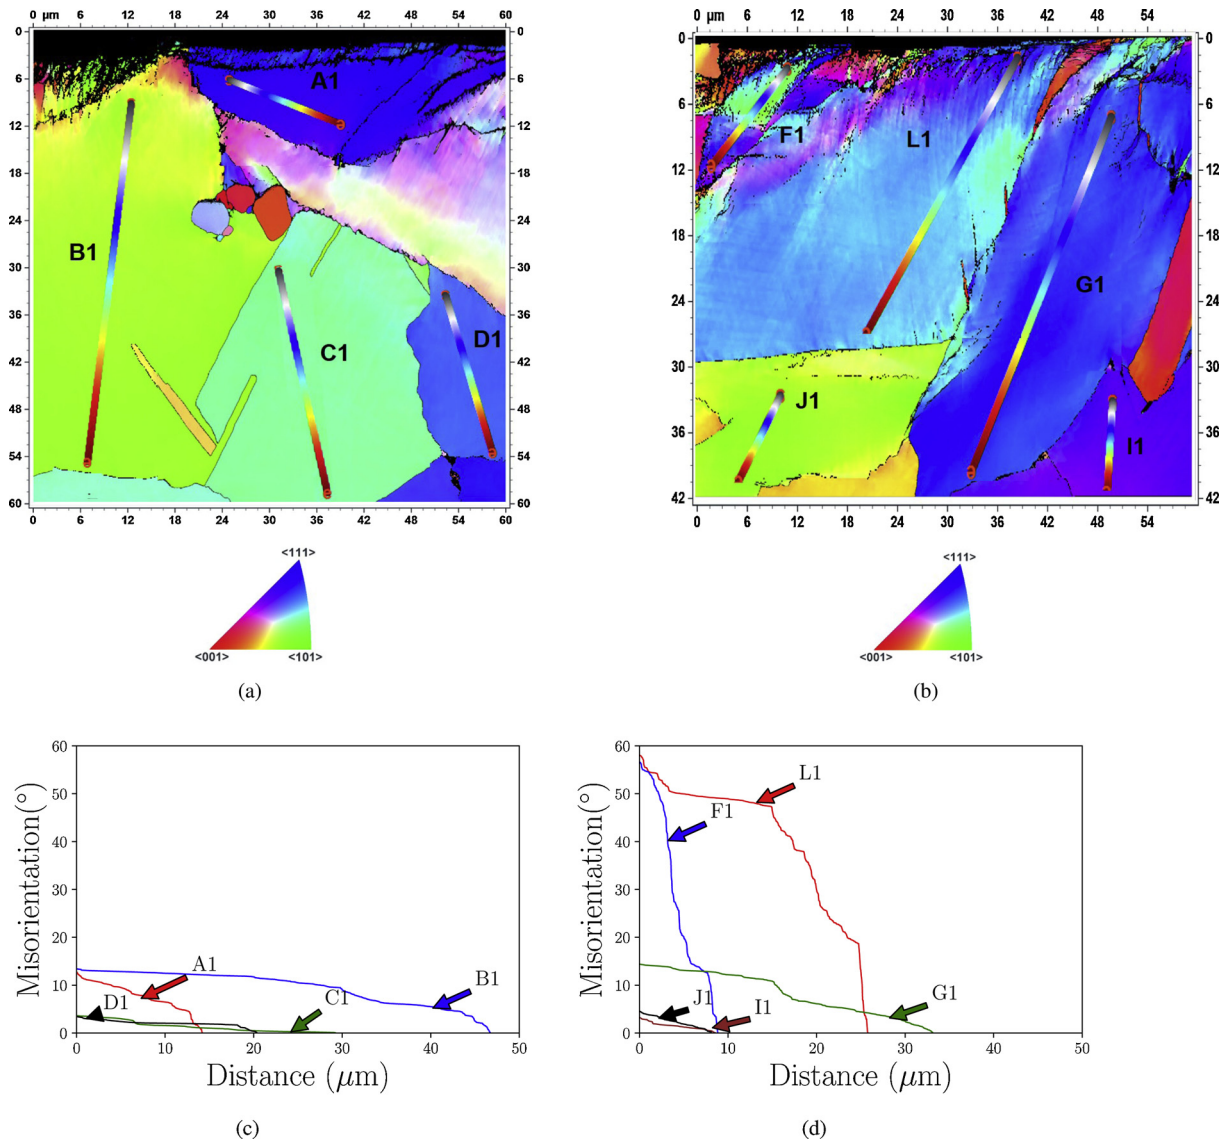
**Fig. 19.** EBSD maps of the machined surfaces (projection axis [001]) obtained in LCO<sub>2</sub> condition using new tool (a) and semi-worn tool (b); misorientation gradients measured inside deformed grains (in the direction as indicated by lines) in the case of: (c) new tool, (d) semi-worn tool.

The EBSD technique is a complementary characterization to SEM technique for investigating the local plastic deformation produced following the machining process. Machining using new tools regardless the cooling strategy induces similar effect. That's why, in this paper, one is content with identifying the effect of tool wear in the case of LCO<sub>2</sub>

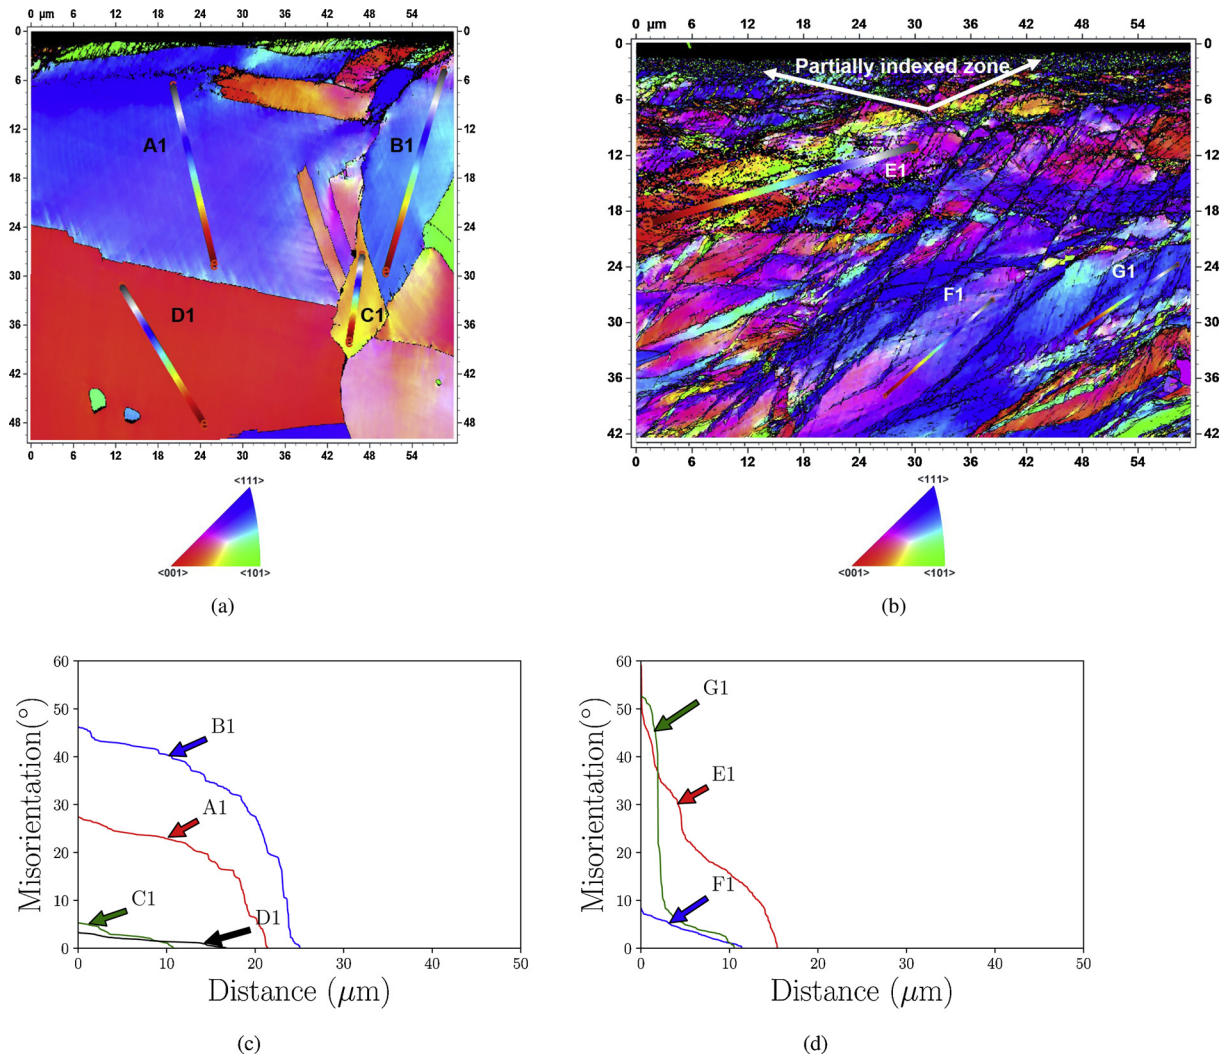
**Fig. 20.** EBSD maps of the machined surfaces (projection axis [001]) obtained in wet condition using a semi-worn tool (a) and in LN<sub>2</sub> condition using worn tool (b); misorientation gradients measured inside deformed grains in the case of: (c) wet, semi-worn tool, (d) LN<sub>2</sub>, worn tool.

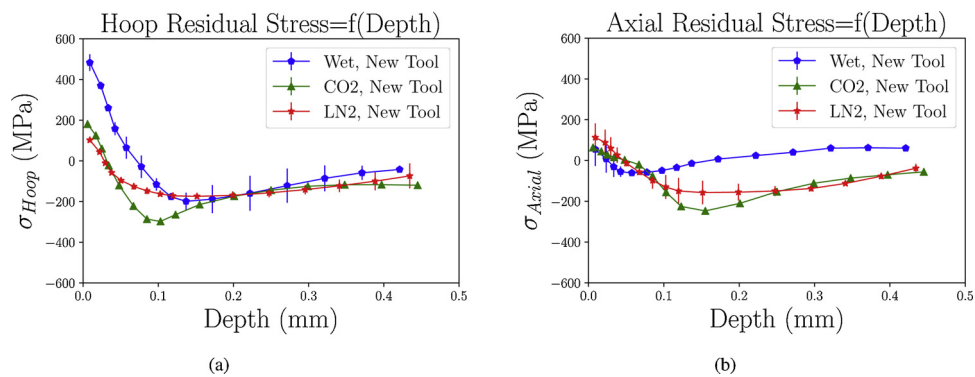
**Fig. 21.** Residual stress profiles near and beneath the machined surface using a new tool wet, LCO<sub>2</sub> and LN<sub>2</sub> cooling conditions measured along: (a) hoop direction (cutting direction); (b) axial direction (feed direction).

Additionally, conventional condition generated the largest tensile hoop stress layer reaching 100  $\mu\text{m}$  below the machined surface and induced a compressive peak holding around -200 MPa. In contrast,  $\text{LCO}_2$  cooling condition revealed the largest compressive depth initiating from 35  $\mu\text{m}$  to more than 400  $\mu\text{m}$  and provided the highest compressive peak reaching almost -300 MPa. Concerning the  $\text{LN}_2$  condition, beneath the machined surface within 30  $\mu\text{m}$ , hoop stress shifted to compressive values showing larger compressive depth compared to conventional condition. Overall, under cryogenic conditions, as the depth beneath the workpiece surface rose, the tensile hoop stresses rapidly dropped and quickly reached compressive levels before slowly returning to bulk values in the case of machining using new tools.

As for the axial stress profiles, results indicated very low tensile values near the surface that shifted gradually to compressive trend under wet and  $\text{LN}_2$  cryogenic conditions. However, under  $\text{LCO}_2$  cryogenic condition, residual stress in the feed direction induced more

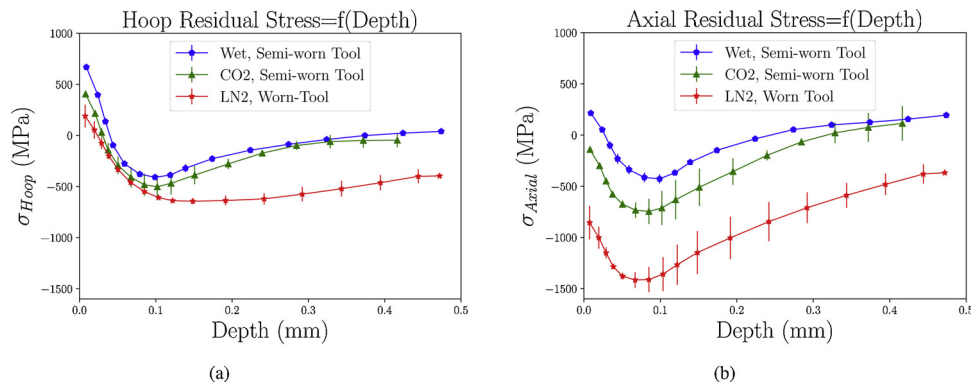
Fig. 22. Residual stresses profiles near and beneath the surface machined using semi-worn tools under conventional and LCO<sub>2</sub> cooling conditions and worn tool under LN<sub>2</sub> condition measured along: (a) hoop direction; (b) axial direction.

With regard to the LCO<sub>2</sub> cooling condition, as expected, near the surface, hoop residual stresses rose significantly reaching 405 MPa and then decreased gradually to compressive values at the depth of 50 µm showing higher compressive peak around -468 MPa in comparison with the values obtained in the case of using new tool. Alternatively, along the axial direction, residual stresses tended to be much more compressive from the first increment (10 µm) and penetrated to a deeper depth inducing greater compressive peak holding -746 MPa compared to the result obtained when cutting with a new tool. Another aspect that should be noticed is that when comparing conventional and LCO<sub>2</sub> cooling conditions that exhibited the same tool wear state, results showed better residual stress distribution revealed in the case of LCO<sub>2</sub> strategy indicating the advantage of cryogenic approaches with respect to fatigue resistance.

Concerning the LN<sub>2</sub> cooling method, when examining the residual stress distribution near the surface, in the cutting direction, it is obvious that residual stresses were tensile. Nevertheless, they are surprisingly maintained almost at the same range when using a new tool holding 189 MPa versus 102 MPa respectively. Consequently, one is interested to mention that when machining with severe tool wear, it is well known that temperatures rise drastically near the surface due to the increase of friction contact area between tool flank face and the workpiece. However, LN<sub>2</sub> cryogenic condition that reveals the highest tool wear level induces lower tensile residual stresses along the cutting direction compared to conventional and LCO<sub>2</sub> cooling conditions. In the other hand, along the feed direction, very close to the surface, stresses are much more compressive shifting from 113 MPa to -855 MPa when the
