Abir ABDESSALEM, Sahbi TAMBOURA, Joseph FITOUSSI, Hachmi Ben DALY, Abbas TCHARKHTCHI, Fodil MERAGHNI - Microstructure investigation of hydrothermal damage of aged SMC composites using Micro-computed tomography and scanning electron microscopy - Engineering Failure Analysis - Vol. 121, p.105177 - 2021

# Microstructure investigation of hydrothermal damage of aged SMC composites using Micro-computed tomography and scanning electron microscopy

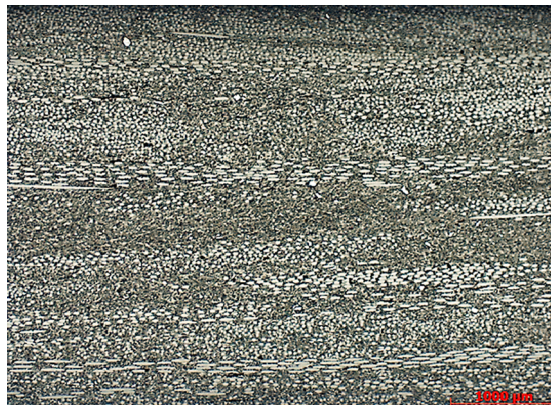
Fig. 3. Microscopic observation of the non-aged sample surface.

From microscopic images we found, for the non-aged material, porosities  $7\% \pm 0.4\%$  and average diameter of  $6.5 \mu m$  to  $9 \mu m$ .
