Mechanical properties and bio-tribological performance of PVD (Ta/ZrN)_n multilayer coatings on UHMWPE in bovine serum lubrication

Abstract

Keywords PVD coating · Ta/ZrN · UHMWPE · Wear

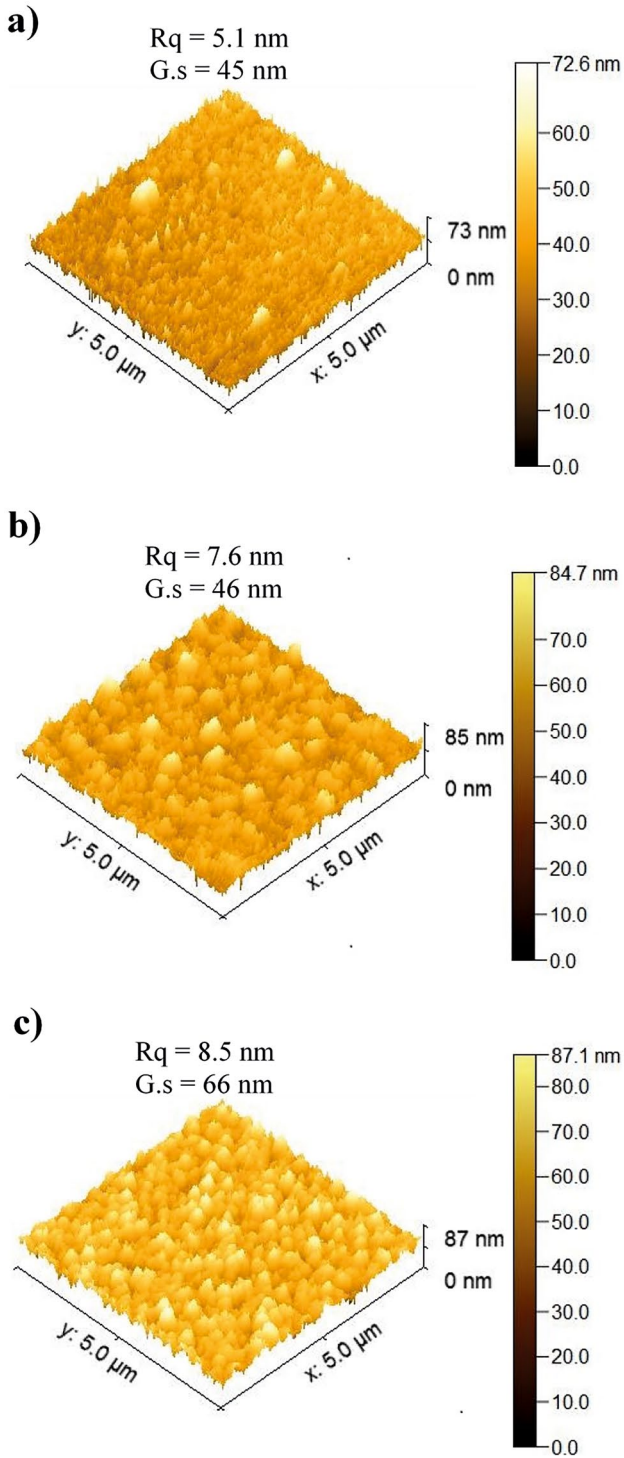
Fig. 4 3-D AFM images of Ta/ZrN multilayers deposited on Si substrate: **a** ML1, **b** ML2, and **c** ML3 specimens

Figure 4 shows the 3D AFM images of the multilayer surface morphologies deposited on the Si substrate, which clearly indicates that all coatings exhibit a relatively smooth surface. Specimen ML3 was found to have the highest grain size (66 ± 1 nm) and a higher surface roughness compared to specimens ML1 and ML2.
