M.H. STAIA, Eli-Saul PUCHI-CABRERA, Alain IOST, E. CARRASQUERO, Y.Y. SANTANA, J.G. LA BARBERA-SOSA, Didier CHICOT, Adrien VAN GORP - Sliding wear of a-C:H coatings against alumina in corrosive media - Diamond and Related Materials n°38, p.139-147 - 2013

Sliding wear of a-C:H coatings against alumina in corrosive media

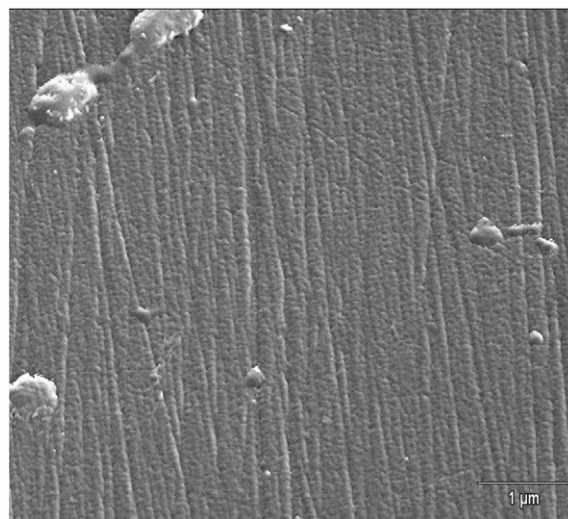
Fig. 1. SEM micrograph, indicating the morphology of the a-C:H coating on 316L stainless steel.

The overall coating thickness determined by Calotest (CSEM, Switzerland) was of 2.2 μm . The morphology of the coating (see Fig. 1) shows the presence of the typical defects that are inherent to the deposition process. The mechanical properties of the substrate, as well as the hardness of these coatings, have been determined and published elsewhere [18].

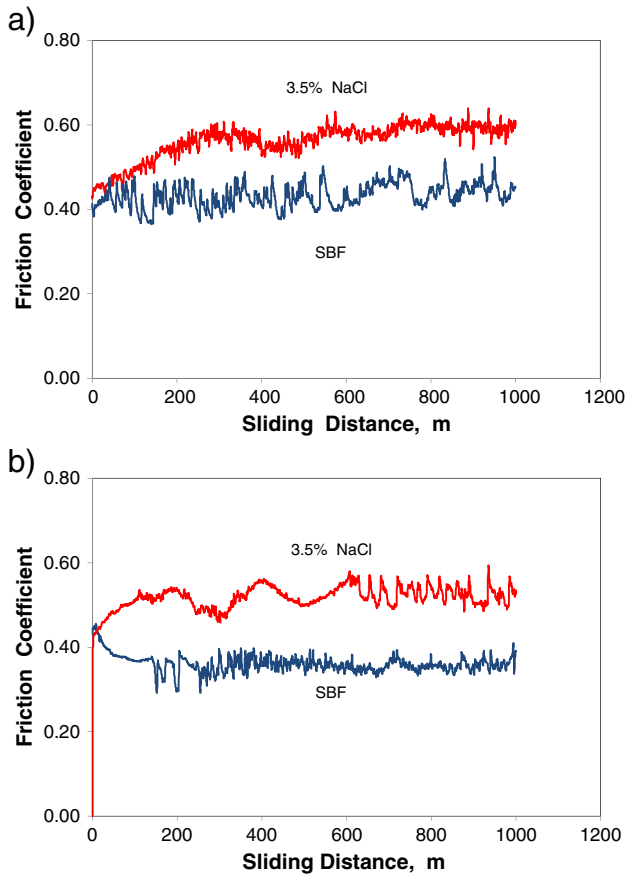
Fig. 2. Friction coefficient vs. sliding distance for 316L stainless steel in the SBF and 3.5% NaCl corrosive solution at a normal load of: (a) 2 N; (b) 5 N.

Fig. 2a and b shows the variation of the friction coefficients for the 316 stainless steel samples against the alumina ball as function of sliding distance in both corrosive solutions for the normal loads used during the tests. It can be observed that the friction coefficient in the 3.5% NaCl solution is 0.6, a value that is 25% higher than that of the corresponding experiments conducted with the SBF solution. The same trend was observed when a higher normal load was employed.

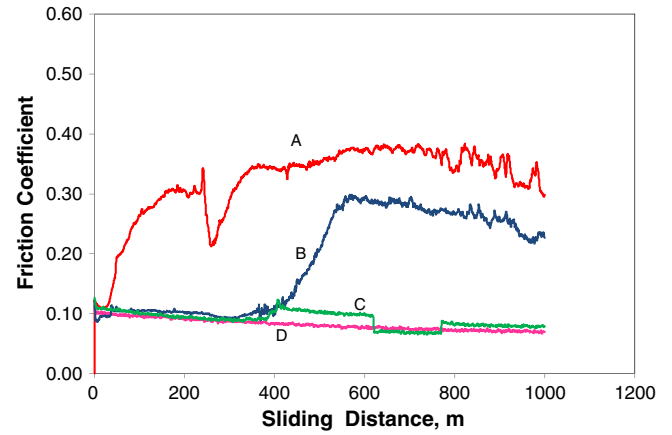
Fig. 4. Variation of the friction coefficient with the sliding distance for a coated sample tested with a 5 N normal load: (A) in the SBF solution; (B) in the 3.5% NaCl solution; (C) coated sample tested a 2 N normal load in a SBF solution; (D) coated sample tested a 2 N normal load in a 3.5%NaCl solution.

The typical friction behavior of the coated samples under the conditions tested in this work is shown in Fig. 4. It can be observed that the friction coefficient for the samples tested employing a 2 N normal load shows values of 0.08 and 0.09 for the NaCl and SBF, respectively. Some small events take place, as indicated in curve C corresponding to the coated sample in the presence of the SBF solution, which could be attributed to the interaction of the liquid under this load with the coating defects, producing locally a higher amount of debris.

In both cases, the coatings have been worn due to the interaction with the alumina ball, but have maintained their adherence to the substrate without spalling or delamination. However, the friction coefficients exhibited by the coated samples under a normal load of 5 N are considerably higher and the events taking place during the friction evolution curve with the sliding distance indicate that coating failure has occurred starting from the first meters of sliding for the sample A and around 400 m for the sample B.

At a sliding distance of around 240 m, the coating is completely worn out and the friction coefficient reaches a steady state value of 0.38 at the end of the test, similar to the value found in the contact steel/alumina ball at a 5 N applied normal load.

However, in the case of the coated sample tested at 5 N in the presence of NaCl, it is interesting to mention the fact that even after 1000 m of sliding distance, the recorded friction coefficient value of 0.26 is less than 0.54 that was reported previously in Fig. 2b, a value that was determined for the tribocouple 316L stainless steel/alumina ball. This response indicates that a new surface was formed during sliding, where the delaminated coating was pushed by the sliding ball in the soft steel substrate, leading to a much harder surface than for the above mentioned tribocouple.

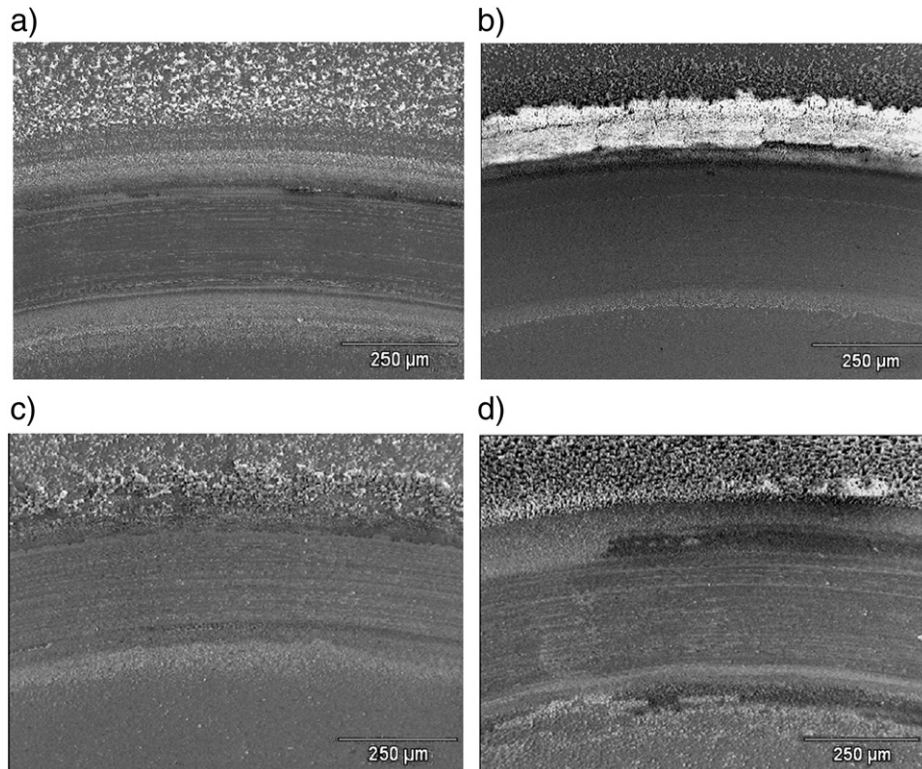
Fig. 3. SEM micrographs of the wear track corresponding to the 316 stainless steel samples tested in: (a) SBF solution at 5 N; (b) 3.5% NaCl solution at 5 N; (c) SBF solution at 2 N; (d) 3.5% NaCl solution at 2 N.

Fig. 3 illustrates the characteristic morphological features of the wear tracks determined by SEM analysis corresponding to the steel substrate, whose friction coefficients were reported previously in Fig. 2. In general, it is observed that a higher quantity of debris is produced when the substrate is immersed in the NaCl solution than in the SBF solution and their amount increases with the applied load.

As shown in Fig. 3, at a higher load of 5 N the depth and width of the wear tracks are much larger when compared with the wear tracks obtained for a load of 2 N. In this case, it was easier to determine the

It is interesting to mention here the fact that, for the system immersed in NaCl solution, the presence of the coating has changed the expected behavior of the substrate in this type of solution (see Fig. 3) since the high amount of wear debris resulted from the action of the NaCl solution in contact with bare steel has been considerably diminished, as consequence of the creation of a totally new surface, which exhibits a higher resistance to corrosive wear (see Figs. 4 and 5b).

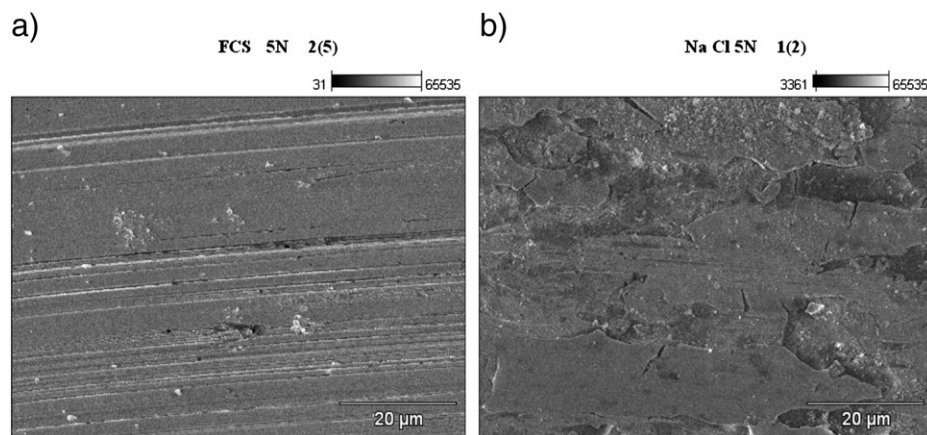
Fig. 5. SEM micrographs corresponding to the morphology of the center of the wear tracks of the coated samples for the load of 5 N: (a) sample immersed in the SBF solution indicating the presence of some abrasive features on the bare steel surface and showing the coating absence. The white particles correspond to the alumina debris from the ball; (b) sample immersed in the 3.5% NaCl, where the fractured coating is still present and some parts have been embedded into the substrate surface.

Fig. 5a and b shows the morphological characteristics of the worn coated surface, indicating the presence of abrasive features produced as a consequence of the differences between the hardness of the two counterparts.

As it can be observed, in the case of the sample immersed in the 3.5% NaCl solution (see Fig. 5b), the fracture of the coating has taken place and some parts have been embedded in the substrate, giving rise to a new surface with different tribological characteristics.

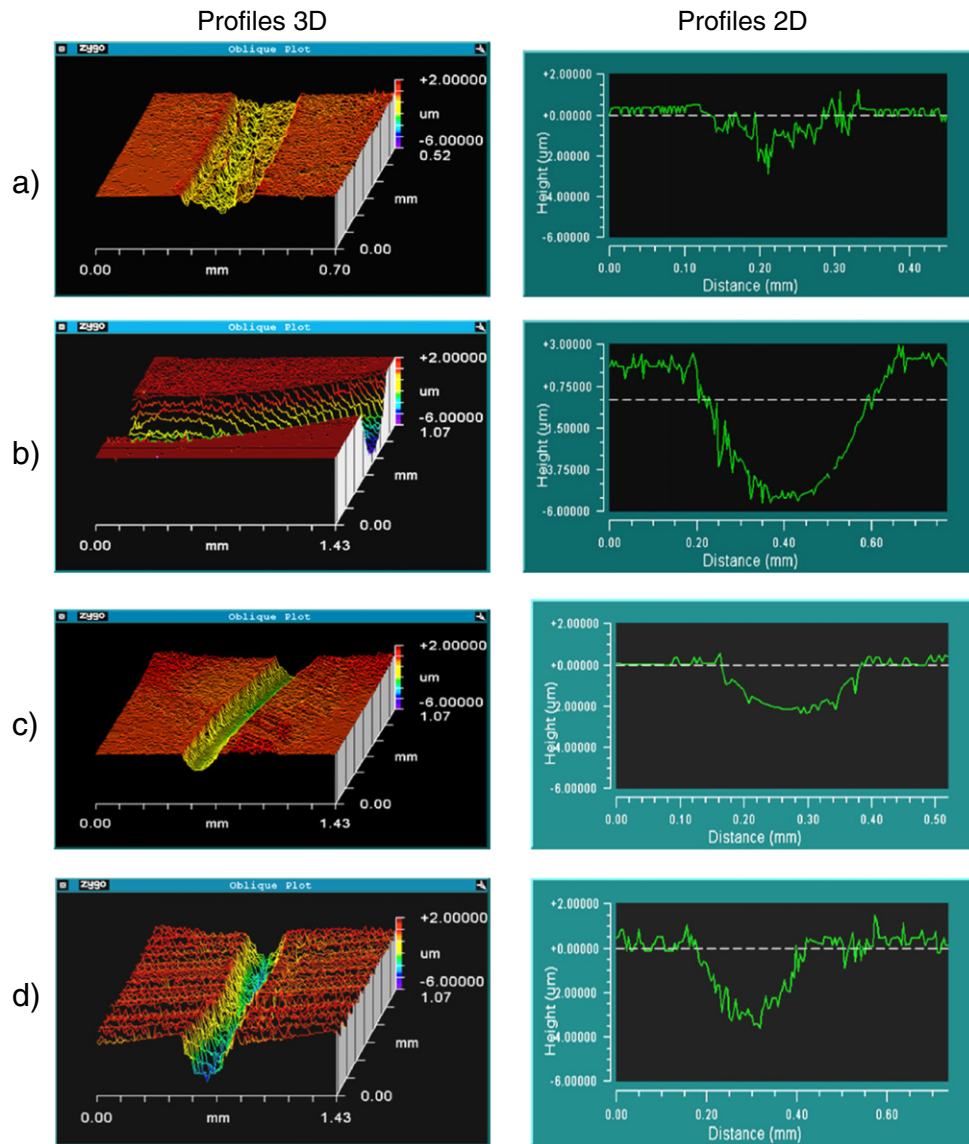
Fig. 6. Profiles of the wear tracks corresponding to the DLC coating tested in: (a) SBF solution at 2 N; (b) SBF solution at 5 N; (c) 3.5% NaCl solution at 2 N; (d) 3.5% NaCl solution at 5 N.

The 2D and 3D profiles obtained by means of the optical profilometer of the wear tracks for all the coated systems tested under the experimental setting described previously are shown in Fig. 6.

From Fig. 6 it can be clearly observed that when the normal load employed corresponds to the lower value of 2 N, the coatings are still present on the stainless steel substrate and, therefore, the value of the intrinsic rate constant can be calculated by dividing the wear volume by the product between normal load and the sliding distance (see Table 1).

However, the wear track profile corresponding to the sample tested in the SBF solution has an irregular shape, which makes the evaluation of the cross sectional area with the same precision as for the sample immersed in the NaCl solution difficult. Nevertheless, it was found that the value of the wear constant, k , was of approximately $2 \times 10^{-6} \text{ mm}^3/\text{Nm}$ and no significant differences were obtained between the wear rate of the DLC coating in 3.5% NaCl and the SBF solution, respectively.

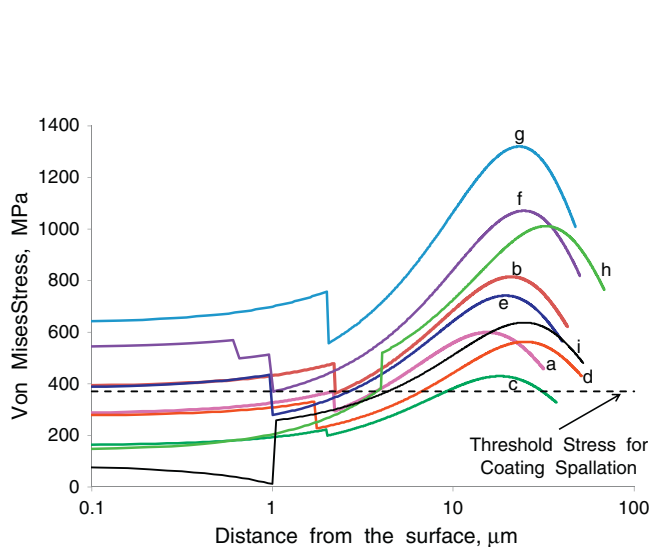
Fig. 7. Variation of the von Mises stress with the distance from the surface for the systems under study and for other DLC coated systems reported in the literature and described in Table 2.

to the work of Park et al. [15], as the distance from the surface increases, the stress also increases smoothly within the coating up to the interface. At this location one or two discontinuities can be observed, depending on the presence of a bonding interlayer between the substrate and coating. At these interfaces the stress decreases abruptly. Once the substrate is achieved, the stress continues to rise as the distance from the surface increases. Thus, a maximum stress value is achieved, after which the stress starts to decrease. In the case of curve i, it can be observed that the stress decreases smoothly within the coating and rises abruptly at the interface, after which it exhibits the same trend found for the other curves. The different coated systems have been identified with a corresponding letter both in Tables 2 and 3. A dotted line indicating a stress of 370 MPa is also included in the plot, which indicates the

However, it should also be borne in mind that below the coating, the existence of a 316L stainless steel layer could provide an elastic support to it. For example, for curves a and b in Fig. 7, corresponding to the tests conducted in the present research, it can be seen that when a normal load of 2 N is applied (curve a), the thickness of the elastic layer, of about 8.3 μm, is approximately 4 times the thickness of the coating and decreases to 5.5 μm for a load of 5 N (curve b). Consequently, it will be expected that plastic deformation of the substrate occurs at a distance from the surface greater than approximately 3 μm (curve f) and that during a wear test carried out in air, for both values of the applied load, no cracking will occur that could give rise to the coating detachment.

As can be seen in Fig. 7, the state of stress for the coated system under a load of 5 N (curve b) is more severe than in the case of a 2 N load (curve a). Therefore, it could be argued that its severity enhances the corrosive action of the solutions, similarly to the commonly observed stress corrosion-cracking phenomenon.

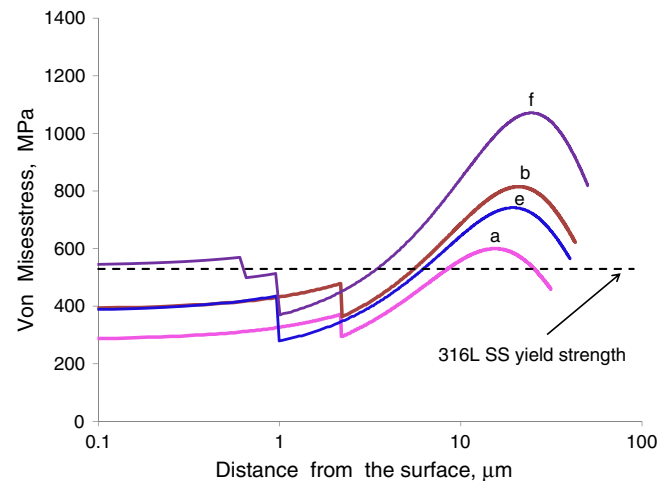
Fig. 8. Stress distribution curves for the coated systems whose substrate is 316L stainless steel: curve a (wear test carried out in 3.5% NaCl solution at 2 N normal load—present work); curve b (wear test carried out in 3.5% NaCl solution at 5 N normal load—present work); curve e (wear test carried out in water at 4 N normal load—Yi et al. [12]); curve f (wear test carried out in Ringer solution and 9 N normal load—Azzi et al. [10]). Dotted line corresponds to the substrate yield strength of 530 MPa.

Fig. 8, on the other hand, illustrates the stress distribution curves only for the coated systems whose substrate is 316L stainless steel. From Table 3 and Fig. 8, it can be observed that for the coated systems investigated in the present work (corresponding to curves a and b in Fig. 8), as well as in those studied by Yi et al. [12] (curve e) and Azzi et al. [10] (curve f), the substrate yield strength is approximately equal to 530 MPa. These coated systems should behave similarly, given the fact that the maximum values of the von Mises stress computed for each system exceed the yield strength of the substrate for all the normal loads used.
