M.H. STAIA, Eli-Saul PUCHI-CABRERA, Alain IOST, E. CARRASQUERO, Y.Y. SANTANA, J.G. LA BARBERA-SOSA, Didier CHICOT, Adrien VAN GORP - Sliding wear of a-C:H coatings against alumina in corrosive media - Diamond and Related Materials n°38, p.139-147 - 2013

# Sliding wear of a-C:H coatings against alumina in corrosive media

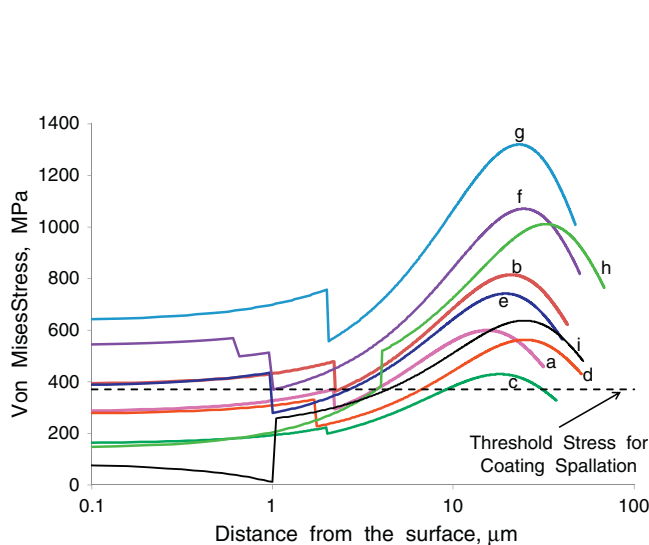
**Fig. 7.** Variation of the von Mises stress with the distance from the surface for the systems under study and for other DLC coated systems reported in the literature and described in Table 2.

However, it should also be borne in mind that below the coating, the existence of a 316L stainless steel layer could provide an elastic support to it. For example, for curves a and b in Fig. 7, corresponding to the tests conducted in the present research, it can be seen that when a normal load of 2 N is applied (curve a), the thickness of the elastic layer, of about 8.3 μm, is approximately 4 times the thickness of the coating and decreases to 5.5 μm for a load of 5 N (curve b). Consequently, it will be expected that plastic deformation of the substrate occurs at a distance from the surface greater than approximately 3 μm (curve f) and that during a wear test carried out in air, for both values of the applied load, no cracking will occur that could give rise to the coating detachment.

As can be seen in Fig. 7, the state of stress for the coated system under a load of 5 N (curve b) is more severe than in the case of a 2 N load (curve a). Therefore, it could be argued that its severity enhances the corrosive action of the solutions, similarly to the commonly observed stress corrosion-cracking phenomenon.
