Yessine AYED, Guénaël GERMAIN, Amine AMMAR, Benoit FURET - Degradation modes and tool wear mechanisms in finish and rough machining of Ti17 Titanium alloy under high-pressure water jet assistance - Wear - Vol. 305, n°1-2, p.228-237 - 2013

Degradation modes and tool wear mechanisms in finish and rough machining of Ti17 Titanium alloy under high-pressure water jet assistance

This article presents the results of an experimental study on the Ti17 titanium alloy, which was carried out to analyze tool wear and the degradation mechanisms of an uncoated tungsten carbide tool insert. Two machining conditions, roughing and finishing, have been studied under different lubrication conditions. The experimental procedure included measurement of the cutting forces and the surface roughness. Different techniques have been used to explain the tool wear mechanisms. Distribution maps of the elemental composition of the titanium alloy and the tool inserts have been created using Energy Dispersive X-ray Spectroscopy (EDS). An area of material deposition on the tool rake face, characterized by a high titanium concentration has been observed. The width of this area and the concentration of titanium, de

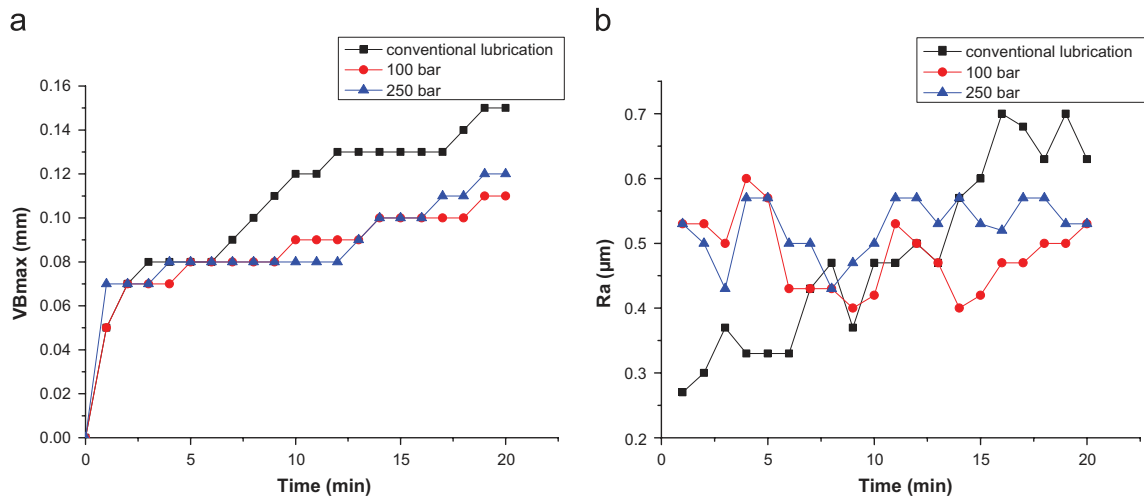
Fig. 3. (a) Flank wear (VB) and (b) surface roughness (R_a).

Fig. 3(a) shows the evolution of the flank wear criterion (VB) and (b) the evolution of the R_a criterion. For all the configurations, flank wear (VB) does not exceed 0.15 mm after 20 min of machining, but its evolution is slower with HPWJA. Indeed, in conventional lubrication after the running-in phase, flank wear increases linearly to 0.15 mm after 20 min.

However, for the HPWJA condition, after the running-in phase, the flank wear remains constant for a significant period. Indeed, in both assistance configurations (100 bars and 250 bars), flank wear remains constant at about 0.08 mm for approximately 6 min at a pressure of 100 bars and for about 9 min at a pressure of 250 bars. After this stable regime, flank wear increases in a way similar to conventional lubrication. Fig. 3(b) shows a significant variation of surface roughness. For conventional lubrication, the surface roughness tends to increase linearly as a function of machining time, going from $R_a = 0.25 \mu\text{m}$ to $R_a = 0.7 \mu\text{m}$ (i.e. R_a reaches three times its initial value). For tests with high-pressure water jet assistance, the initial surface roughness is higher, but its value remains globally constant (between $0.4 \mu\text{m}$ and $0.6 \mu\text{m}$ throughout the test). In addition, there is no marked tendency for the surface roughness to increase even at the end of the test. The surface roughness thus appears uninfluenced by flank wear.
