# Mechanical behavior study of plasma sprayed hydroxyapatite coatings onto Ti6Al4V substrates using scratch test

**Abstract.** Mechanical behavior and fracture mechanisms of plasma sprayed hydroxyapatite coatings on Ti-6Al-4V substrate were assessed taking into consideration two variables: the coating thickness and the substrate roughness. The results show that the specimens having a substrate arithmetic average roughness parameter  $R_a = 2.29 \mu\text{m}$  is favorable with respect to  $R_a = 1.23 \mu\text{m}$ . For coating thickness above  $105 \mu\text{m}$ , cracks can be observed in the coating/substrate interface and the higher critical load  $P_{c2}$  (used generally in comparative evaluation of adherence) decreases. A  $90 \mu\text{m}$  coating thickness sprayed on a substrate having an arithmetic average roughness parameter  $R_a$  equal to  $2.29 \mu\text{m}$  seems to be the best compromise between microstructure, mechanical resistance (high critical loads and fairly good contact quality) and long term stability in the physiological medium (low dissolution rate) for an orthopedic application.

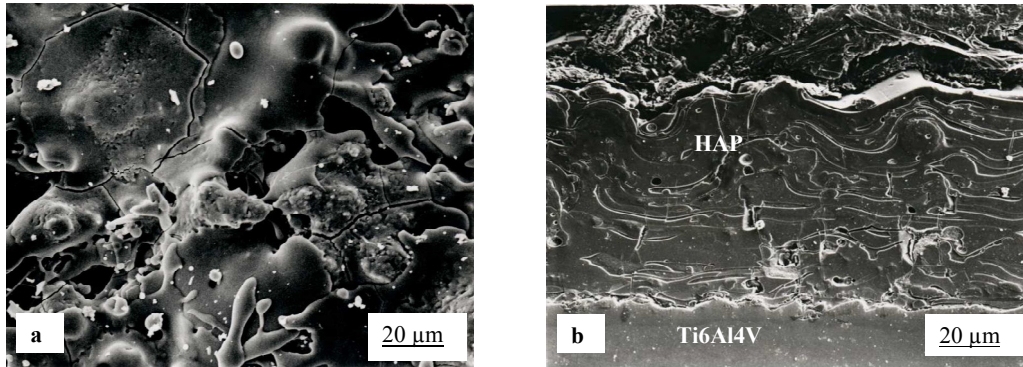
Figure 1: SEM micrographs showing: a) a typical top view of an HAP coating surface produced by air plasma spraying (coating thickness  $CT = 105 \mu\text{m}$ , substrate  $Ra = 2.29 \mu\text{m}$ ), b) a typical microstructure of the plasma-sprayed HAP through a coating cross-section ( $CT = 75 \mu\text{m}$ , substrate  $Ra = 1.23 \mu\text{m}$ ).

**Microstructure.** In a preliminary study, the X-ray diffraction reveals that HAP is the principal phase of coatings [8]. SEM observations of the plasma-sprayed coatings reveal typical features presented in numerous other studies [13-17]. The as-sprayed coating surface is characterized by unmelted or partially melted particles, fully molten splats, pores and emerging cracks that propagate in the molten areas (Fig. 1a). A lamellar microstructure with an orientation closely parallel to the coating/substrate interface is observed on cross-sections (Fig. 1b).

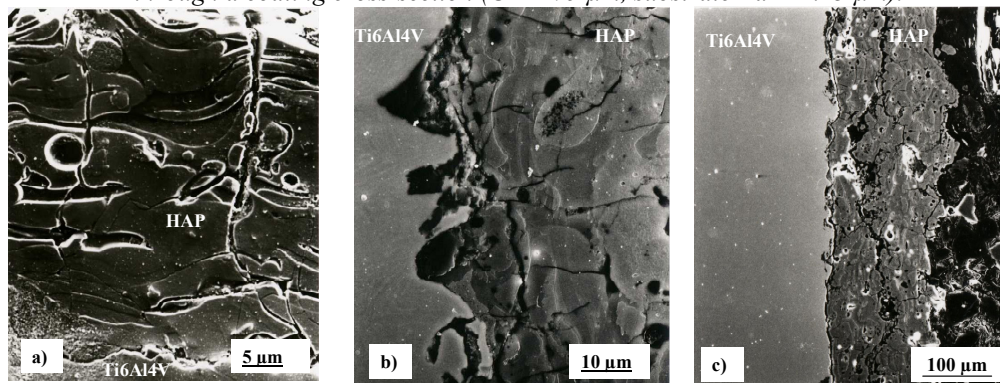
Figure 2: HAP coating cross sections showing: a) large perpendicular cracks emerging at the top surface ( $CT = 50 \mu\text{m}$ , substrate  $Ra = 1.23 \mu\text{m}$ ), b) fine perpendicular cracks ( $CT = 165 \mu\text{m}$ , substrate  $Ra = 2.29 \mu\text{m}$ ), c) interfacial and interlamellar cracks ( $CT = 150 \mu\text{m}$ , substrate  $Ra = 2.29 \mu\text{m}$ ).

The lamellar microstructure arising from the accumulation of the well-flattened molten splats contains also partially melted particles and various cracks. Some of the cracks are normal and others are parallel to the coating/substrate interface. Two kinds of normal cracks can be detected: large ones that emerge and open on the top surface of coating in the molten areas (Fig. 2a) and fine ones localized near the coating/substrate interface (Fig. 2b). It must be mentioned that the density of fine normal cracks increases when thickness of the coating increases. The parallel cracks are either localized in the interfaces of melted splats (interlamellar cracks) or in the interface between the coating and the substrate (interfacial cracks). For coatings deposited on the substrate having the

higher arithmetic average roughness parameter, cracks propagating in the interface are always detected when thickness is above  $105\ \mu\text{m}$  (Fig. 2c) and a good interfacial bonding is obtained when thickness is less or equal to  $90\ \mu\text{m}$ . Coatings deposited on the substrate having the lower arithmetic average roughness parameter  $R_a$  generally show the worse bonding quality with an increasing interfacial cracking propensity when thickness increases. It must be outlined that pores and cracks lower the coating mechanical performance on one hand but support the ingrowth of the tissue into the ceramic material on the other hand.

If the existence of pores can be related to entrapped gases, poorly melted particles and poor bonding between adjacent splats, cracking is the result of relaxation of the residual stresses developed in the ceramic coating during the deposition process [14-16, 18]. In this study, while the largest cracks normal to the coating/substrate interface are very probably the result of the relaxation of the residual tensile stresses [16], the parallel cracks are mainly promoted by in plane compressive stresses producing induced through-thickness tensile stresses [19, 20]. Finally, since the thermal expansion of HAP is above that of Ti-6Al-4V, the finest perpendicular cracks detected near the coating/substrate interface is thought to be the result of tensile stresses due to the thermal expansion mismatch. As mentioned by Yang et al. [20], the mechanism of residual stress generation and the impact of these residual stresses are so complicated that only few works are devoted to the quantitative prediction of the magnitude stress.

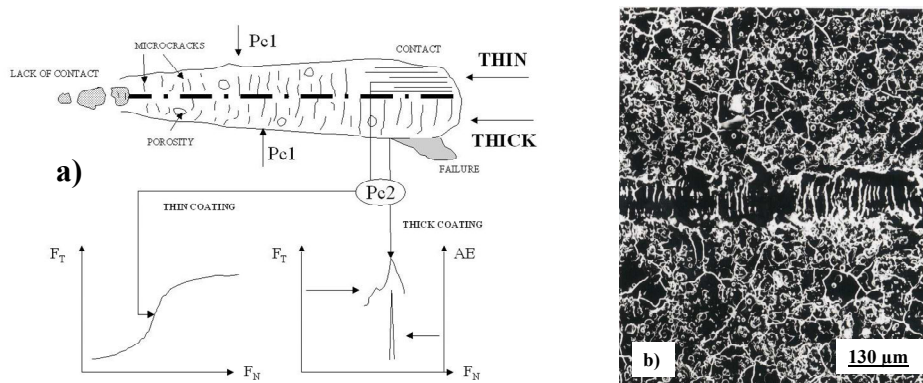
Figure 3: a) Synoptic of the events occurring on a typical scratch track under progressive loading and determination methodology of the critical loads for thick and thin coatings.  $P_{c1}$ : Normal load at which a microcrack reaches 50 % of the scratch track width.  $P_{c2}$ : Normal load ( $F_N$ ) corresponding either to the inflexion point of the frictional force ( $F_T$ ) graph for thin coating or to a sharp pulse on the acoustic emission signal (AE) combined with a sudden decrease of the frictional force for a thick coating, b) Example of microcracks formed during the scratch test in the range of applied loads near the  $P_{c1}$  value. This top view is related to the part of the graph indicated in Fig. 4.

An instantaneous adhesive spalling observed by visual inspection occurs generally before the contact between stylus and substrate, mainly in thick coating at high loads. This instantaneous spalling arises probably from the lateral crack propagation in the coating/substrate interface. On the other hand, for thin coatings, stylus can reach the substrate at intermediate loads without any instantaneous coating spalling ahead of the moving stylus. All these events are summarized on a synoptic of a typical scratch track in Fig. 3a. This figure presents also schematically how critical loads  $P_{c1}$  and  $P_{c2}$  were approximately determined.

Determination of the critical load  $P_{c1}$  for crack initiation was delicate. In fact, it is impossible to estimate directly and thoroughly  $P_{c1}$  considering only the graph of the frictional force or the graph of the acoustic emission because no significant change in these curves is observed (Fig. 4). Indeed, the frictional force does not change significantly for this critical load since cracks are produced behind stylus according to the Hertz theory [9]. As to the acoustic emission, microcracks initiating at  $P_{c1}$  produce only short single peaks hidden in the noisy background. The critical load  $P_{c1}$  was finally determined from numerous and attentive scanning electron microscopy observations of all coatings. These observations based on a comparative study of crack length revealed that the normal load value, for which a microcrack reaches a length of 50% of the scratch track width, may be a satisfactory criterion to evaluate  $P_{c1}$ . An example of the microcracks formed in a range of applied loads near the  $P_{c1}$  value is presented on Fig. 3b.

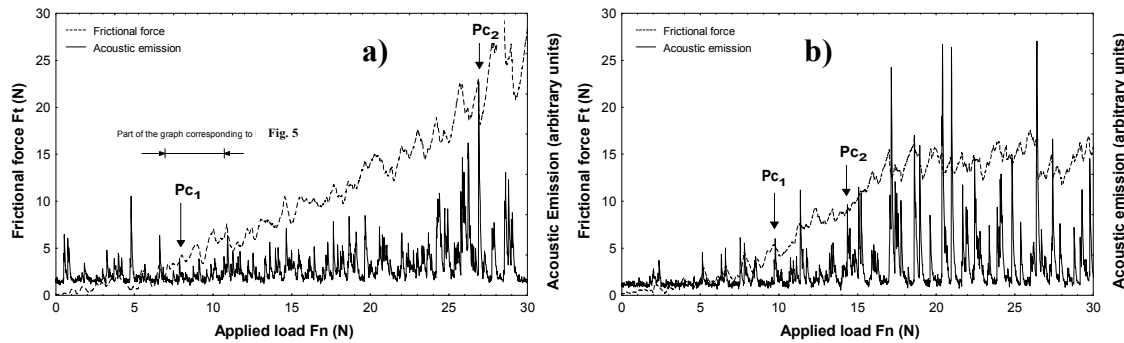
Figure 4: Typical acoustic emission and frictional force variations during a scratch test in the case of: a) a thick coating ( $CT = 105 \mu\text{m}$ , substrate  $Ra = 1.23 \mu\text{m}$ ), b) a thin coating ( $CT = 50 \mu\text{m}$ , substrate  $Ra = 1.23 \mu\text{m}$ ).

emission curves combined simultaneously with a local sharp decrease of the frictional force at high loads (Fig. 4a). However, secondary pulses especially on acoustic emission curves may prevent to find the true peak and hence to estimate precisely  $P_{c2}$ . The secondary pulses appear at high loads and are mainly due to local coating failures that occur when the stylus interacts with pores or preexisting thermal cracks due to the plasma-spraying process. Sometimes, the stylus can cross over the largest defects associated with large and sharp discontinuities of surface topography resulting in significant sharp pulses on frictional force without significant effect on acoustic emission signal. The presence of such secondary pulses hampers the precise estimation of  $P_{c2}$  directly from the acoustic emission or the frictional force curves. This fact emphasizes the very usefulness of microscopic observations even if the lack of sufficient contrast of imaging between the coating and the substrate can be also an obstacle. In fact, the major problems encountered to estimate thoroughly  $P_{c2}$ , due either to the interaction between stylus and initial flaws generated during the plasma-spraying process in the coatings or to the lack of sufficient contrast of imaging, have been already mentioned by other authors [10, 12, 21].

Fig. 4b presents a typical graph of frictional force evolution and acoustic emission of a thin coating tested in this work. In this case, the higher critical load was assessed from microscopic observations and corresponds to the normal load for which the contact between the stylus and the substrate occurs. At first sight, it seems that the normal load value  $P_{c2}$  determined by these microscopic observations is not so far as the abscissa corresponding to the inflexion point on the frictional force graph. However, as mentioned by Stephanopoulos et al. [22], such a behavior is more representative of the interaction between the stylus and the substrate after the occurrence of contact rather than coating/substrate adhesion. As a consequence, it can be suspected that our experimental conditions of scratching may be no longer probing to predict adhesion of the HAP coatings which thickness is less or equal to 90  $\mu\text{m}$ .

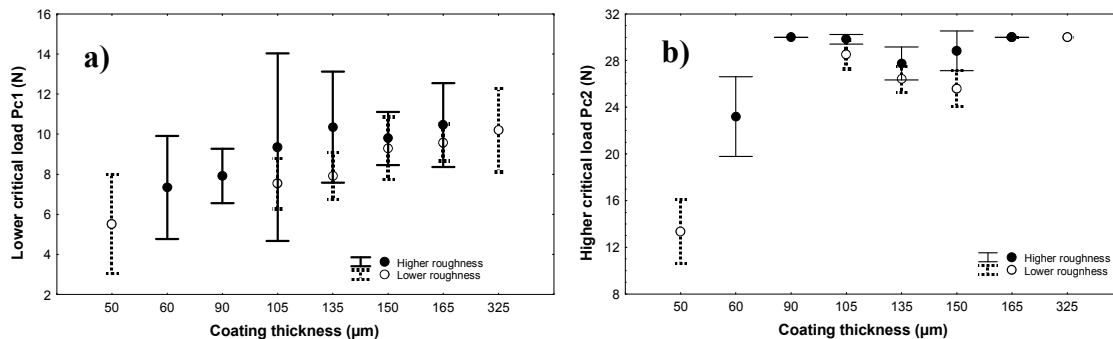
Figure 5: Lower (Left) and higher (Right) critical loads  $P_{c1}$  and the associated standard errors as a function of coating thickness for the two studied substrate roughness. Results correspond to 5 and 8 measurements whatever the experimental conditions.

Critical load  $P_{c1}$  is plotted versus coating thickness in Fig. 5 for the two values of the arithmetic average roughness of the substrate considered in this study. Whatever the substrate roughness, the mean of this lower critical load increases with thickness. This result can be explained taking into consideration the observed increasing propensity of microcracking that occurs during the cooling process when coating thickness increases. Since microcracking is considered to be the main relaxation process of residual stresses during cooling of plasma sprayed coatings, short cracks due to the scratch testing may be expected to initiate more easily in the studied thin coatings. Moreover, for a given coating thickness, Fig. 5 reveals a trend showing that the substrate having the higher arithmetic average roughness parameter induces a better coating resistance to microcrack initiation since the mean of the lower critical loads recorded are higher than that of the substrate having the lower arithmetic average roughness parameter.

$P_{c2}$  critical load values versus coating thickness are plotted in Fig. 5b for the two values of the arithmetic average roughness of the substrate considered in this study. It must be noted that it was not possible to determine the higher critical load for some of the thick coatings because of the upper experimental device loading limit (30 N). The higher  $P_{c2}$  values for specimens having the substrate roughness  $R_a$  of 2.29  $\mu\text{m}$  can be related to a better adherence. It must be outlined that the scratch test do not allow to obtain an absolute measure of coating adhesion because numerous extrinsic and intrinsic parameters influence the testing results [12].
