Aliasghar BEHNAMGHADER, Davood SHARIFI, Sarang SOROORI, Narjes BAGHERI, Ranna TOULOUEI, Roghieh NEMATI, Denis NAJJAR, Alain IOST - Bone Tissue Response to Plasma Sprayed Hydroxyapatite Coatings: An In Vivo Study on Rabbit Femoral Condyles - IRANIAN JOURNAL OF PHARMACEUTICAL SCIENCES - Vol. 4, n°1, p.57-62 - 2008

Bone Tissue Response to Plasma Sprayed Hydroxyapatite Coatings: An *In Vivo* Study on Rabbit Femoral Condyles

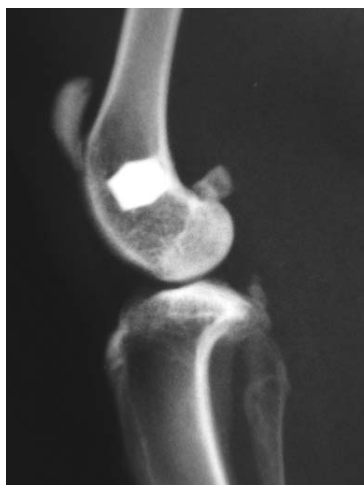
Figure 3. A HA-coated sample, indicating no local reaction and dislocation.

After sacrifice, the macroscopic evaluation revealed all coated (groups II) and uncoated (groups III) samples were well incorporated into the bone. The radiographic interpretation did not indicate any specific changes in the groups II and III (Figure 3). The histological examination of sections of all three groups revealed no evidence of infection, inflammation, foreign body reaction or necrosis of the tissue surrounding the samples. In control group, the holes were completely filled with dense connective tissue containing relatively parallel collagen bundles and immature bone trabecular fragments and unmineralized osteoid tissue. The bone trabecular structure was immature with many remodeling marks.
