# Identification of scratch mechanisms on a retrieved metallic femoral head

D. Najjar<sup>a,\*</sup>, M. Bigerelle<sup>a,b</sup>, H. Migaud<sup>c</sup>, A. Iost<sup>a</sup>

## Abstract

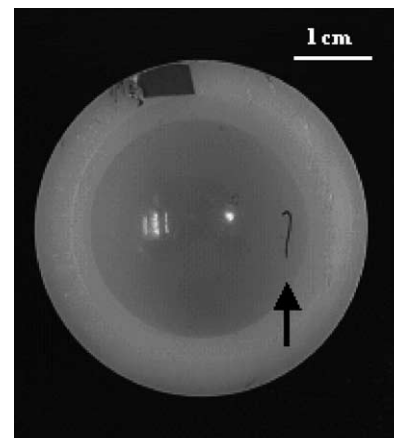
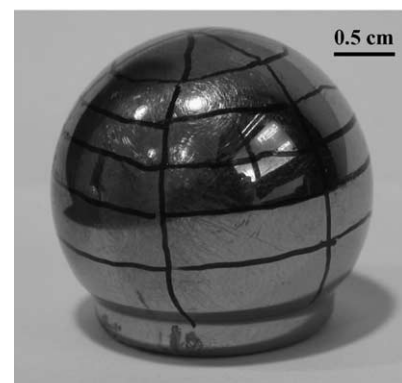
Fig. 1. Visualisation of (a) the retrieved UHMWPE acetabular liner with an embedded titanium fiber-mesh piece marked with a black arrow, (b) the retrieved 28 mm diameter titanium based femoral head and the lines drawn for the reference frame.

After revision surgery, a visual inspection clearly revealed that the retrieved titanium (TA6V) femoral head was severely scratched and that a hard foreign body was embedded in the UHMWPE acetabular liner (Fig. 1a). This foreign body, several millimeters in length, came from the titanium fiber-mesh which was deposited on the Harris–Galante metallic cup during the fabrication process. It must be pointed out that polyethylene and metallic debris were detected by histological analyses on the peri-prosthetic tissues.

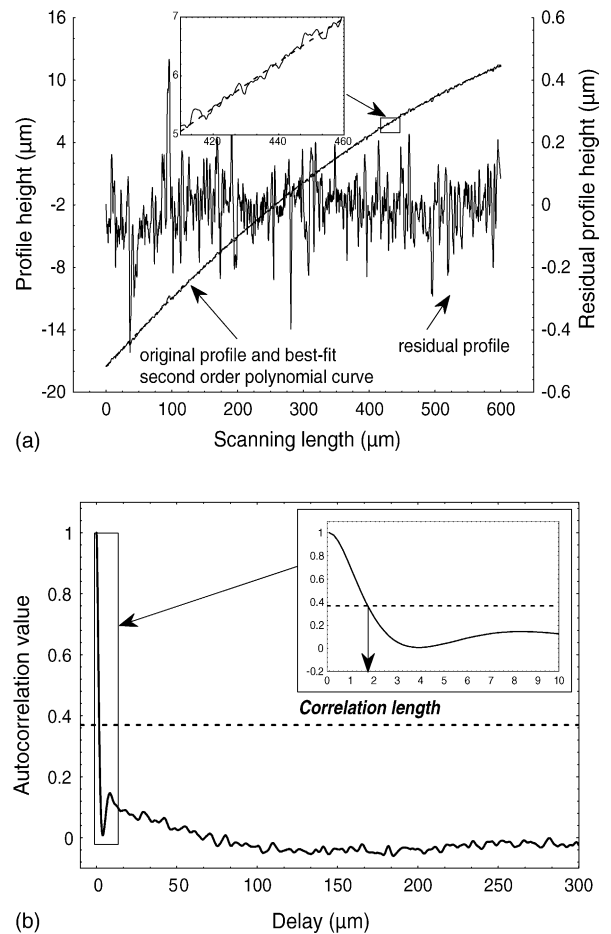
Fig. 2. Example of results showing: (a) a residual profile obtained by removing the form of an experimental profile by means of a best-fitting second order polynomial curve, (b) the related autocorrelation function of the residual profile.

In the specific algorithm developed by the authors, the form was removed by means of a fitting method before estimating any roughness parameter of interest. The best-fitting curve selected for this pre-processing operation was a second order polynomial curve whose coefficients are estimated by the least squares method. [Fig. 2a](#) presents an example

of an original profile, its best-fitting second order polynomial curve and the related residual profile. The relevance of selecting a second order polynomial curve for this pre-processing operation of form removal is a posterior justified: qualitatively, by the high goodness-of-fit that can be noticed between this fitting curve and the original profile and, quantitatively, by analysing the autocorrelation function related to the residual profile. Indeed, it can be seen in [Fig. 2b](#) that this autocorrelation function rapidly decays and the related correlation length (defined as the length over which the autocorrelation decays to a fraction of its initial value taken as  $1/e$ ) is extremely short compared to the scanning length.

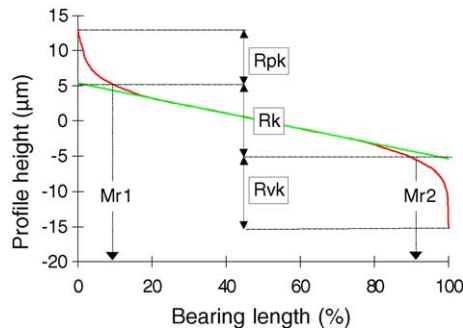
Fig. 3. Schematic representation of a bearing area curve as well as the related roughness parameters  $R_k$ ,  $R_{pk}$ ,  $R_{vk}$ ,  $Mr_1$ ,  $Mr_2$ .

Fig. 3 shows a schematic example of a bearing area curve having a S-shape appearance as it is the case for many engineering surfaces. The horizontal axis represents the bearing area lengths as a percentage of the total assessment length of the profile and the vertical axis represents the heights of the profile. This figure also presents the roughness parameters  $R_k$ ,  $R_{pk}$ ,  $R_{vk}$ ,  $Mr_1$  and  $Mr_2$  that can be inferred from the bearing area curve according to the guidelines mentioned in the DIN 4776 and ISO 13565-2 standards [13,14]. The parameter  $R_k$  is called the core depth which measures the height of the core material. The parameter  $R_{pk}$  is called the reduced peak height which denotes the portion of the protruding peaks above the core profile. The parameter  $R_{vk}$  is called the reduced valley depth which denotes the portion of deep valleys extending into the material below the core profile. The parameter  $Mr_1$  represents the material ratio at the transition between protruding peaks and core. Finally, the parameter  $Mr_2$  represents the material ratio at the transition between core and deep valleys.

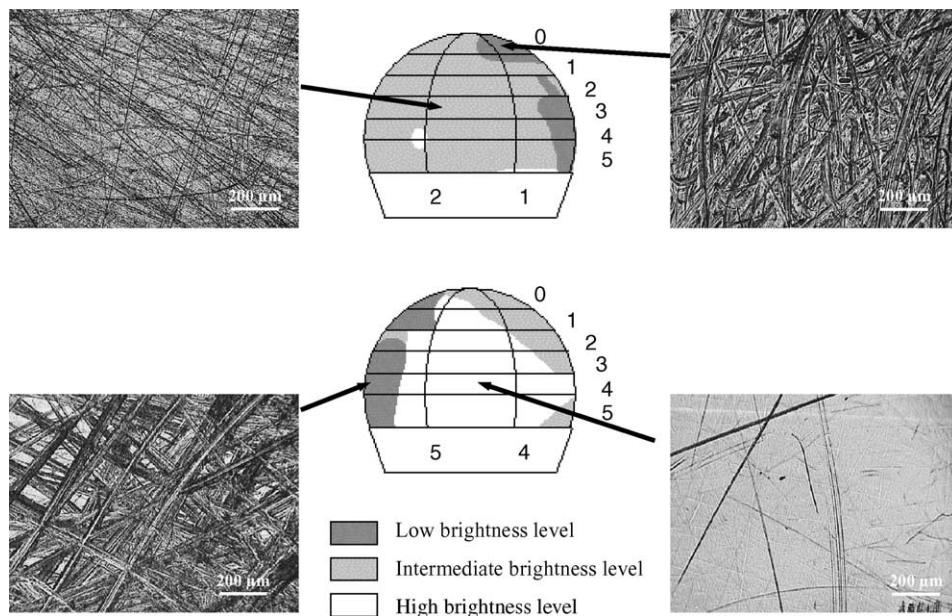
Fig. 4. Summary of the qualitative results obtained combining a visual inspection and observations carried out by means of an optical microscope.

- regions covering about 30% of the femoral head surface and visually having a bright finish. A light degree of damage is noticed in these regions which contain only isolated scratches.

- Regions covering between 10 and 20% of the femoral head surface and visually having a low brightness level; two regions of this type were detected and located along a meridian. A severe degree of damage is noticed in these regions whose topography consists of a high density of large, deep and randomly oriented scratches. These large scratches are thought to be directly related to the third-body abrasive action of the metallic millimeter-sized fiber on the metallic femoral head, consequently producing numerous metallic micrometer-sized wear debris.

- Regions covering more than 50% of the femoral head surface and visually having an intermediate brightness level. A moderate degree of damage is noticed in these regions whose topography consists of a high density of numerous small and randomly oriented scratches. These numerous small scratches are thought to be mainly a kind of “collateral damage” due to the third-body abrasive action of the small metallic micrometer-sized wear debris generated by the friction of the metallic fiber against the femoral head.

Fig. 4 summarises the results obtained combining a visual inspection and observations by optical microscopy. Three kinds of regions can be observed on the retrieved titanium femoral head under consideration:

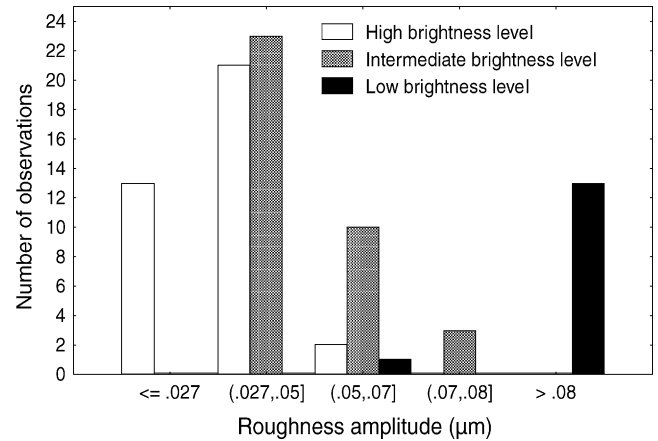
Fig. 6. Histogram of the arithmetic mean roughness values recorded from the areas scanned over the entire surface of the retrieved femoral head.

The values of the arithmetic mean roughness of the 86 areas scanned by means of the contacting profilometer are presented in Fig. 6. Fifty seven of these reported values are lower than  $0.05 \mu\text{m}$  which is the upper limit tolerance mentioned in the standard ISO 7206-2 for the roughness of a metallic femoral head [15]. However, about 50% of

Most importantly, Fig. 6 clearly shows a breakdown value of  $0.08 \mu\text{m}$  above which all the reported values of the arithmetic mean roughness parameter are related to areas having a low brightness level. This means that the arithmetic mean roughness parameter can be used to discriminate areas which are severely damaged against the others. However, most of the reported values of this parameter (exactly seventy three values) fall below  $0.08 \mu\text{m}$  and, except in one case, all of them are related to areas having either a bright finish or an intermediate brightness level. Unfortunately, no breakdown value can be clearly identified for separating these areas which are either lightly or moderately damaged. In this range of values, the gentle evolution noticed on the figure indicates that the arithmetic mean roughness may not be sufficiently relevant for a significant statistical discrimination of these two kinds of areas.

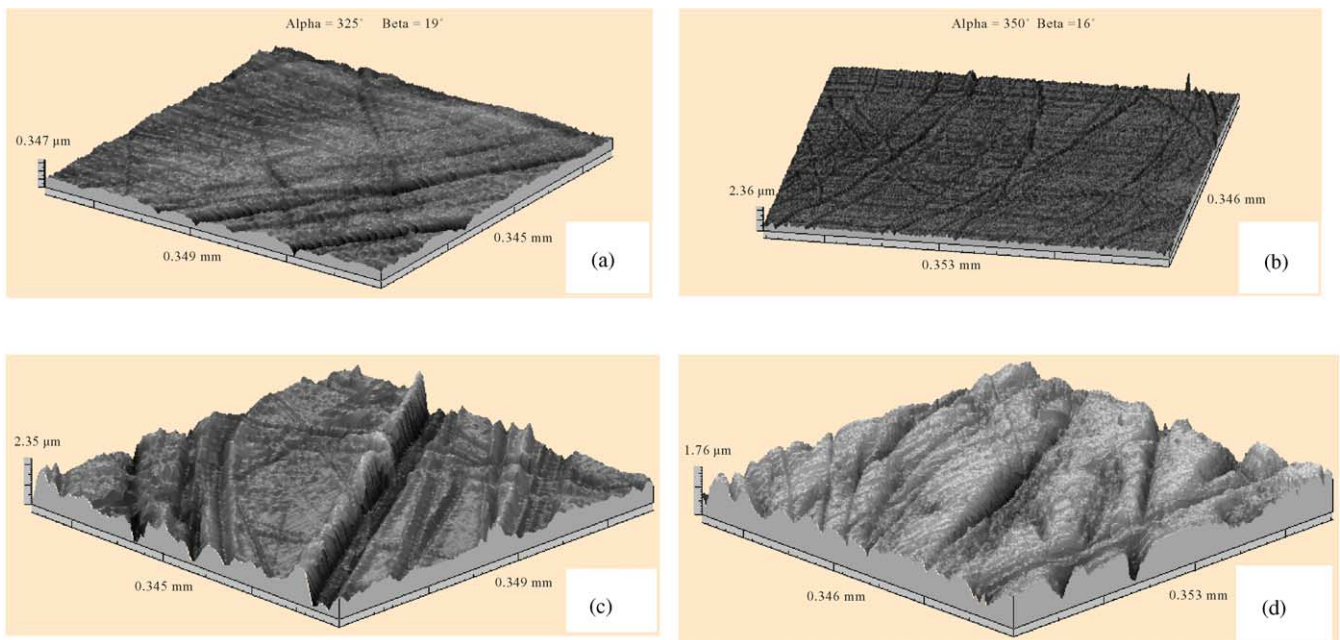
Fig. 5. Isometric plots of typical areas having: (a) a high brightness level, (b) an intermediate brightness level, (c) a low brightness level and large scratches with pile-up material to the sides, (d) a low brightness level and large scratches without any pile-up material. These areas are respectively denoted 5A, 5B, 5C and 5D.

The topographical patterns related to these three kinds of regions can also be observed on the isometric plots of typical areas recorded by means of the three dimensional contacting profilometer. Examples of such typical isometric plots are presented in Fig. 5 for areas that originate from regions having respectively a high, an intermediate and a low brightness levels. As far as the areas originating from regions having a low brightness level are concerned, the surface topogra-

phy always consists of large scratches superimposed onto a background of small scratches. Furthermore, pile-up metallic material can be detected to the sides of the large scratches in some areas (Fig. 5c) while not in others (Fig. 5d).

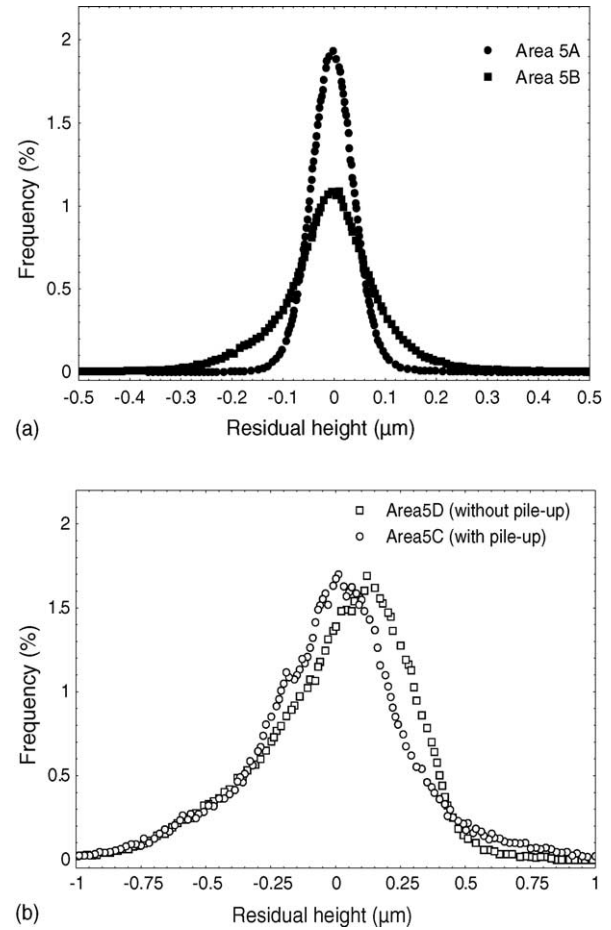
Fig. 7. Amplitude Density Functions of the four typical areas: (a) 5A and 5B, (b) 5C and 5D.

While the ADF was also assessed for each scanned area, Fig. 7 only provides examples of the typical distribution histograms of profile heights, which are representative of the overall areas. In fact, the four selected distributions are precisely those corresponding to isometric plots presented in Fig. 5, that is to say distributions characterising the four typical kinds of surface topography encountered in this study. The bearing area curves related to these typical areas are also given in Fig. 8 and the roughness parameters deduced from these curves are reported in Table 1.

Except for the distribution related to the severely damaged areas containing large scratches without pile-up material to the sides, all the distributions are symmetric compared to the reference surface and approach the Gaussian distribution (Fig. 7). Therefore, for these three kinds of area, there are as many peaks as valleys about the reference surface and these features are consistent with a random damage process. More-

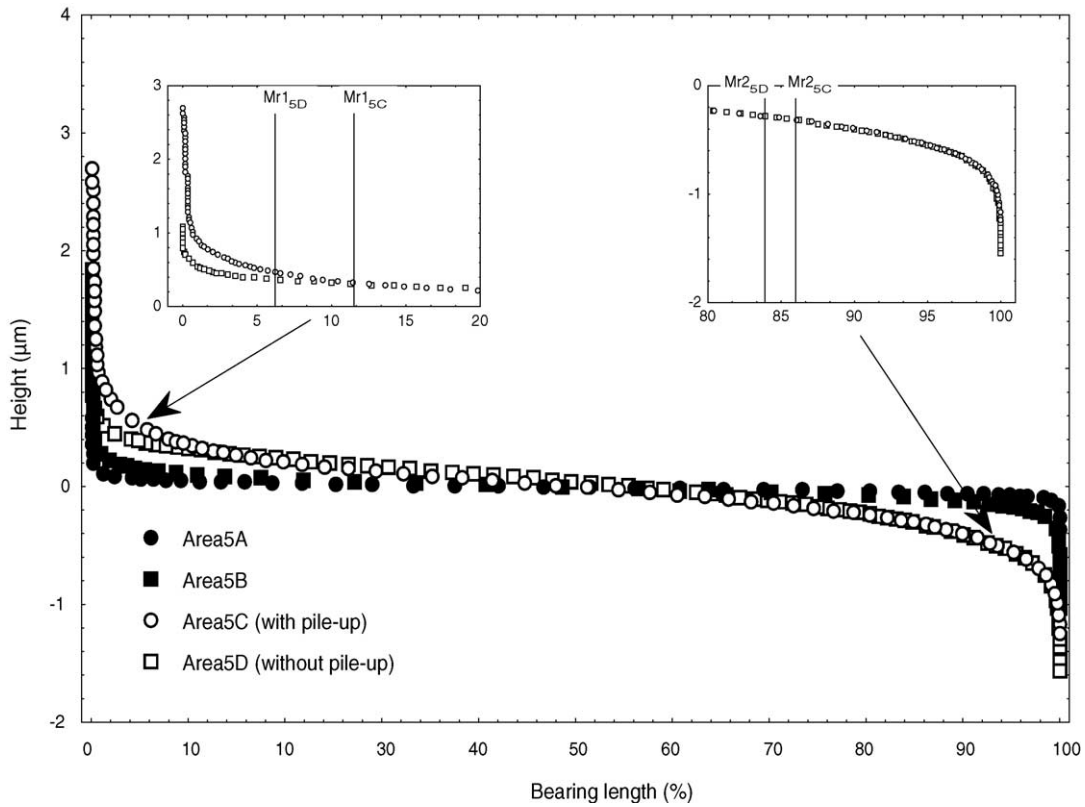
Fig. 8. Bearing area curves of the four typical areas 5A, 5B, 5C and 5D.

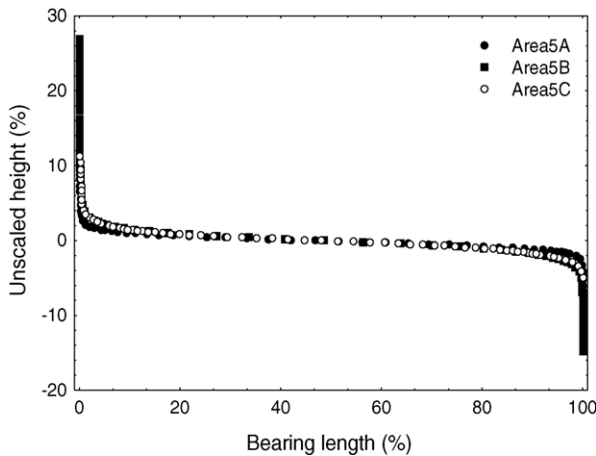
Fig. 9. Modified bearing area curves of the typical areas 5A, 5B and 5C.

In order to verify the previous assumption, a modified bearing area curve was constructed for each area under consideration by dividing the original values of the heights reported on the vertical axis by the root-mean square roughness  $R_q$  calculated from the related ADF. Fig. 9 shows that all the modified bearing area curves are quite similar as well as the related dimensionless roughness parameters  $R_{pk}^*$ ,  $R_k^*$  and  $R_{vk}^*$

that can be extracted from these curves (Table 1). This result thus seems to confirm that the surface topography of these damaged areas follows a scaling law.

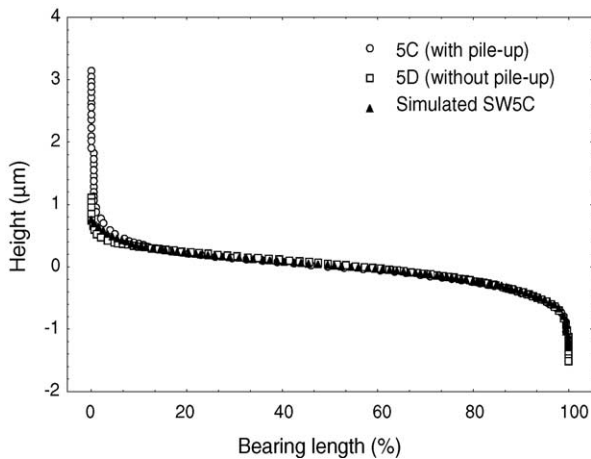
Fig. 10. Bearing area curves of the simulated worn area SW5C compared with those of the original areas 5C and 5D.

In order to verify this new assumption, an algorithm simulating an elementary abrasive wear process was specifically developed and applied on the experimental data file related to the severely damaged area containing large scratches with pile-up material to the sides. The basic idea of this model is that the higher the height of a peak of the profile, the lower its probability of resistance during a wear cycle. This probability of resistance is assessed assuming an exponential decay of the related probability density function, which is characterised by a single parameter defining the magnitude of the wear process. Finally, the probability to remove a peak at a given height is simply obtained by subtracting its probability of resistance from 1. Based on a Monte-Carlo process, the details of this algorithm which simulates the effect of an abrasive wear process that acts continuously to remove the highest peaks of the surface topography are reported in [Appendix B](#). Provided an optimisation of the parameters of this elementary wear model by means of a  $\chi^2$  calculation, a satisfying goodness-of-fit can be obtained between the bearing area curves related to the processed data file and to the severely damaged area containing large scratches without pile-up material ([Fig. 10](#)). Moreover, while the ADF of original data file is symmetric, the ADF of the processed data file is negatively skewed like the ADF related to severely damaged area con-

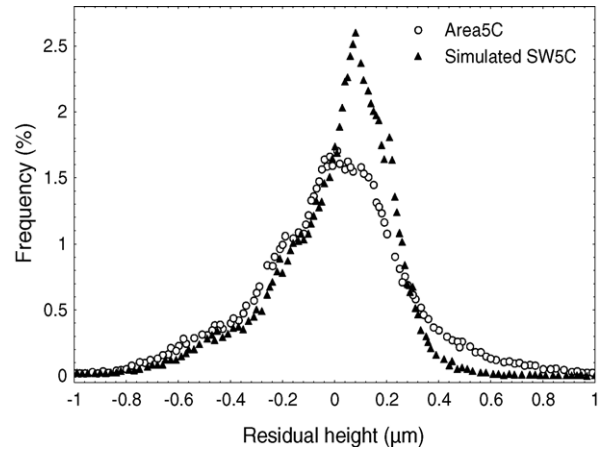
Fig. 11. Amplitude density functions of the simulated worn area SW5C compared with that of the original area 5C. Note the asymmetric shape of this ADF while that related to the original area 5C was symmetric before applying the simulated wear process.

taining large scratches without any pile-up material ([Fig. 11](#)). Therefore, these results confirm that an abrasive wear process may have acted continuously in some severely damaged areas, consequently removing the highest peaks while leaving the deepest valleys unaffected. In fact, this continuously acting wear process is strongly believed to be caused by multiple passages of the metallic fibermesh piece over the areas under consideration.

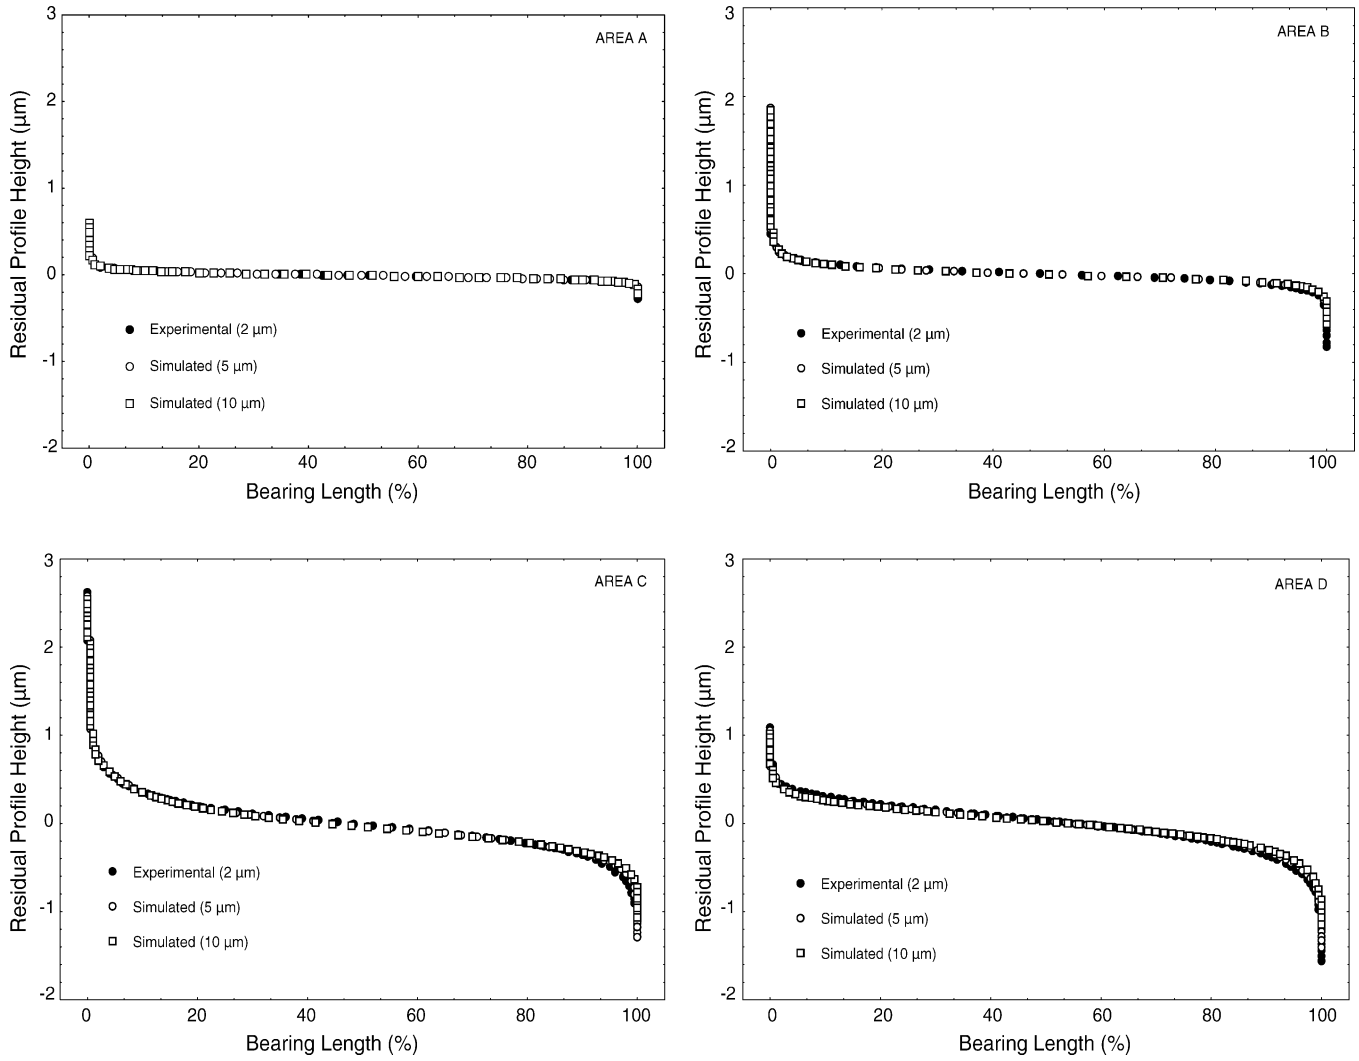
Fig. A1. Effect of a simulated 5 or 10  $\mu\text{m}$  stylus tip radius on the bearing area curves of the four typical areas scanned by means of a three dimensional profilometer having a 2  $\mu\text{m}$  stylus tip radius.
