Thierry PALIN-LUC, Serge LASSERRE, J-Y. BERARD - Experimental Investigation on the Significance of the Conventional Endurance Limit of a Spheroidal Graphite Cast Iron - Fatigue and Fracture of Engineering Materials and Structures - Vol. 21, n°2, p.191–200 - 1998

EXPERIMENTAL INVESTIGATION ON THE SIGNIFICANCE OF THE CONVENTIONAL ENDURANCE LIMIT OF A SPHEROIDAL GRAPHITE CAST IRON

Keywords—Cast iron; High cycle fatigue; Endurance limit; Small load cycles; Crack initiation; SEM observations.

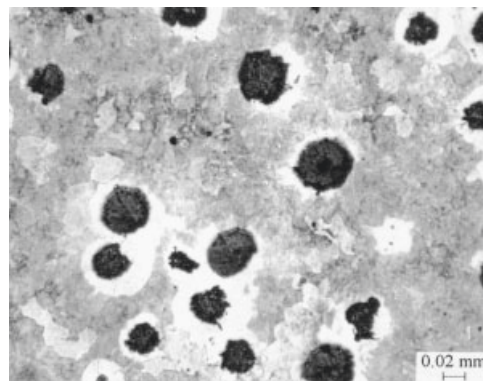
Fig. 1. Optical micrograph of the spheroidal graphite cast iron (after nital etching).

The test material was a spheroidal graphite cast iron with a pearlitic matrix (close to FGS 800-2 AFNOR standard) as used in the production of engine crankshafts. Ferrite was localized around the spheroids of graphite, with the ferrite and nodules included in a pearlitic matrix. This structure is called ‘bull’s eyes’ (Fig. 1). The chemical composition of this material was as follows (wt%): C = 3.50–3.90, Si = 1.80–2.80, Mn = 0.85, Cu = 0.03, Sn = 0.01, Ni = 0.03, S < 0.02, P < 0.05. After the heat treatment of heating and holding at 920°C for 1–2 h, slow cooling at 870°C for 3–4 h, then air cooling, the main mechanical characteristics of this cast iron are as follows: Young’s modulus = 164.9 GPa, Poisson’s ratio = 0.275, Proof (0.02%) stress = 320 MPa, $S_m = 795$ MPa, $A = 9\%$, $S_d = 280$ MPa, $S_d(sq) = 268$ MPa.

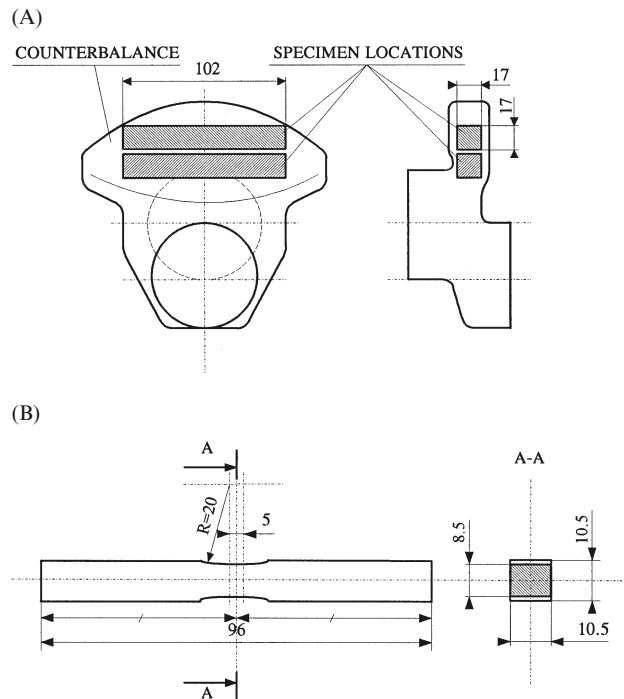
Fig. 2. (A) specimen locations in the crankshaft counterbalance; (B) geometry of specimens (dimensions in mm).

All the specimens used in this study were machined from the counterbalances of crankshafts after casting and the heat treatment described above. Parallelepiped blocks were cut in the counterbalances as indicated in Fig. 2(A) and then specimens were machined from these blocks to dimensions shown in Fig. 2(B). The testing area was ground and polished with emery paper of 1000 grade and finished with diamond powder (2 μ m grain size).

Five specimens of square cross-section (Fig. 2(B)) were loaded in fully reversed four point plane bending under constant stress amplitude. Their conventional endurance limit (infinite life) under this loading is $Sd(sq) = 268$ MPa. Four stress amplitudes were chosen: 280, 268, 230 and 180 MPa. According to the $S-N$ curve of the material the probabilities of failure before 10^6 cycles under the stress amplitudes 280 and 268 MPa, respectively, are: 0.50 and 0.12. For 230 and 180 MPa these probabilities of failure are less than 3×10^{-6} which are low enough to consider that the behaviour of the specimens loaded under these amplitudes was not representative of any phenomenon linked with the endurance limit. Each specimen was loaded under one of these stress amplitudes and then observed in the SEM during test interruptions. However, under 268 MPa two specimens were tested.

specimens were cut from the crankshafts. Specimens were produced from cast iron which was located far from the geometric centre of the crankshaft (Fig. 2). In such an area of the component, which is not the last solidification area of liquid metal, there is very little chance to find microporosities. On the contrary, when the specimens are machined at the centre of cast rods [4,6,12] or from large blocks [7] there is a greater probability to have porosities because specimens are made with the last solidified metal.

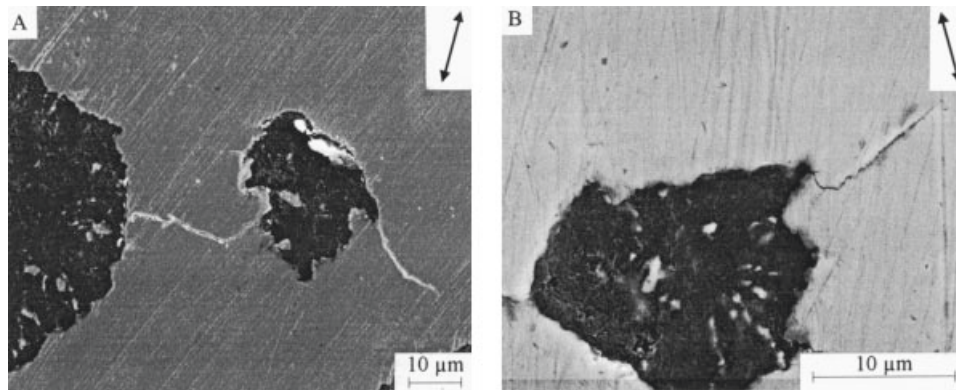
Fig. 3. SEM observations of a specimen surface loaded at (A) 280 MPa, (B) 268 MPa; each after 50,000 cycles. Arrows indicate loading direction.

- (i) either the distance between two spheroids is less than 20 μm which is approximately the diameter of spheroids (Fig. 3(A));
- (ii) or the shape of the spheroid is very irregular and a micro-crack initiated at a spheroid sharp edge (Fig. 3(B)).

The high stress concentrations generated by the spheroids in these two cases explained the crack initiation behaviour.

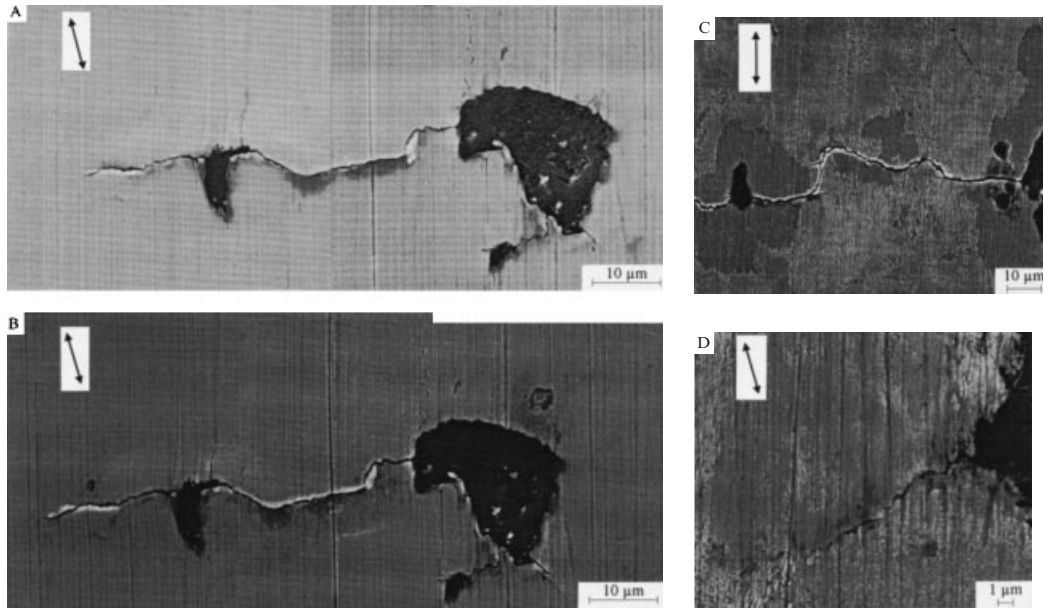
Fig. 4. SEM observations of a specimen surface. Arrows indicate loading direction. (A) loaded at 268 MPa for 150,000 cycles, (B) loaded at 268 MPa for 10^6 cycles. (C) 268 MPa for 10^6 cycles; after a nital etching. (D) 180 MPa for 10^6 cycles; after a nital etching.

Under the three higher stress levels (280, 268 and 230 MPa) several micro-cracks initiated and propagated between zero and 150,000 cycles. After this number of cycles, micro-cracks did not evolve significantly (see Fig. 4(A) and (B)). On the specimen loaded at 180 MPa, the micro-cracks which appeared between 150,000 and 300,000 cycles did not grow, even after 10^6 cycles. They were always very small (Fig. 4(D)).

The observations on specimens after a nital etching showed that micro-cracks had propagated across the pearlitic matrix of the material when the specimens were loaded at the three higher stresses (see example in Fig. 4(C)). On the specimen loaded at the lower stress amplitude, 180 MPa, micro-cracks never propagated across the matrix, i.e. they never propagated through the boundary between ferrite and pearlite even after 10^6 cycles of loading (Fig. 4(D)).

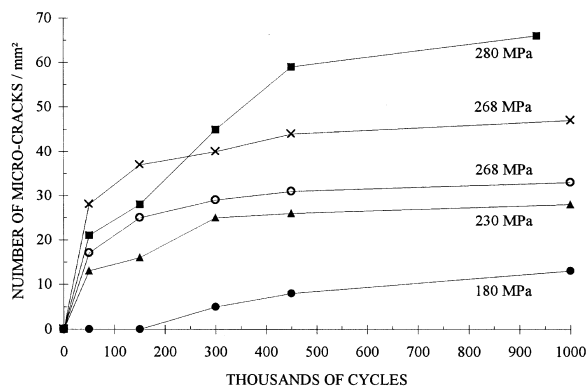
Fig. 5. Evolution of the surface density of micro-cracks for each specimen.

was scanned. The evolution of the surface density of micro-cracks as a function of the number of cycles is shown in Fig. 5.

For the specimen loaded at a stress amplitude of 180 MPa, the surface density of micro-cracks increases more slowly than for the other specimens loaded at higher stresses. The first micro-cracks appear between 150,000 and 300,000 cycles for a stress amplitude of 180 MPa while they initiate before 50,000 cycles for the higher stress amplitudes as shown in Fig. 5.

Furthermore, the curves in Fig. 5 flatten out and have an horizontal asymptote. It seems to prove that the number of micro-cracks does not evolve when the number of loading cycles tends to infinity ($> 10^6$ cycles). This conclusion has to be moderated because the counting method used

to draw these curves did not take into account the micro-cracks which have coalesced between two observation stages. When two micro-cracks coalesced only one micro-crack was counted. Nevertheless, this disadvantage of the method is not important for the significance of Fig. 5 for the number of cycles below 300,000. Up to this number only a few coalescences were observed; at the lowest stress amplitude no coalescence was ever observed.

The curves shown in Fig. 5, corresponding to the two specimens loaded at 268 MPa, are somewhat different from each other. This difference is probably due to the very large scatter of the number of cycles to failure when the stress level is near the endurance limit. On one of these two specimens a macro-crack was detected after 933,500 cycles in the fatigue testing machine; the test was stopped. This specimen was probably a 'weak specimen'.

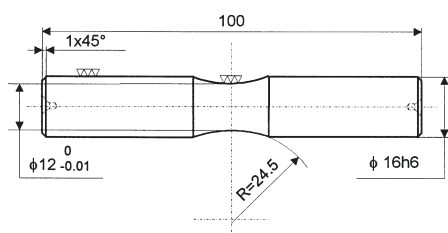
Fig. 6. Specimen used for cumulative damage tests (dimensions in mm).

Cumulative damage tests, in a stress-block format, have been done on smooth cylindrical specimens (Fig. 6) in the same material as before. The specimens were ground; the roughness of the median torus is such that $Ra < 0.2 \mu\text{m}$. This torus creates a theoretical stress concentration factor of 1.07 in bending. Each specimen was loaded in four point plane bending; each loading was composed of two different types of blocks (low and high) alternatively applied to the specimen until failure (Fig. 7). The block duration was fixed at 5000 cycles. Transition between two blocks was less than 10 cycles at the operating frequency of 50 Hz. This can be neglected when compared with the duration of one block.

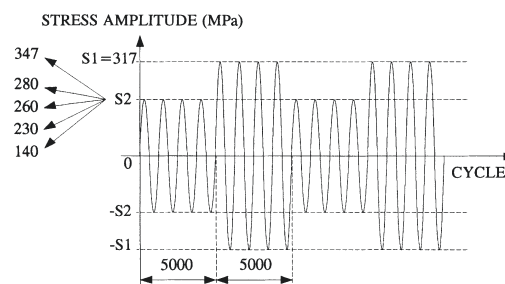
Fig. 7. Loading in blocks. S_1 is the same for all the specimens, S_2 is specimen-dependent.

Five test series were carried out. Several loadings were applied on 50 specimens (10 in a series). One type of block was fixed to a fully reversed stress amplitude S_1 of 317 MPa (above the endurance limit), the corresponding median life on the $S-N$ curve is 315,000 cycles. Five different stress amplitudes S_2 were tested for the second type of block: 140, 230, 260, 280 and 347 MPa (Fig. 7). In plane bending, the conventional endurance limit of the specimens used (Fig. 6) is $S_d = 280 \text{ MPa}$; this is different from the limit of the specimens with a square cross-section $S_d(sq)$ [9]. Under a loading where the two blocks have the same amplitude (317 MPa) the lifetime is

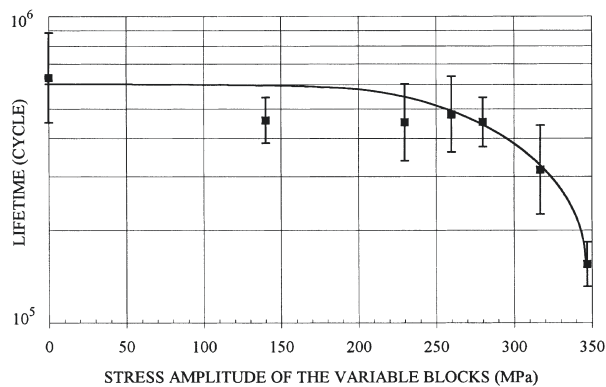
Fig. 8. Cumulative damage test results.

Fatigue test results are shown in Fig. 8. This figure shows the lifetime as a function of the different stress amplitudes S_2 used in tests. The points represent the median lives, the bar lines show the standard deviation of the lifetime. Note that 68% of the test results are within each scatter band.

Figure 8 shows that the total life of the specimens under block loading (with blocks below the endurance limit) is shorter than the expected life if these blocks did not contribute to the damage process. On the tested spheroidal graphite cast iron specimens, blocks below the endurance limit participate in damage when they are applied to specimens with other blocks above the endurance limit. Furthermore, the curve of Fig. 8 proves that when the amplitude of the low blocks is higher than about 210–250 MPa, their influence is more significant than when they are below 210 MPa.

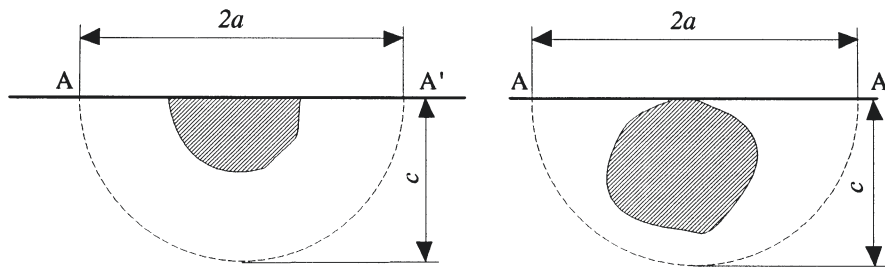
Fig. 9. Three-dimensional aspect of a micro-crack around a spheroid (from [4,6]).

A number of assumptions have to be made about the equilibrium shape of the observed micro-cracks. We have supposed (as proposed in [4] and [6]) that micro-cracks are in one of the configurations illustrated by Fig. 9. Even if the apparent size of a nodule at the surface is small we suppose, as suggested in [6], that the nodules behave like holes which give rise to the formation of a crack on their equatorial plane. With this assumption, Fig. 10(A) illustrates the non-propagating crack length ($2a$) observed on the surface of the tested specimens versus the stress amplitude.

For a plate specimen, with finite thickness t , in a bending configuration the real crack shape at equilibrium is a semi-circle [13] such that $c/a = 1$. By using the results of Scott and Thorpe [13] we have plotted in Fig. 10(B) the maximum of the stress intensity factor, K_{\max} , versus the stress amplitude applied to the specimen; dark marks represents the K_{\max} value corresponding to the mean value of crack length, each segment shows the scatter associated with the scatter of crack length (values calculated with 5 to 10 micro-cracks). These values of K_{\max} were calculated at the intersection AA' between the nodule and the specimen surface (Fig. 9), where its value is higher than along the other parts of the particule contour [6].

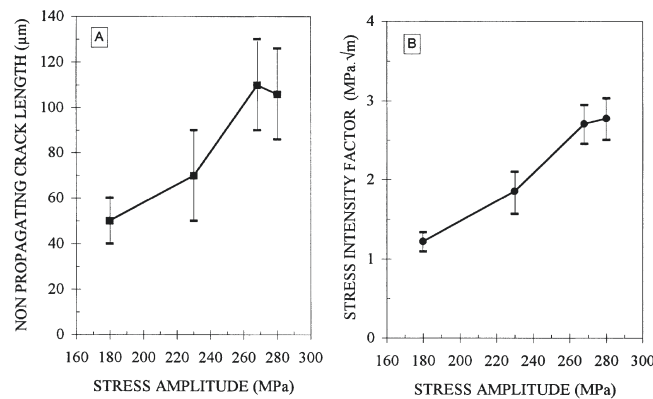
Fig. 10. The effect of stress amplitude on (A) non-propagating crack length, $2a$, and (B) maximum value of the stress intensity factor.

Each scatter band represents 68% of the measured crack lengths $2a$ (5 to 10 micro-cracks at each stress amplitude).

The fatigue tests reported in this study were done in plane bending with $R_\sigma = S_{\min}/S_{\max} = -1$. It is difficult to compare the previous values of K_{\max} with the values given in the literature because they are usually given for a stress ratio $R_\sigma > 0$. Nevertheless, we can see in Fig. 10(B) that at the endurance limit ($Sd(sq) = 268$ MPa) of the specimen $K_{\max} = 2.7 \text{ MPa}\sqrt{\text{m}}$ for cracks arrested in the pearlitic matrix. This value is close to the threshold value reported in [6] for tests with plate specimens loaded in plane bending ($R_\sigma = 0.1$) at their endurance limit, i.e. $K_{\max} = 3.1 \text{ MPa}\sqrt{\text{m}}$; this value corresponds to short cracks (length of about 0.1 mm) arrested in the matrix of a ferritic spheroidal graphite cast iron. For the micro-cracks which are arrested at the interface between ferrite and pearlite (specimen loaded at 180 MPa) the stress intensity factor is small, $K_{\max} \approx 1 \text{ MPa}\sqrt{\text{m}}$, compared with the corresponding value at the endurance limit. We can conclude that this is an approximate value of the threshold of the stress intensity factor for micro-cracks arrested at the ferrite/pearlite interface for a bull's eyes cast iron.
