EXPERIMENTAL INVESTIGATION ON THE SIGNIFICANCE OF THE CONVENTIONAL ENDURANCE LIMIT OF A SPHEROIDAL GRAPHITE CAST IRON

Abstract—Fatigue tests were performed on a spheroidal graphite cast iron in four point plane bending under constant stress amplitude and block loading conditions. The microstructure of this material has a ‘bull’s eyes’ appearance, i.e. the spheroids of graphite are surrounded by ferrite and these nodules and ferrite zones are included in a pearlitic matrix. Scanning electronic microscope observations were carried out at different fractions of life for constant stress amplitude loadings above and below the conventional endurance limit. Non-propagating micro-cracks were observed at a stress level equal to the conventional endurance limit. These observations showed that another limit can be defined below the conventional endurance one, i.e. one below which micro-cracks were not observed to initiate in the matrix. These cracks were found to arrest at the ferrite/pearlite interface when the material was tested below this new limit. This concept was used to rationalize fatigue results from tests with loading in blocks above and below the conventional endurance limit.

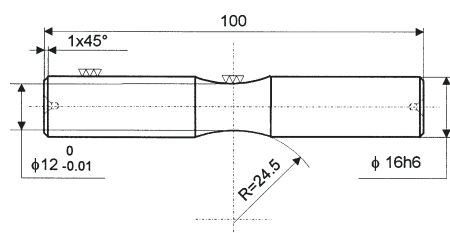
Fig. 6. Specimen used for cumulative damage tests (dimensions in mm).

Cumulative damage tests, in a stress-block format, have been done on smooth cylindrical specimens (Fig. 6) in the same material as before. The specimens were ground; the roughness of the median torus is such that $Ra < 0.2 \mu\text{m}$. This torus creates a theoretical stress concentration factor of 1.07 in bending. Each specimen was loaded in four point plane bending; each loading was composed of two different types of blocks (low and high) alternatively applied to the specimen until failure (Fig. 7). The block duration was fixed at 5000 cycles. Transition between two blocks was less than 10 cycles at the operating frequency of 50 Hz. This can be neglected when compared with the duration of one block.
