Thierry PALIN-LUC, Serge LASSERRE, J-Y. BERARD - Experimental Investigation on the Significance of the Conventional Endurance Limit of a Spheroidal Graphite Cast Iron - Fatigue and Fracture of Engineering Materials and Structures - Vol. 21, n°2, p.191–200 - 1998

EXPERIMENTAL INVESTIGATION ON THE SIGNIFICANCE OF THE CONVENTIONAL ENDURANCE LIMIT OF A SPHEROIDAL GRAPHITE CAST IRON

Abstract—Fatigue tests were performed on a spheroidal graphite cast iron in four point plane bending under constant stress amplitude and block loading conditions. The microstructure of this material has a ‘bull’s eyes’ appearance, i.e. the spheroids of graphite are surrounded by ferrite and these nodules and ferrite zones are included in a pearlitic matrix. Scanning electronic microscope observations were carried out at different fractions of life for constant stress amplitude loadings above and below the conventional endurance limit. Non-propagating micro-cracks were observed at a stress level equal to the conventional endurance limit. These observations showed that another limit can be defined below the conventional endurance one, i.e. one below which micro-cracks were not observed to initiate in the mat

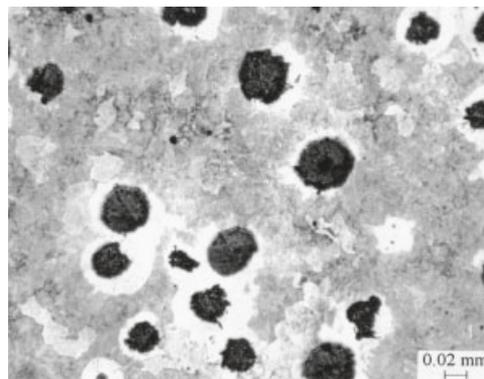
Fig. 1. Optical micrograph of the spheroidal graphite cast iron (after nital etching).

The test material was a spheroidal graphite cast iron with a pearlitic matrix (close to FGS 800-2 AFNOR standard) as used in the production of engine crankshafts. Ferrite was localized around the spheroids of graphite, with the ferrite and nodules included in a pearlitic matrix. This structure is called ‘bull’s eyes’ (Fig. 1). The chemical composition of this material was as follows (wt%): C = 3.50–3.90, Si = 1.80–2.80, Mn = 0.85, Cu = 0.03, Sn = 0.01, Ni = 0.03, S < 0.02, P < 0.05. After the heat treatment of heating and holding at 920°C for 1–2 h, slow cooling at 870°C for 3–4 h, then air cooling, the main mechanical characteristics of this cast iron are as follows: Young’s modulus = 164.9 GPa, Poisson’s ratio = 0.275, Proof (0.02%) stress = 320 MPa, $S_m = 795$ MPa, $A = 9\%$, $S_d = 280$ MPa, $S_d(sq) = 268$ MPa.

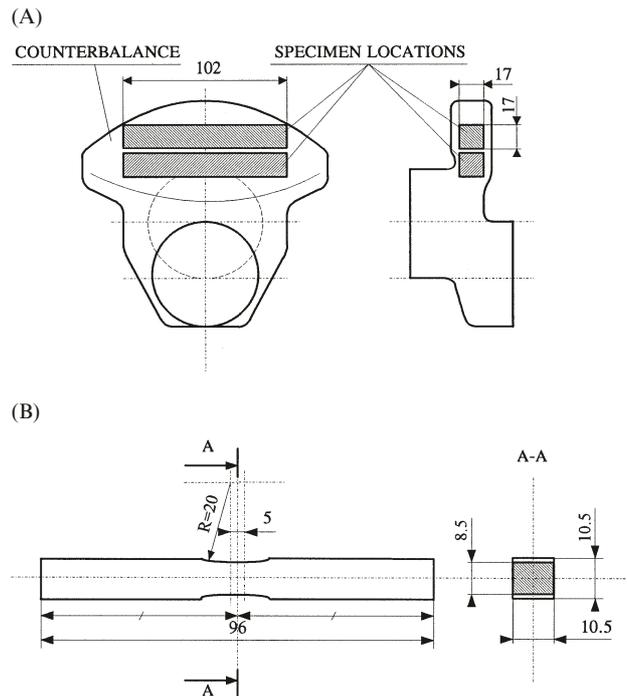
Fig. 2. (A) specimen locations in the crankshaft counterbalance; (B) geometry of specimens (dimensions in mm).

All the specimens used in this study were machined from the counterbalances of crankshafts after casting and the heat treatment described above. Parallelepiped blocks were cut in the counterbalances as indicated in Fig. 2(A) and then specimens were machined from these blocks to dimensions shown in Fig. 2(B). The testing area was ground and polished with emery paper of 1000 grade and finished with diamond powder (2 μ m grain size).

Five specimens of square cross-section (Fig. 2(B)) were loaded in fully reversed four point plane bending under constant stress amplitude. Their conventional endurance limit (infinite life) under this loading is $Sd(sq) = 268$ MPa. Four stress amplitudes were chosen: 280, 268, 230 and 180 MPa. According to the $S-N$ curve of the material the probabilities of failure before 10^6 cycles under the stress amplitudes 280 and 268 MPa, respectively, are: 0.50 and 0.12. For 230 and 180 MPa these probabilities of failure are less than 3×10^{-6} which are low enough to consider that the behaviour of the specimens loaded under these amplitudes was not representative of any phenomenon linked with the endurance limit. Each specimen was loaded under one of these stress amplitudes and then observed in the SEM during test interruptions. However, under 268 MPa two specimens were tested.

specimens were cut from the crankshafts. Specimens were produced from cast iron which was located far from the geometric centre of the crankshaft (Fig. 2). In such an area of the component, which is not the last solidification area of liquid metal, there is very little chance to find microporosities. On the contrary, when the specimens are machined at the centre of cast rods [4,6,12] or from large blocks [7] there is a greater probability to have porosities because specimens are made with the last solidified metal.

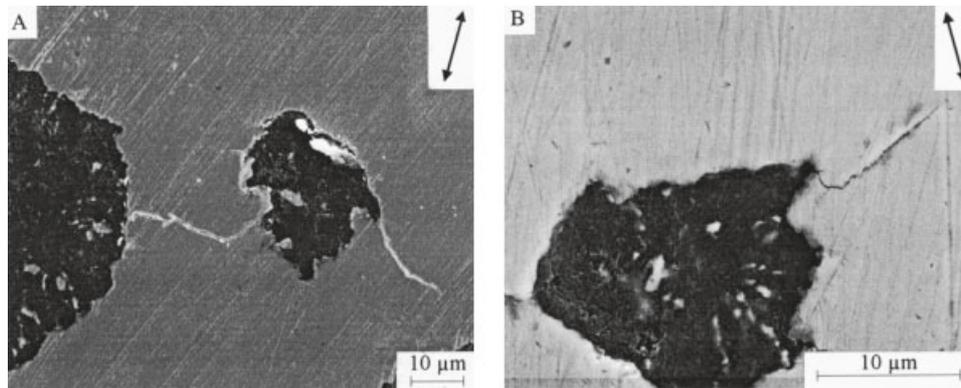
Fig. 3. SEM observations of a specimen surface loaded at (A) 280 MPa, (B) 268 MPa; each after 50,000 cycles. Arrows indicate loading direction.

- (i) either the distance between two spheroids is less than 20 μm which is approximately the diameter of spheroids (Fig. 3(A));
- (ii) or the shape of the spheroid is very irregular and a micro-crack initiated at a spheroid sharp edge (Fig. 3(B)).

The high stress concentrations generated by the spheroids in these two cases explained the crack initiation behaviour.

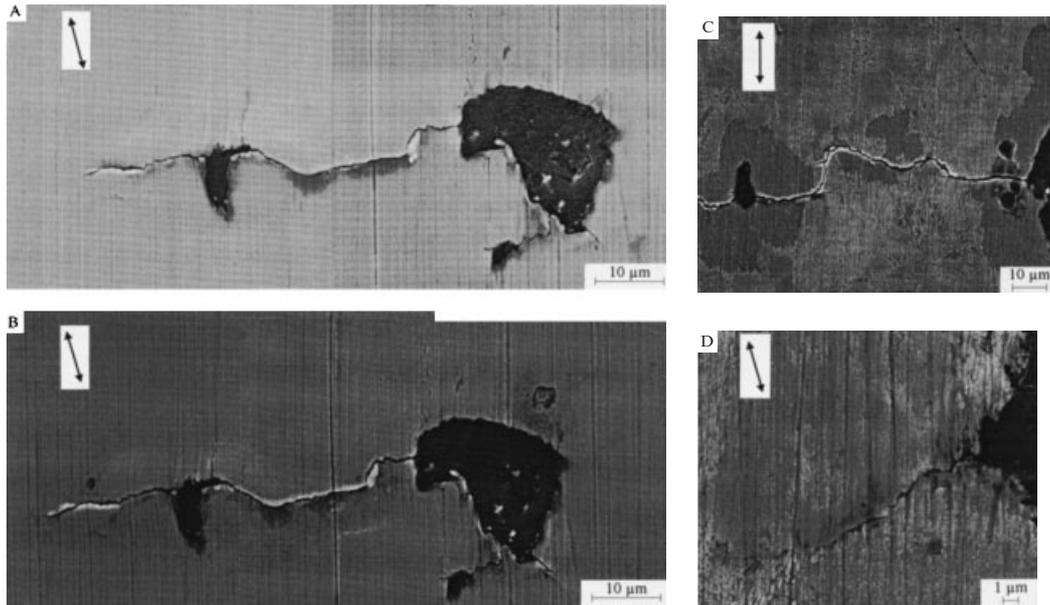
Fig. 4. SEM observations of a specimen surface. Arrows indicate loading direction. (A) loaded at 268 MPa for 150,000 cycles, (B) loaded at 268 MPa for 10⁶ cycles. (C) 268 MPa for 10⁶ cycles; after a nital etching. (D) 180 MPa for 10⁶ cycles; after a nital etching.

Under the three higher stress levels (280, 268 and 230 MPa) several micro-cracks initiated and propagated between zero and 150,000 cycles. After this number of cycles, micro-cracks did not evolve significantly (see Fig. 4(A) and (B)). On the specimen loaded at 180 MPa, the micro-cracks which appeared between 150,000 and 300,000 cycles did not grow, even after 10^6 cycles. They were always very small (Fig. 4(D)).

The observations on specimens after a nital etching showed that micro-cracks had propagated across the pearlitic matrix of the material when the specimens were loaded at the three higher stresses (see example in Fig. 4(C)). On the specimen loaded at the lower stress amplitude, 180 MPa, micro-cracks never propagated across the matrix, i.e. they never propagated through the boundary between ferrite and pearlite even after 10^6 cycles of loading (Fig. 4(D)).

It can be concluded that the matrix of the material keeps its mechanical integrity when the material is loaded at 180 MPa even after 10^6 cycles. For higher stress amplitudes, micro-cracks will initiate within the pearlitic matrix.

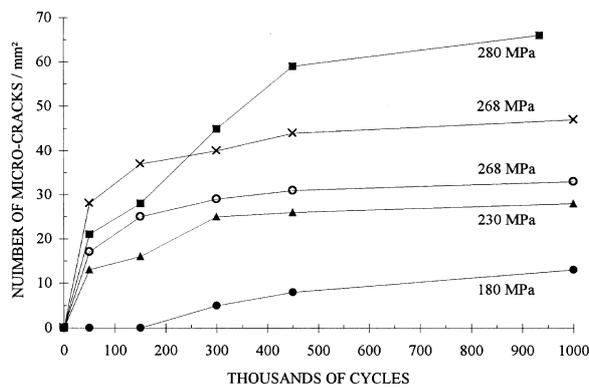
Fig. 5. Evolution of the surface density of micro-cracks for each specimen.

was scanned. The evolution of the surface density of micro-cracks as a function of the number of cycles is shown in Fig. 5.

For the specimen loaded at a stress amplitude of 180 MPa, the surface density of micro-cracks increases more slowly than for the other specimens loaded at higher stresses. The first micro-cracks appear between 150,000 and 300,000 cycles for a stress amplitude of 180 MPa while they initiate before 50,000 cycles for the higher stress amplitudes as shown in Fig. 5.

Furthermore, the curves in Fig. 5 flatten out and have an horizontal asymptote. It seems to prove that the number of micro-cracks does not evolve when the number of loading cycles tends to infinity (> 10⁶ cycles). This conclusion has to be moderated because the counting method used

to draw these curves did not take into account the micro-cracks which have coalesced between two observation stages. When two micro-cracks coalesced only one micro-crack was counted. Nevertheless, this disadvantage of the method is not important for the significance of Fig. 5 for the number of cycles below 300,000. Up to this number only a few coalescences were observed; at the lowest stress amplitude no coalescence was ever observed.

The curves shown in Fig. 5, corresponding to the two specimens loaded at 268 MPa, are somewhat different from each other. This difference is probably due to the very large scatter of the number of cycles to failure when the stress level is near the endurance limit. On one of these two specimens a macro-crack was detected after 933,500 cycles in the fatigue testing machine; the test was stopped. This specimen was probably a ‘weak specimen’.

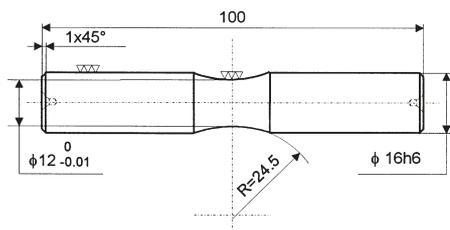
Fig. 6. Specimen used for cumulative damage tests (dimensions in mm).

Cumulative damage tests, in a stress-block format, have been done on smooth cylindrical specimens (Fig. 6) in the same material as before. The specimens were ground; the roughness of the median torus is such that $Ra < 0.2 \mu\text{m}$. This torus creates a theoretical stress concentration factor of 1.07 in bending. Each specimen was loaded in four point plane bending; each loading was composed of two different types of blocks (low and high) alternatively applied to the specimen until failure (Fig. 7). The block duration was fixed at 5000 cycles. Transition between two blocks was less than 10 cycles at the operating frequency of 50 Hz. This can be neglected when compared with the duration of one block.

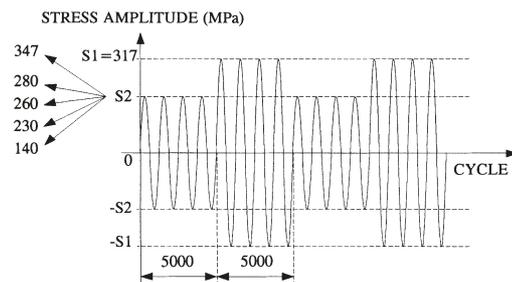
Fig. 7. Loading in blocks. S_1 is the same for all the specimens, S_2 is specimen-dependent.

Five test series were carried out. Several loadings were applied on 50 specimens (10 in a series). One type of block was fixed to a fully reversed stress amplitude S_1 of 317 MPa (above the endurance limit), the corresponding median life on the $S-N$ curve is 315,000 cycles. Five different stress amplitudes S_2 were tested for the second type of block: 140, 230, 260, 280 and 347 MPa (Fig. 7). In plane bending, the conventional endurance limit of the specimens used (Fig. 6) is $S_d = 280 \text{ MPa}$; this is different from the limit of the specimens with a square cross-section $S_d(sq)$ [9]. Under a loading where the two blocks have the same amplitude (317 MPa) the lifetime is

given by the $S-N$ curve under constant amplitude. Under a loading where the low stress amplitude is equal to zero the lifetime is supposed to be twice the lifetime under only the high amplitude S_1 , i.e. 630,000 cycles.

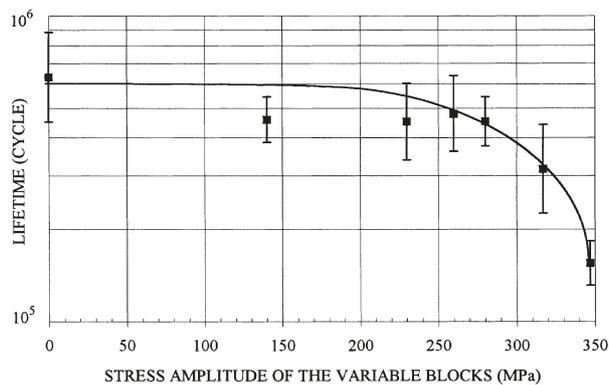
Fig. 8. Cumulative damage test results.

Fatigue test results are shown in Fig. 8. This figure shows the lifetime as a function of the different stress amplitudes S_2 used in tests. The points represent the median lives, the bar lines show the standard deviation of the lifetime. Note that 68% of the test results are within each scatter band.

Figure 8 shows that the total life of the specimens under block loading (with blocks below the endurance limit) is shorter than the expected life if these blocks did not contribute to the damage process. On the tested spheroidal graphite cast iron specimens, blocks below the endurance limit participate in damage when they are applied to specimens with other blocks above the endurance limit. Furthermore, the curve of Fig. 8 proves that when the amplitude of the low blocks is higher than about 210–250 MPa, their influence is more significant than when they are below 210 MPa.

According to these test results, it seems that a new limit exists below the conventional endurance limit. The influence of blocks with a stress amplitude between this new limit and the endurance one is very important on the lifetime of the material. This is not the case for stress amplitudes below this new limit.

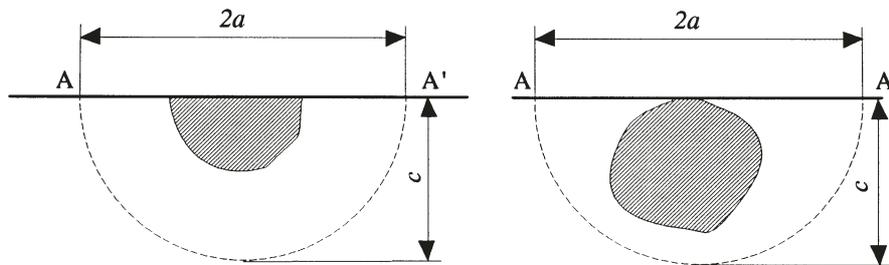
Fig. 9. Three-dimensional aspect of a micro-crack around a spheroid (from [4,6]).

A number of assumptions have to be made about the equilibrium shape of the observed micro-cracks. We have supposed (as proposed in [4] and [6]) that micro-cracks are in one of the configurations illustrated by Fig. 9. Even if the apparent size of a nodule at the surface is small we suppose, as suggested in [6], that the nodules behave like holes which give rise to the formation of a crack on their equatorial plane. With this assumption, Fig. 10(A) illustrates the non-propagating crack length ($2a$) observed on the surface of the tested specimens versus the stress amplitude.

For a plate specimen, with finite thickness t , in a bending configuration the real crack shape at equilibrium is a semi-circle [13] such that $c/a = 1$. By using the results of Scott and Thorpe [13] we have plotted in Fig. 10(B) the maximum of the stress intensity factor, K_{\max} , versus the stress amplitude applied to the specimen; dark marks represents the K_{\max} value corresponding to the mean value of crack length, each segment shows the scatter associated with the scatter of crack length (values calculated with 5 to 10 micro-cracks). These values of K_{\max} were calculated at the intersection AA' between the nodule and the specimen surface (Fig. 9), where its value is higher than along the other parts of the particule contour [6].

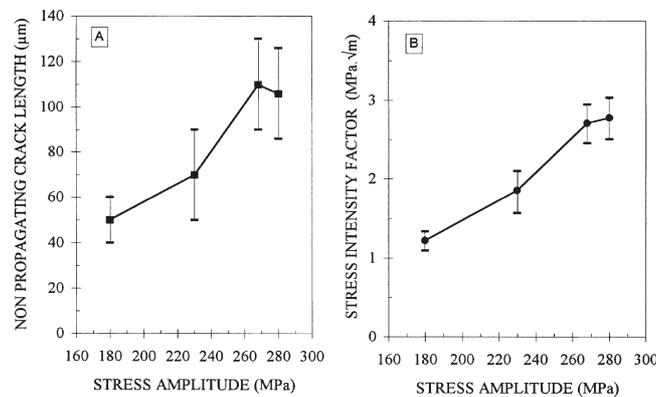
Fig. 10. The effect of stress amplitude on (A) non-propagating crack length, $2a$, and (B) maximum value of the stress intensity factor.

Each scatter band represents 68% of the measured crack lengths $2a$ (5 to 10 micro-cracks at each stress amplitude).

The fatigue tests reported in this study were done in plane bending with $R_\sigma = S_{\min}/S_{\max} = -1$. It is difficult to compare the previous values of K_{\max} with the values given in the literature because they are usually given for a stress ratio $R_\sigma > 0$. Nevertheless, we can see in Fig. 10(B) that at the endurance limit ($Sd(sq) = 268$ MPa) of the specimen $K_{\max} = 2.7$ MPa \sqrt{m} for cracks arrested in the pearlitic matrix. This value is close to the threshold value reported in [6] for tests with plate specimens loaded in plane bending ($R_\sigma = 0.1$) at their endurance limit, i.e. $K_{\max} = 3.1$ MPa \sqrt{m} ; this value corresponds to short cracks (length of about 0.1 mm) arrested in the matrix of a ferritic spheroidal graphite cast iron. For the micro-cracks which are arrested at the interface between ferrite and pearlite (specimen loaded at 180 MPa) the stress intensity factor is small, $K_{\max} \approx 1$ MPa \sqrt{m} , compared with the corresponding value at the endurance limit. We can conclude that this is an approximate value of the threshold of the stress intensity factor for micro-cracks arrested at the ferrite/pearlite interface for a bull's eyes cast iron.
