Isothermal fatigue damage mechanisms at ambient and elevated temperature of a cast Al-Si-Cu aluminium alloy

Pablo Wilson^{a,b}, Nicolas Saintier^{a,*}, Thierry Palin-Luc^a, Sebastien Bergamo^b

ABSTRACT

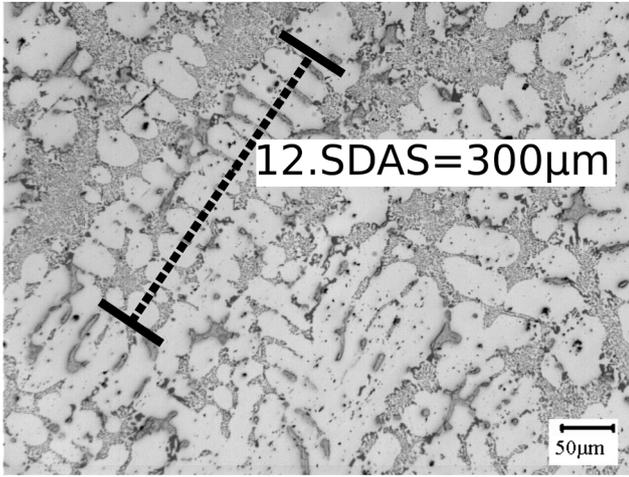
Fig. 1. Optical microstructure of specimen and SDAS measurement.

The microstructure exhibits dendritic solidification shown in Fig. 1. The secondary dendritic arm spacing (SDAS) is measured over 1 mm² in the center of the round bar, corresponding to the fatigue tested zone. Table 2 shows the observed mean SDAS value equal to 24 μm (measured on 102 values), which is among the values observed in the literature for similar casting process [16]. The casting process of the bars was specifically tailored in order for the SDAS to be relatively low and reproduce high cooling rates locations in components.

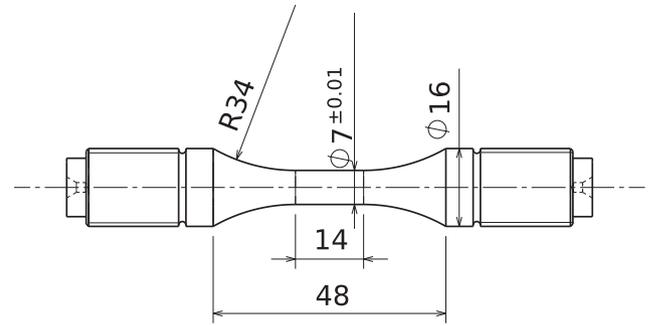
Fig. 2. Specimen geometry for low-cycle fatigue test.

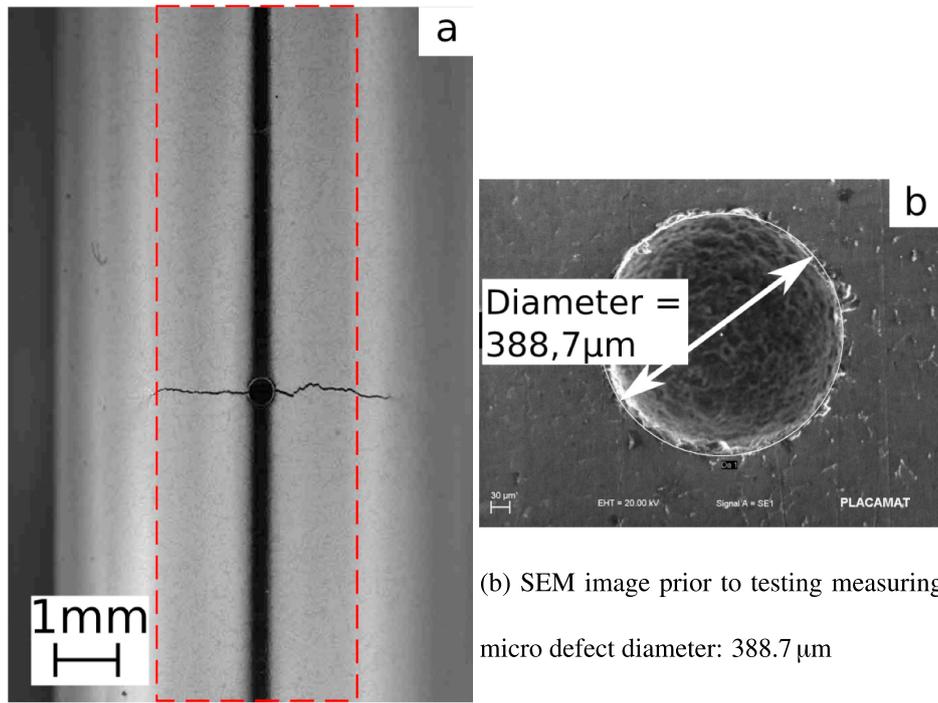
(a) Digital picture of specimen with microdefect

(b) SEM image prior to testing measuring micro defect diameter: 388.7 μm

Fig. 3. Test setup of crack monitoring specimens.

Artificial microdefects were machined at the surface of some specimens to follow crack propagation more easily. An hemisphere of 400 μm was machined by electro discharge. Fig. 3(a) shows micro defect in the middle part of a test specimen, while Fig. 3(b) shows SEM image used to measure the micro defect diameter before fatigue testing. All diameters are in the interval [359–401 μm]. For later crack propagation calculations, the measured value is used avoiding part of the bias caused by the scatter in the microdefect sizes.

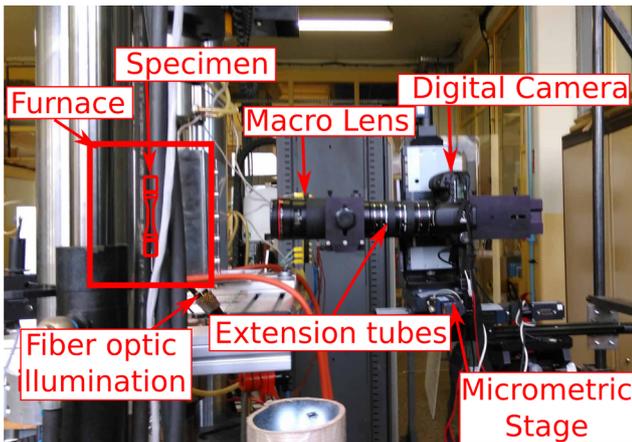
Fig. 4. Crack propagation monitoring setup.

To monitor the crack propagation, the digital camera was synchronized with the test rig and a picture was taken for each cycle at the maximum load, therefore maximizing the crack opening (see Fig. 4). Special care is taken as to obtain high quality pictures during crack propagation over a large surface of the cylindrical specimen. While standard direct illumination can be used to observe flat area, such as for SENT specimens, indirect illumination is here used and allows us to monitor crack propagation on standard LCF cylindrical specimens: the walls of the furnace are illuminated, and the reflection of the walls on the specimen are captured by the camera. Compared to direct illumination, this method avoids a glare effect caused by the specimen curvature. The camera settings are set to minimize the motion blur while maximizing signal to noise ratio (Canon EOS 40D, Canon EF 180 mm f/3.5L Macro USM Macro lens, $f/8$, $1/13s$, iso 1000). An image treatment is then applied. Firstly, all the pictures are registered to the first one thereby eliminating slight translations between pictures. Secondly, an averaging is done over sequential images: considering time (i.e. cycles) as the third dimension, a Gaussian filter of standard deviation 6 time unit (i.e. 6 cycles) is applied. The image enhancement obtained can be seen in Fig. 5: the crack path can clearly be identified with respect to the microstructure. For the last cycles, when the crack tip propagation is too fast and image averaging causes blur, the raw data images are considered. The observation setup allows for microstructure observation of an approximate area of 33 mm² (the 11 mm height is limited by the sensor size, whereas the 3 mm width is limited by the depth-of-field).

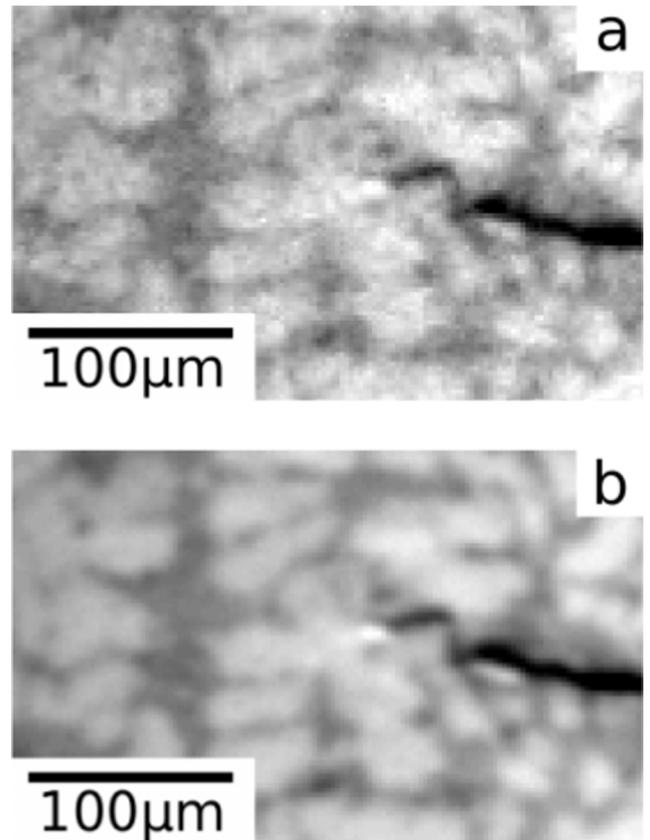
Fig. 5. Image treatment of crack propagation monitoring (a) raw image, (b) after image processing.

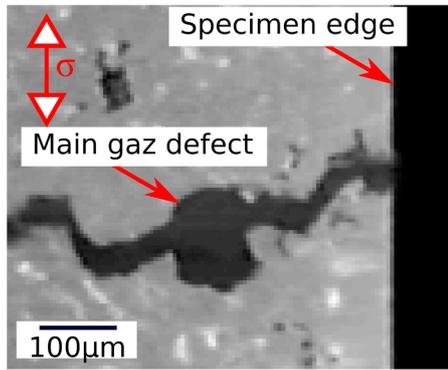
(a) Spherical gas porosity identified by micro-tomography (specimen 62T5, $\Delta\varepsilon/2 = 0.3\%$, 250°C , $R_\varepsilon = -1$, $N_f = 2089$ cycles)

Fig. 6. Crack initiation on defects: classification.

- Gaz porosity: large gaz porosities ($>100 \mu\text{m}$) were are close to the specimen surface. Fig. 6a shows such a defect identified by microtomography, revealing the crack initiates around the mid plane of the defects, where the stress concentration factor is the highest.
- Casting shrinkage: large shrinkages ($>100 \mu\text{m}$) are also found close to the specimen surface (see Fig. 6(b)). The convolutions caused by the shrinkage imply a lower defect sphericity and high acuteness.
- Defect cluster: also located close to the specimen surface, they appear larger than isolated defects ($>500 \mu\text{m}$). Fig. 6(c) displays a cluster of defects that caused the main crack initiation. In this case, rigorous measurement of the defect size cannot be achieved (the frontiers of the cluster being unclear).
- Large oxides: in three cases, large oxides are revealed on the fracture

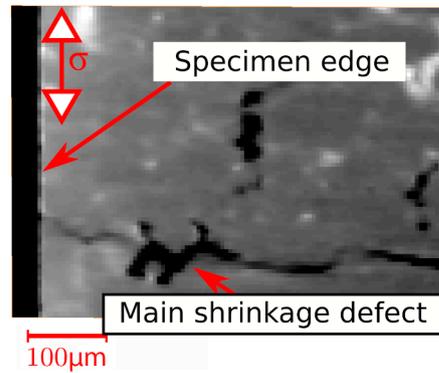
(b) Shrinkage defect identified by micro-tomography (specimen 130T5, $\Delta\varepsilon/2 = 0.3\%$, 150°C , $R_\varepsilon = -1$, $N_f = 2443$ cycles)

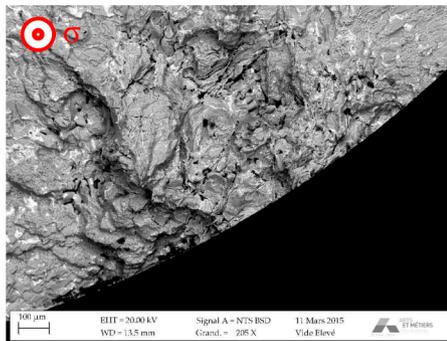
(c) SEM-BSE image of defect cluster (specimen 22T5, $\Delta\varepsilon/2 = 0.3\%$, 20°C , $R_\varepsilon = -1$, $N_f = 2689$ cycles)

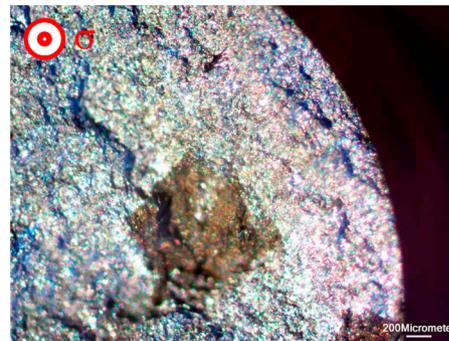
(d) Optical microscopy: large oxide (specimen 4T5, $\Delta\varepsilon/2 = 0.4\%$, 20°C , $R_\varepsilon = -1$, $N_f = 257$ cycles)

surface by optical microscopy (see Fig. 6(d)). No special test condition (imposed strain or temperature) reveals this type of initiation. These oxides are a consequence of the casting process (no oxide filter is used before casting, whereas these filters are present for real component casting). Therefore, these tests are not taken into account for the rest of this study.

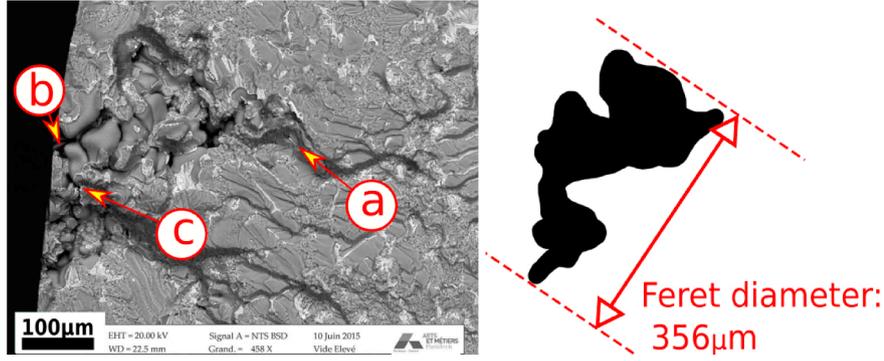
(a) Raw SEM image of initiating defect. (b) Manually binarized defect identification

(2D Feret diameter: 356 μm)

Fig. 7. Manual identification of defects. (specimen 87T5, $\Delta\epsilon/2 = \pm 0.30\%$, 20 °C, $R_\epsilon = -1$, $N_f = 2904$).

In order to systematically measure defects size, SEM images are manually binarized. Fig. 7 shows such an example of image processing. While more robust, automatized treatments are here unable to identify defects, hence a manual process is used.

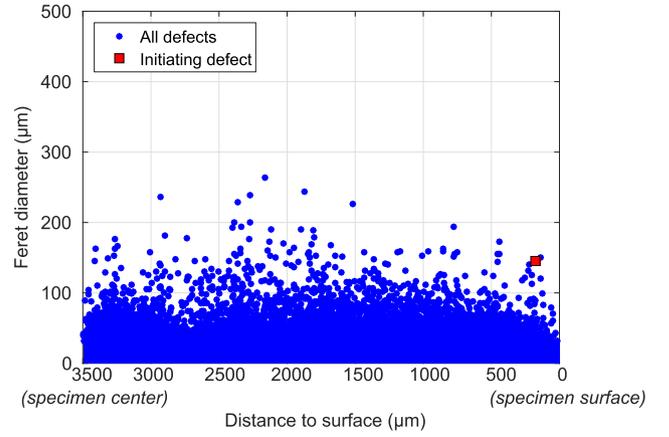
Fig. 8. Defect population of cycled specimens: the crack-initiating defect is not the largest in the whole volume (Specimen 130T5: $\Delta\epsilon/2 = \pm 0.3\%$, 150 °C, $R_\epsilon = -1$, $N_f = 2396$ cycles).

larger in size illustrating the fact that the defect size is not the critical parameter to identify the crack initiating defect: both size and defect location have to be considered.

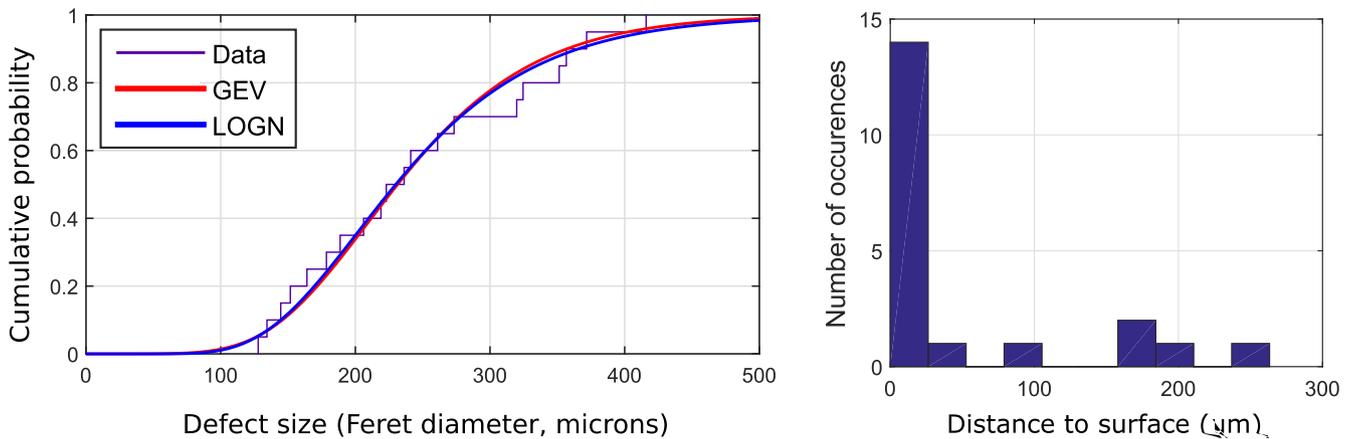
(a) Empirical distribution function of experimental sample (which appears as a step function) and cumulative distributions of defect size distributions fit (GEV: generalized extreme value distribution, LOGN: log-normal distribution)

(b) Histogram of critical defect distance to specimen surface: all defects are located very close to the surface, the center of the specimen is at 3500 μm .

Fig. 9. Distance of critical defects to the surface.

Despite those difficulties, the Feret diameter is here considered as representative of the defect size and measured for each crack initiating defect. For all defects both SE and BSE images were used to unambiguously identify defects limits. Feret diameters (for gas and shrinkage porosities) are between 127 and $415\ \mu\text{m}$ (see Table 4). The empirical cumulative defect size distribution is presented in Fig. 9a

The criticality of defect location is confirmed by observing fracture surfaces of all LCF tests. Histogram 9b shows distance to surface for identified defects (gas, shrinkage and cluster defects). 13 of the 20 initiation defects occur at or very close to specimen surface, and all are less than 260 μm from the specimen surface, confirming previous observation from tomography data: defect size and location (noticeably with respect to the free surface) combined analysis has to be done in order to assess the defect criticality.

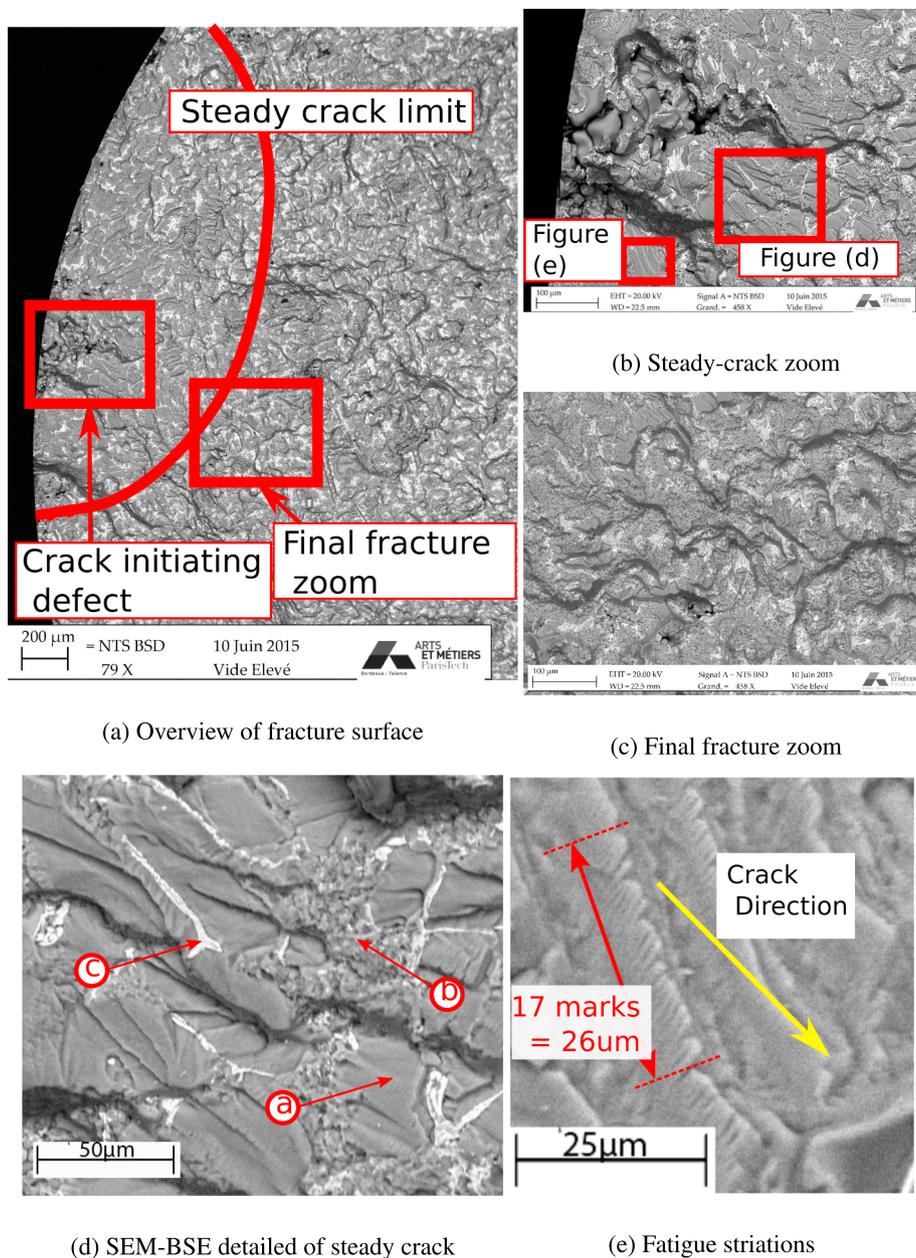
Fig. 10. Crack propagation fracture surface (Specimen 87T5: $\Delta\epsilon/2 = \pm 0.3\%$, $20\text{ }^\circ\text{C}$, $R_\epsilon = -1$, $N_f = 2904$ cycles).

Fatigue crack propagation features are detailed depending on crack propagation regime. Detailed mechanisms are illustrated on specimen 87T5 ($\Delta\epsilon/2 = \pm 0.3\%$). Firstly, Fig. 10a gives us an overview of the fracture surface by SEM.

The crack propagation can be separated in two or three main parts. *Crack initiation* (Fig. 10b). While unclear at higher temperatures, relatively lower temperature tests show a first propagation stage that can be differentiated from the subsequent steady-crack propagation. During this first crack initiation, several cracks develop along the regions of highest stress concentrations around large defects (as was seen in [14] or [19]). However, these regions of high stress concentration are not necessarily in the same horizontal plane (i.e. the plane

Steady-crack propagation (Fig. 10d). The initiating porosity defect appears on the left side, and large flat areas perpendicular to the loading direction appear, corresponding to mode I crack propagation. These can better be seen in Fig. 10d where 3 morphological features appear: label (a) corresponds to flat regions perpendicular to loading, corresponding to crack propagation in the aluminium dendrites; label (b) is typical of the propagation in the eutectic region; label (c) shows a sliced intermetallic. The propagation in the aluminium dendrites leads to the development of fatigue striations as is indicated in Fig. 10e, and confirms observations proposed in [20].

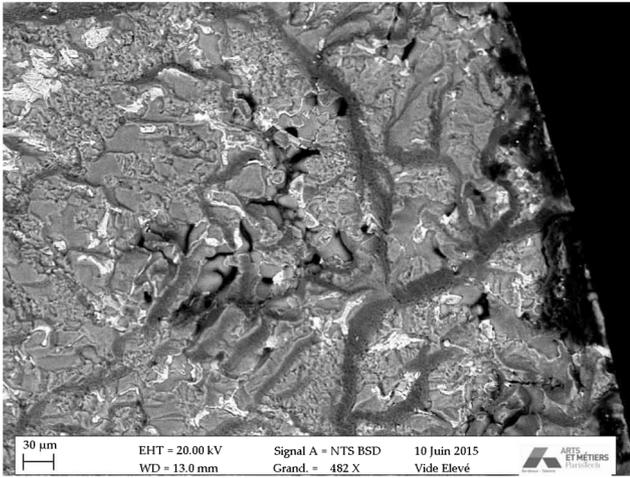
Fig. 11. SEM-BSE of fracture surface (Specimen 71T5: $\Delta\varepsilon/2 = \pm 0.3\%$, 200°C , $R_\varepsilon = -1$, $N_f = 2622$ cycles).

In comparison with Fig. 10d, which is on a specimen tested at 20 °C, Fig. 11 displays the steady-crack region for a higher test temperature (200 °C) with an identical imposed total strain amplitude ($\Delta\epsilon/2 = \pm 0.3\%$). A detailed observation shows the crack propagation occurs in pure mode I at ambient temperature: the crack path is only slightly modified by the microstructure. At higher temperature, as is observed in [21], more tear ridges appear on the fracture surface, these tear ridges occurring mostly in the eutectic regions. This shift in mechanisms could be attributed to the increased plasticity levels at the crack tip caused by the higher temperatures. Indeed, in front of the crack, strain incompatibility cause the brittle particles (such as eutectic silicon and intermetallics) to fracture. The crack path is then later modified and tends to propagate through these fractured particles (see [14]).

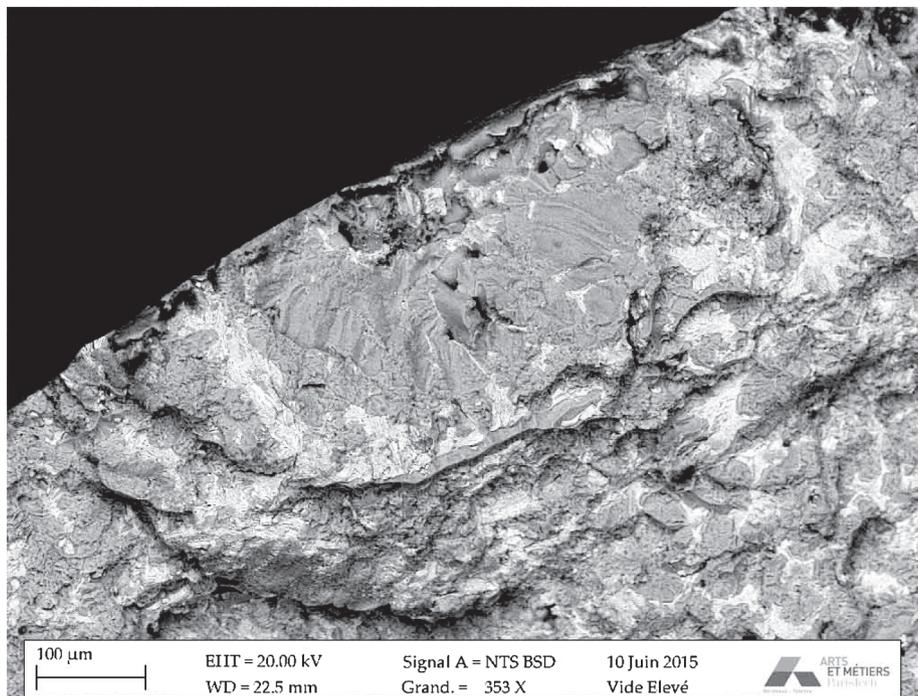
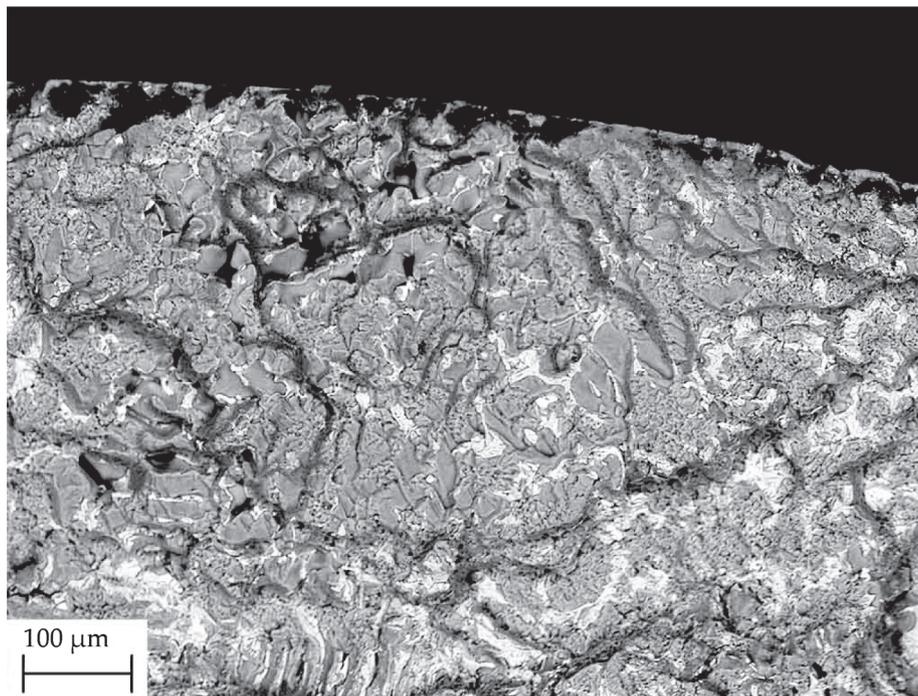
(a) SEM-BSE of fracture surface (Specimen 87T5: $\Delta\varepsilon/2 = \pm 0.3\%$, 20 °C, $R_\varepsilon = -1$, $N_f = 2904$ cycles)

(b) SEM-BSE of fracture surface (Specimen 71T5: $\Delta\varepsilon/2 = \pm 0.3\%$, 200 °C, $R_\varepsilon = -1$, $N_f = 2622$ cycles)

Fig. 12. Effect of temperature on steady-crack propagation at 20 °C and 200 °C: small cracks (note that both figures use the same scale).

The same comparison can be emphasized in Fig. 12 where two short fatigue cracks are illustrated. These fatigue cracks probably developed slower than the main crack, observed elsewhere, and show the first stages of crack propagation. The fatigue crack displayed in Fig. 12a, at ambient temperature, shows much more aluminium matrix than at higher temperature, where the fracture surface consists mostly of eutectic and intermetallic particles (as is shown in Fig. 12b). These observation suggest that the temperature significantly modifies the nature of the plastic deformation in the crack tip zone. It is also noteworthy despite the different mechanisms, the total fatigue life (N_f) only slightly decreases with temperature increase for identical imposed total strain.

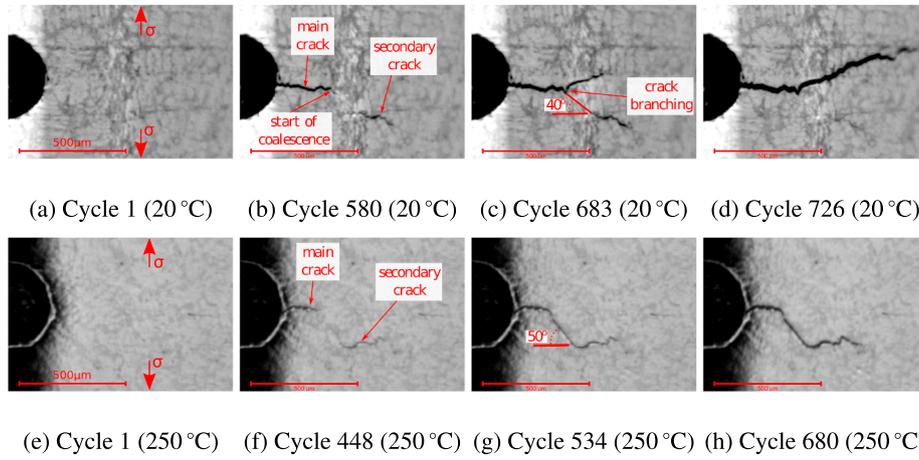
Fig. 13. Crack propagation monitoring. Figures (a)–(d): branching crack mechanism (Specimen 76T5: $\Delta\epsilon/2 = \pm 0.4\%$, 20 °C, $R_\epsilon = -1$, $N_f = 734$ cycles). Figures (e)–(h): coalescence crack mechanism (Specimen 89T5: $\Delta\epsilon/2 = \pm 0.4\%$, 250 °C, $R_\epsilon = -1$, $N_f = 701$ cycles).

In order to better show the temperature effect on the short crack propagation, surface observations were performed on short fatigue cracks initiated from artificial defects. Figs. 13a–d illustrates the case of crack propagation at ambient temperature (Specimen 76T5: $\Delta\epsilon/2 = \pm 0.4\%$, 20 °C, $R_\epsilon = -1$, $N_f = 734$) while Figs. 13e–h illustrates the high temperature case (Specimen 89T5: $\Delta\epsilon/2 = \pm 0.4\%$, 250 °C, $R_\epsilon = -1$, $N_f = 701$).

In both cases, secondary crack is observed ahead of the initial crack. For low temperature test, despite some localisation of the deformation

between the two fatigue cracks, the initial crack does not coalesce with the secondary one and propagates through the aluminium matrix resulting in a rather flat fracture surface. The final images (such as is seen in Fig. 13d) clearly indicate that, later in the test, the secondary crack closes due to the stress shielding effect induced by the main crack propagation. In the case of high temperature tests however, the artificial defect induced fatigue crack quickly coalesce with the secondary crack through a mode II transition (see Fig. 13c). For the high temperature test, two reasons may explain the different observed mechanisms. Firstly, a significant change in the cyclic plastic zone at the crack tip that could induce a larger interaction range with secondary cracking. Similar crack tip interactions and strain localization at high temperature can be seen in [19]. In addition, this localization may be favoured by a shift in plastic deformation mechanisms with higher temperature: Al-Si-Cu alloys (high-stacking fault energy) are known to exhibit dynamic softening mechanisms, such as dynamic recovery during deformation at elevated temperatures. Cyclic plastic deformation ahead the crack tip may trigger such softening mechanisms and

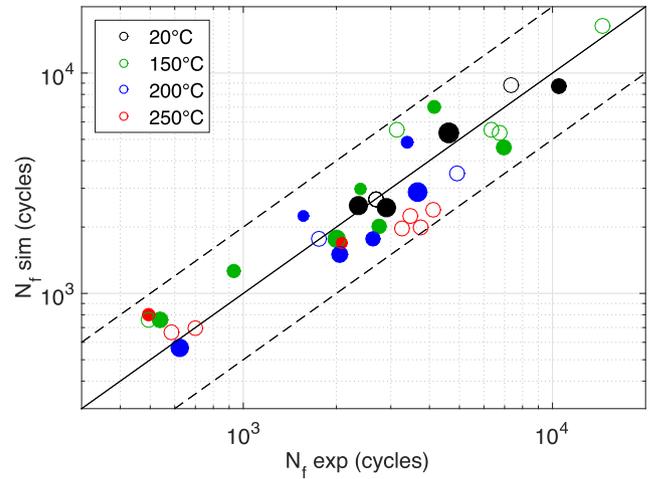
Fig. 15. Numerically predicted fatigue life as a function as experimentally measured for all specimens. Marker area is proportional to Feret diameter, the marker in the legend corresponding to 100 μm . Full markers are used for model identification while empty ones are used for validation for unmeasured defects.

The results are presented in Fig. 15 (empty markers). The model provides good fatigue life estimations for all the temperatures and imposed strains. However, for the highest temperature (250°C), the model does not seem to capture the propagation kinetic and mechanism. This could be caused by the shift in propagation mechanism, with the increased plasticity effect, and the lack of measured defects. Indeed, only 2/8 specimens initiating defects are identified at this temperature, causing them to have small impact on the optimized parameters.

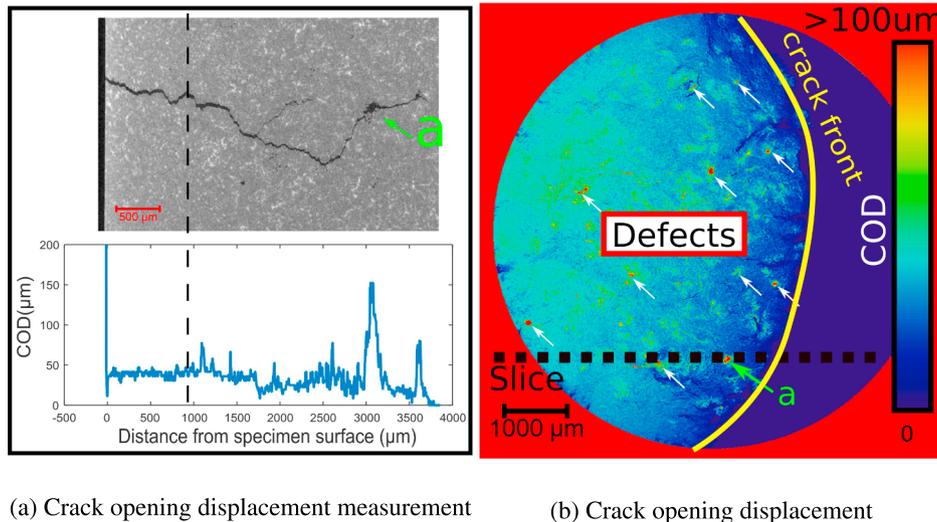
Fig. 14. Crack opening displacement and defect interaction. (specimen 62T5, $\Delta\epsilon/2 = \pm 0.3\%$, 250 °C, $R_\epsilon = -1$, $N_f = 2089$ cycles).

By analysing a specimen interrupted before final failure by tomography, defect interaction with crack can be seen in Fig. 14 for a high temperature test. The method applied is similar to that in [22]: the crack is thresholded and the crack opening displacement (COD) measured by counting the number of voxels belonging to the crack per vertical line l and converting using voxel resolution (see Fig. 14a). It must be noted the opening displacement is measured after testing, implying the specimen is not under tensile loading. In presence of defects, the measured displacement is the sum of COD and defect height, causing defects to appear red¹ on the map. Several defects can be seen for all crack advances. Especially, for the latter stages of crack propagation, defects influence the crack path at larger scales (≈ 1 mm). This can be seen on the slice (see Fig. 14a) which displays a defect (label (a) in Fig. 14) that strongly influences the crack path.

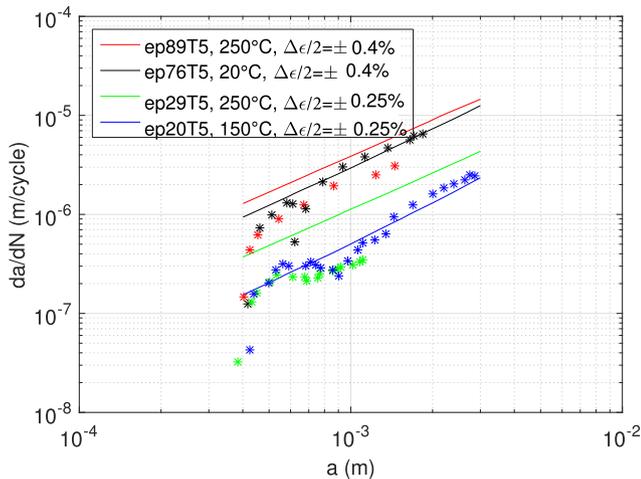
Fig. 16. Experimental (markers) and model (lines) crack propagation rates versus crack length.

Lastly, the results of the crack propagation monitoring experiments are compared to the model. Results are presented in Fig. 16. As is

observed previously, high temperature (250 °C) crack propagation rate is overestimated by the model for two specimens (89T5 and 29T5), but it still captures the right order of magnitude and appears to be conservative, making the model suitable for design purposes. For the two

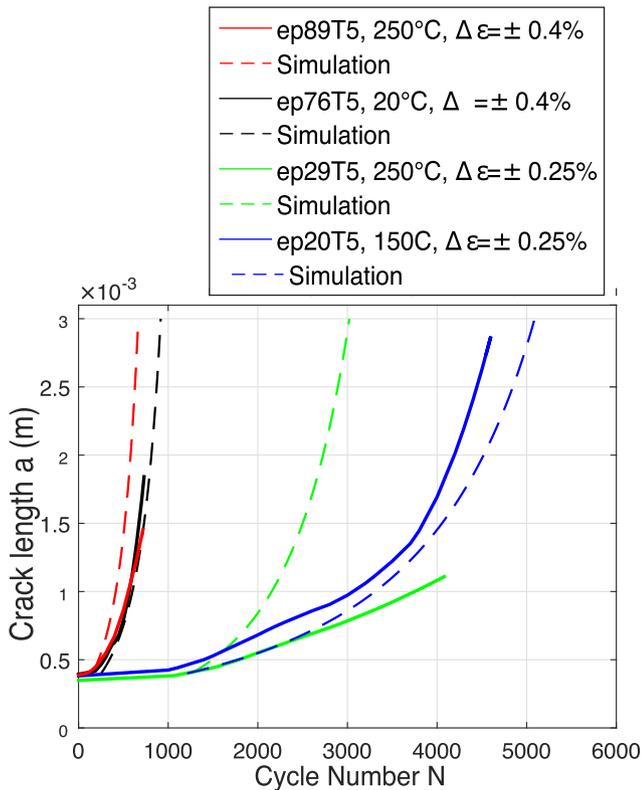
Fig. 17. Experimental (full line) and simulated (dashed line) crack length as a function of the number of cycles.

Crack length simulation is shown in Fig. 17. The initial defect length is taken as the measured hemispherical defect diameter (around 400 μm). The crack propagation model does not take into account the initiation period, and the experimental measured values of cycles to initiation (N_{init}) are therefore used for both simulated and experimental crack propagation data (i.e. the simulated crack propagation only starts at (N_{init}) in Fig. 17). The simulated crack length are in good agreement with the observed data except for the high-temperature (250 °C) low strain ($\Delta\epsilon/2 = \pm 0.25\%$) experiment, which still remains conservative.
