Maxime SAGNARD, Romain ECAULT, Laurent BERTHE, Kay BRUNE - Development of the symmetrical laser shock test for weak bond inspection - Optics and Laser Technology - Vol. 111, p.644-652 - 2019

Full length article

Development of the symmetrical laser shock test for weak bond inspection

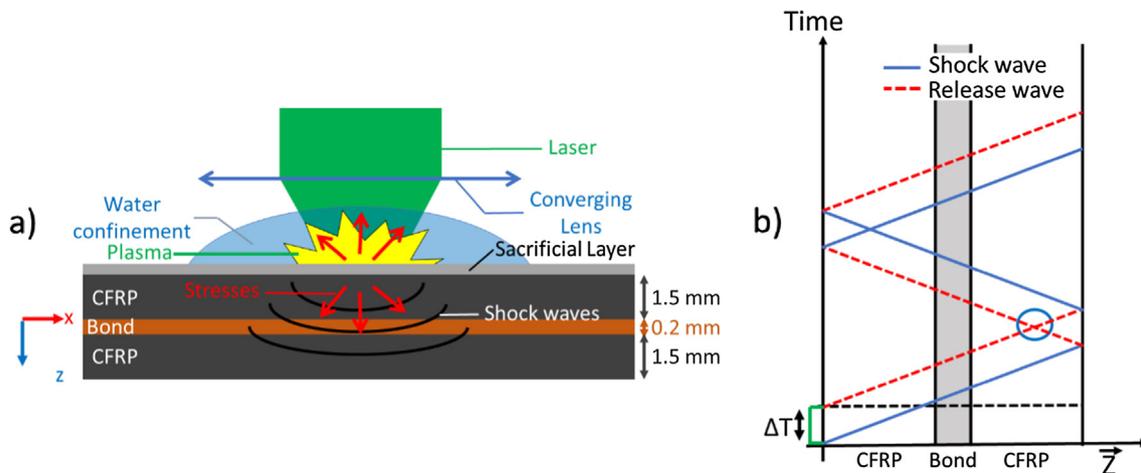
Fig. 1. (a) Representation of a typical LASAT experimental setup and (b) Space-time diagram of a single shot LASAT.

The space/time diagram Fig. 1(b) describes the shock wave's

behaviour within the material. The front of the shock wave is represented using solid lines. The release wave, that sets the material back to its initial state, is represented using dotted lines. The shock wave travels all the way to the back-face of the sample and turns into a release wave. Upon crossing the initial release wave, the reflected shock wave generates a high tensile stress (full circle). For a given material, the position of this high tensile stress simply depends on the shock duration which is defined by the laser's pulse duration ΔT .

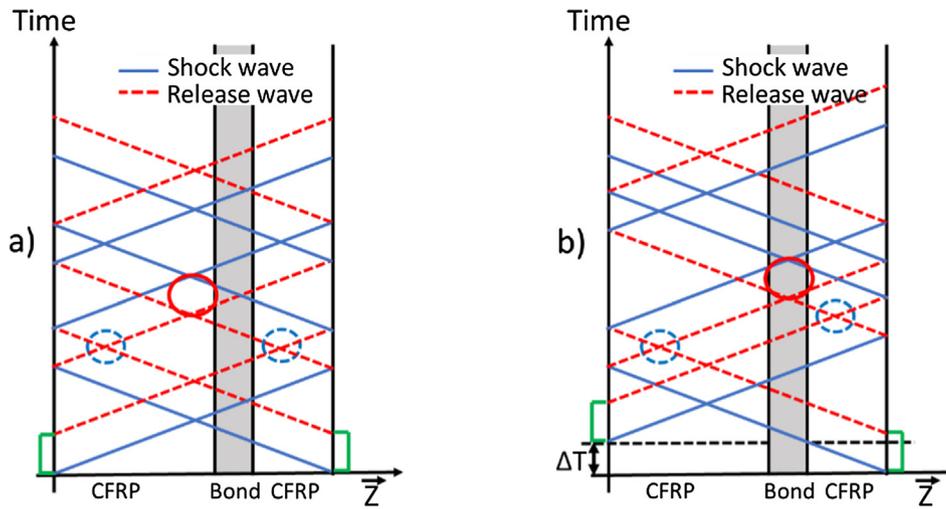
Fig. 2. Time/space diagram of S-LASAT shots: (a) without time delay and (b) with a time delay.

The Symmetrical LAsER Shock Adhesion Test (S-LASAT [19,20]) is proposed to overcome this limitation. This technique consists of generating shock waves from both sides of the tested specimen. As for the single shot setup, high tensile areas are generated on each opposite side of the sample (dotted circles in Fig. 2(a)). However, a higher tensile stress is created at the intersection of the two reflected shock waves (solid circle) and its location does not exclusively rely on the pulse duration.

The high tensile stress location can be shifted by applying a time delay between each laser pulse (Fig. 2(b)). The required time delay can be calculated using Eq. (1):

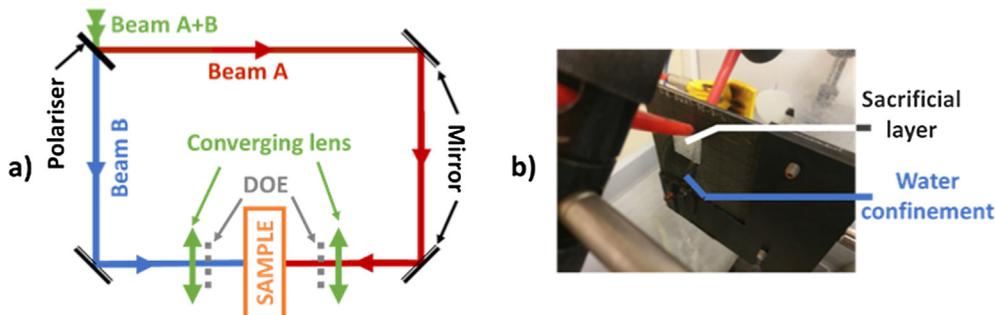
Fig. 3. (a) Schema of the experimental setup. (b) Close up on the sample setup.

A Nd:Yag laser is used to generate a pulse of 7 ns which can deliver up to $2 \times 7 \text{ J}$. To create a symmetrical shot, the Gaïa laser used on the Hephaïstos platform is composed of two lasers which beams are polarised by 90° from one another. Thanks to a polariser, two distinct beams, referred to as Beam A and Beam B, are created and transported through optics to both sides of the tested sample (Fig. 3(a)).

Prior to the shot, the tested area was protected using an aluminium adhesive tape, and the zone was confined using a water trickle to make sure at least 1 mm of water covered the sample during the test (Fig. 3(b)).

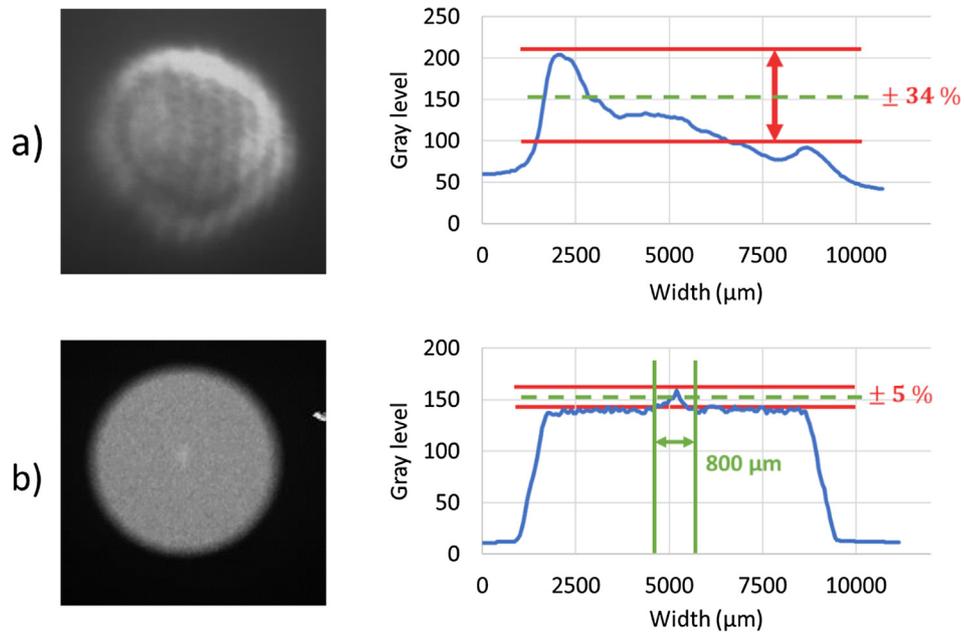
Fig. 4. Spatial repartition of the laser intensity on beam A (a) before DOE were included in the experimental setup and (b) after DOE were included in the experimental setup.

Compared to the last work [13], Diffractive Optical Elements (DOE) were added on both beam paths. This optics makes for a better control of the spatial repartition of the pressure on top of the sample. These serve to break down the initial laser beam, and reform it to assure a good homogeneity of the laser at the focal spot. Fig. 4(a) shows the laser repartition, at the focal spot, with and without DOE. One can a wide important intensity variation before the DOE ($\pm 34\%$ compared to the mean value). Moreover, this variation occurred over the whole spot area. After these optics were included in the experimental setup, a much smoother repartition can be observed (Fig. 4(b)), very close from a top-hat signal, with only a small and very localised intensity variation.

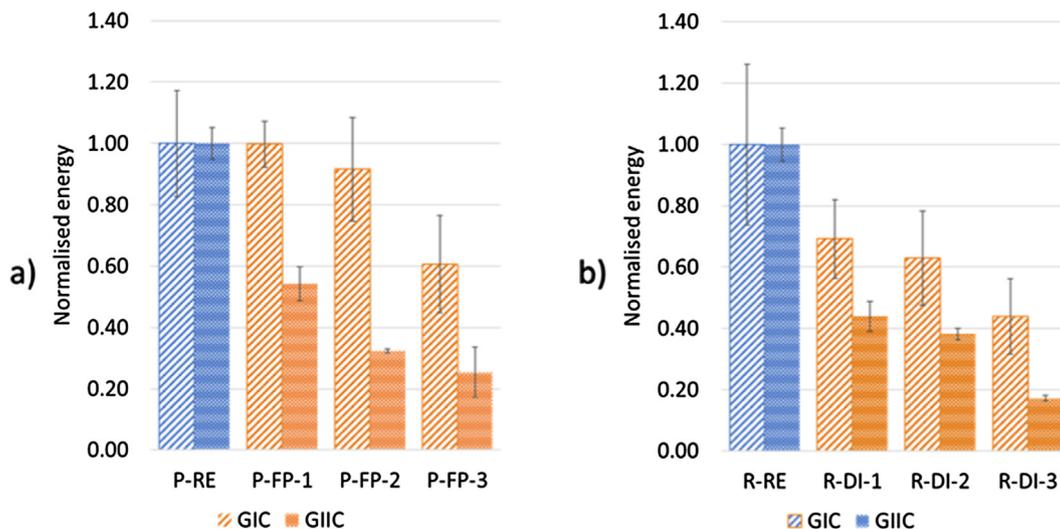
Fig. 5. Mechanical tests for: (a) the production reference sample (P-RE) and the three levels of finger print contamination, low (P-FP-1), medium (P-FP-2) and high (P-FP-3) – (b) the repair reference sample (R-RE) and the three levels of de-icing fluid contamination, low (R-DI-1), medium (R-DI-2) and high (R-DI-3) [22,23].

Fig. 5(a) summarizes the mechanical test results obtained for the production reference, P-RE, sample (blue) and the finger print contamination (orange), and Fig. 5(b) for the repair reference, R-RE, sample (blue) and de-icer contamination (orange). To ease later

comparison with the LASAT, all values have been normalised by the reference sample value. Hence the de-icer results have been normalised using the sound repair sample threshold, and the finger print one by the reference production sample.

Both the GIC and GIIC tests show a general decrease of the bond strength after the contamination. However, because the range of GIC tests' uncertainty bars for a sound and a contaminated sample were overlapping, no direct conclusion could be drawn out. GIIC tests were more consistent and confirmed the loss of adherence/mechanical strength of the contaminated samples.

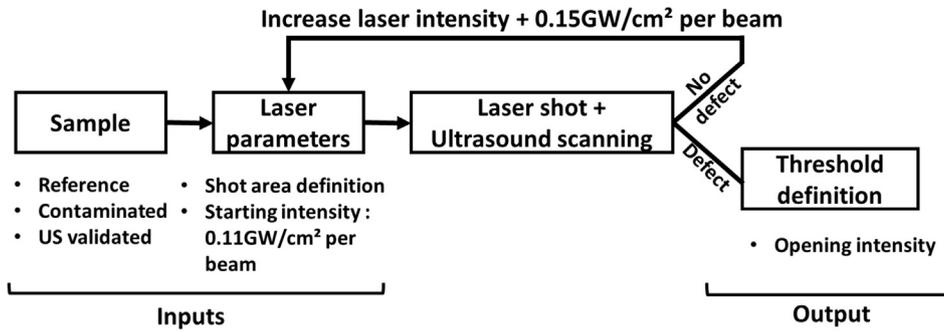
Fig. 6. Block scheme of the experimental procedure.

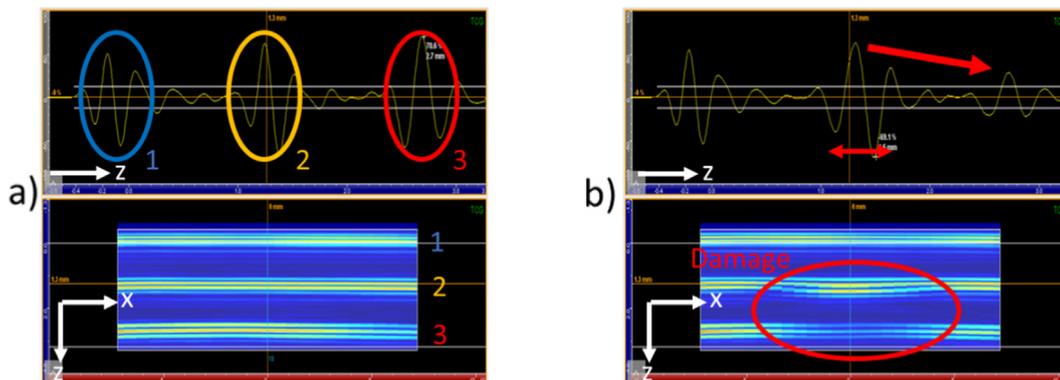
Fig. 7. A-Scan and B-Scan of the bonded CFRP assembly: (a) no damage (b) with damage.

For ultrasonic testing, a 32 elements linear probe was used, with a frequency of 5 MHz. CFRPs act as a low-pass filter, limiting the probe scanning frequency. The sample is composed of three different layers: a CFRP laminate, the adhesive bond, and the second CFRP laminate. Each one of these layers has a specific material impedance that is detected by ultrasounds. Fig. 7(a) is a typical signal obtained for a sound sample. The upper signal is a A-Scan. It is a 1D local measurement and each spike (marked 1, 2 and 3) is due to an impedance modification in the scanned part. In this case, 1 is the signal obtained when the ultrasonic wave first encounters the sample, 2 is the signature signal of the adhesive bond, and 3 is the signal obtained when ultrasounds reach the back of the sample. The lower image, called B-Scan, is a 2D cross-section cartography of the sample.

Ultrasounds cannot go through empty area, typically here disbondings. The signal is blocked, and little to no information is available after the opening. With A-Scan, it can be spotted by a loss of amplitude of one of the echoes. For example, the A-Scan from Fig. 7(b) shows a loss of signal from the back-face echo (3) as well as a widening of the bond echo. The B-Scan confirms the damage location on the bond, and thus, the occultation of the signal below it. Each time the sample was scanned from both sides to assure no defaults were hidden by the damaged bond.

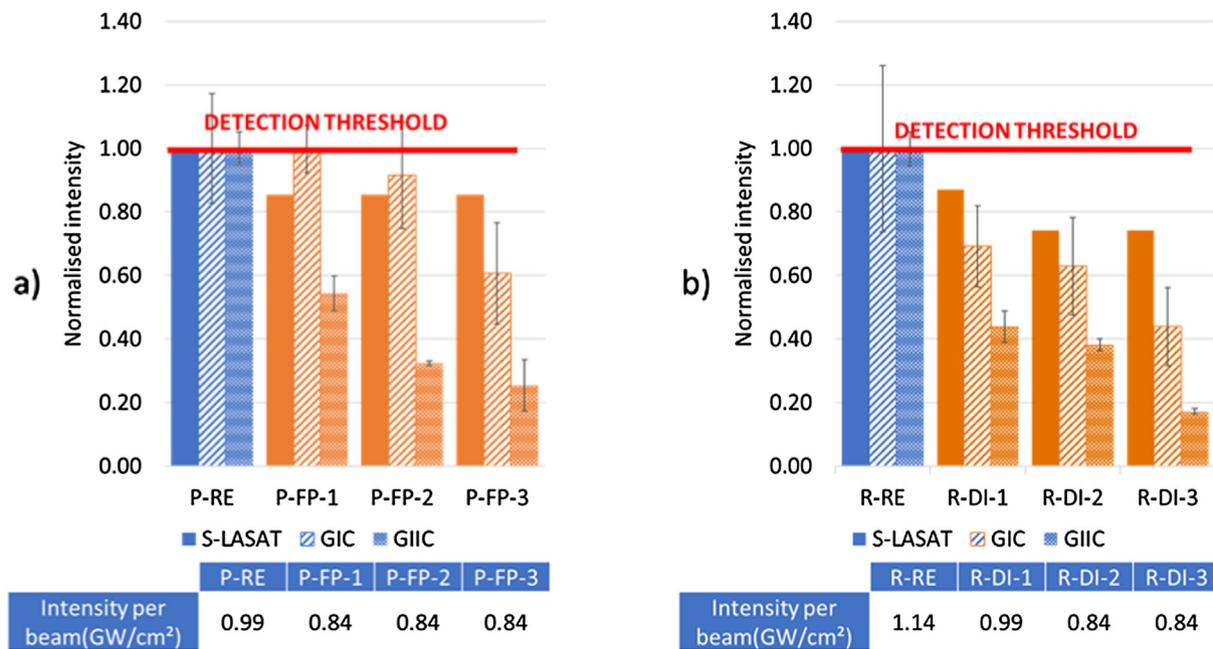
Fig. 8. Normalised results comparison between S-LASAT and the mechanical tests for: (a) the production reference sample (P-RE) and the three levels of finger print contamination, low (P-FP-1), medium (P-FP-2) and high (P-FP-3) – (b) the repair reference sample (R-RE) and the three levels of de-icing fluid.

Results for the finger print and the di-icer contaminations are presented in Fig. 8. To confirm the ability of the S-LASAT to spot a specific contamination, the measured energy required to open the faulty bond must be lower than the one obtained for the reference sample. Since data has been normalised, a contamination correctly isolated must be below the 1.0 mark (represented by the red line entitled “detection threshold” in Fig. 8).

As the GIC and GIIC test showed, the contamination of the sample modified the adherence strength of the sample. The S-LASAT showed the same results: a contaminated bond requires less laser intensity loading to be opened than a healthy one. The same observation was made for both contaminations.

In the case of the finger print sample, the technique did not differentiate the three levels of contamination. However, unlike standard mechanical tests that apply a constant load increase, the LASAT was performed using a load step, limiting the results’ accuracy. A smaller intensity step size could give more precise results. However, even with

such intervals, the technique was able to differentiate the second and third level of the de-icer contamination.

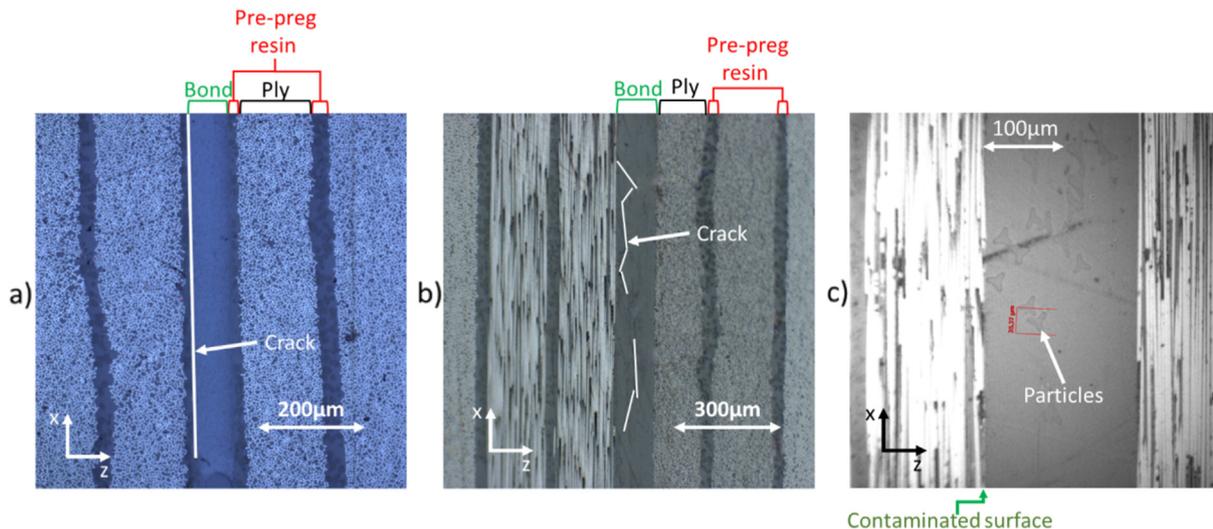
Fig. 9. Photomicrographs of the bond after damage created by S-LASAT: (a) production reference sample [13], (b) repair reference sample [13], and (c) highest degree of de-icing fluid contamination.

Important differences have been spotted however when comparing the damage patterns of the repair and production reference samples. In the production reference sample, the disbonding seemed to propagate mainly between the epoxy from the pre-impregnated CRFP and the

bond (Fig. 9(a)). However, cracks appeared primarily in the centre of the bond for a repair sample (Fig. 9(b)). The difference of bonding surfaces (CFRP fibres vs epoxy) could explain this variance as well as the presence of the knit carrier within the production bond.

Following the same study process, micrographs were realised on both sets of contaminated samples. The damage inside the FP contaminated samples was similar to the one observed before: creation of a disbonding between the epoxy from the pre-impregnated CFRP and the bond. However, no clear crack pattern was found for DI samples, instead microcracks were observed. This type of defect is harder to detect using linear ultrasounds and may not be spotted in the case of a lower contamination. A closer study of the specimen also revealed particles probably from the Safeway KF (Fig. 9(c)).

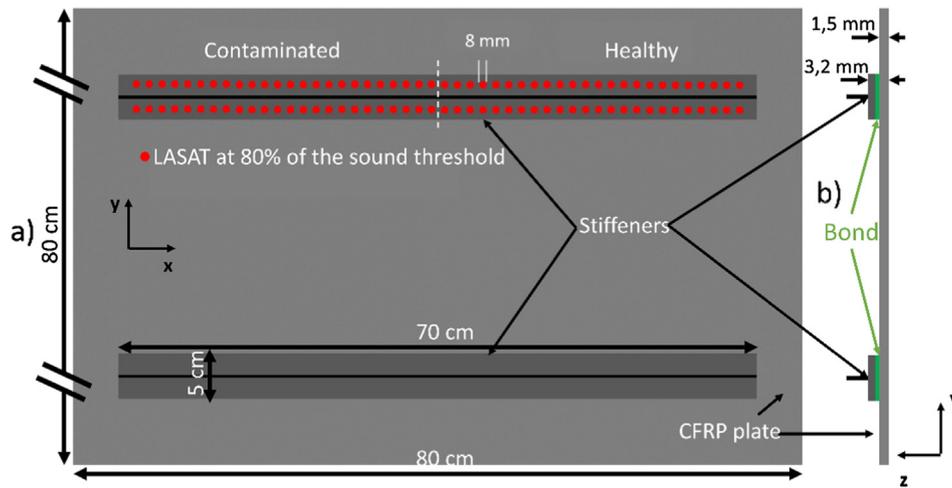
Fig. 10. Production panel: (a) front view with laser shot position and (b) side view with specified thicknesses.

A350 panels have been produced/recovered to test the technique using real parts. The production sample is an $800 \times 800 \times 1.5$ mm CFRP plate on which two $700 \times 50 \times 1.7$ CFRP stiffeners were bonded (Fig. 10). The plate is made of 14 prepreg layers with the following lay-up: $[+45/90/0/90/+45/0/90]_s$. On one half, the stiffeners have been bonded without contamination, and on the other half of the plate both the de-icing fluid and the finger print solution have been applied on the stiffeners' surface before the bond. The goal will be to assess the quality of the bond holding the stiffeners to the CFRP plate. Only the upper stiffener has been tested.

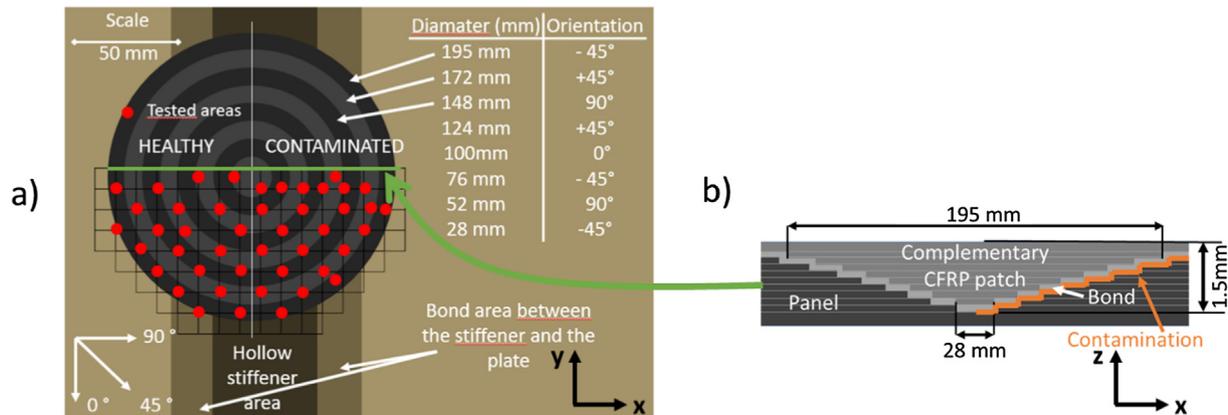
Fig. 11. (a) figure of the shot pattern realised on the repair panel and (b) cross-section of the repair patch geometry.

The repair panel has been cut out of a A350 structure. The middle part of the sample has been grinded all the way to the fibres in a conic shape. Half of the surface was contaminated with both finger print and de-icing fluid solutions (Fig. 11(b)). The hole created in the panel was then patched, starting from the centre to the edge, with the missing CFRP ring (cf. Fig. 11(b)) while keeping the original lay-up of the part (ring diameter and orientation in Fig. 11(a)). The composite was then cured by GMI's tool ANITA EZ0901 hot bonder.

This part had hollow stiffeners on one side, making it impossible to test in this area using a symmetrical shot configuration. It is represented by the dark bar on Fig. 11(a): the darker section is the hollow part and the lighter sections on either side show the areas where the stiffener is assembled onto the panel. Thus, there is a total of three different areas on the patch. The first one only features the repair patch. The S-LASAT

can be applied normally (Fig. 11(b)). The second area above the hollow part was tested using the single shot setup since only one face was available. The third one features both the patch and the zone where the stiffeners have been bonded. These areas then have two bonds: the first one between the plate and the stiffener, and a second one between the plate and the repair patch. S-LASAT can be used, but the extra thickness coming from the stiffeners must be considered.

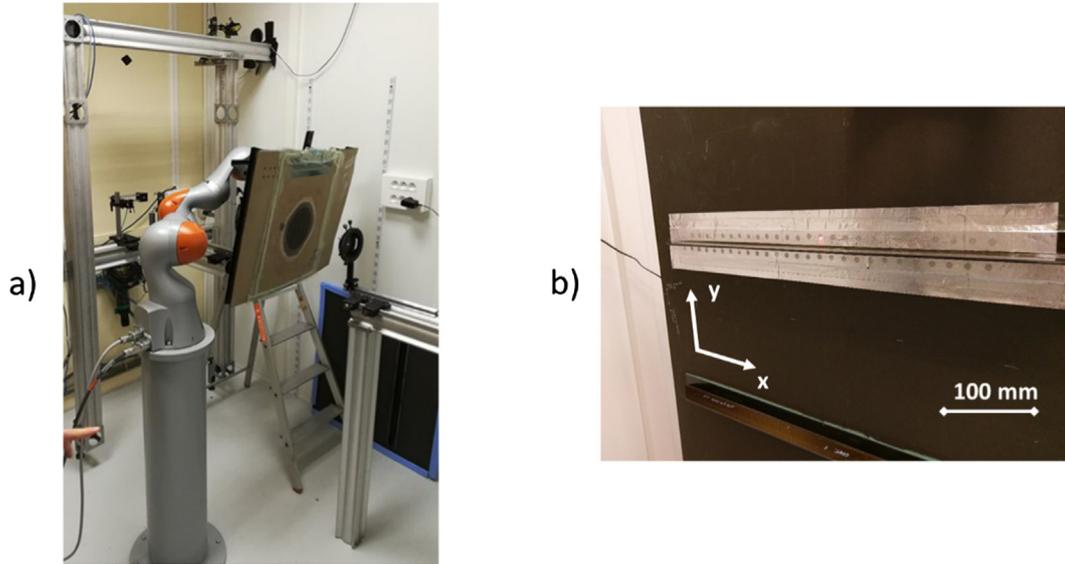
Fig. 12. (a) New experimental setup with the repair panel placed on the robot and (b) one of the stiffener of the production panel after laser shots.

They are covered by the transparent confinement tape. The “dots” are areas that have been test using S-LASAT. This panel is ready to undergo a full ultrasonic scan to find the opened areas.

These parts were too big to fit into the initial experimental setup. A robot has been installed to move the piece around, and the optics had to be rearranged (Fig. 12(a)). The water confinement was not feasible either. Instead, a solid constraining material in the form of a thick transparent adhesive layer was used. Its confinement capabilities are comparable to the water in the intensity range $0-3 \text{ GW/cm}^2$. Tests on the coupon sample have also validated this choice. The sacrificial layer is the same as before. Fig. 12(b) is a picture of the production panel. Two bands of sacrificial aluminium tape were placed on the stiffener.
