Bassem BARKIA, Thierry AUGER, Jean Louis COUROUAU, Julie BOURGON - Wetting by liquid sodium and fracture path analysis of sodium induced embrittlement of 304L stainless steel - Journal of Materials Research - Vol. 33, n°2, p.121-129 - 2018

Wetting by liquid sodium and fracture path analysis of sodium induced embrittlement of 304L stainless steel

The wettability of the 304L steel is an important parameter in Liquid Metal Embrittlement studies. Empirically, it is found to be greatly enhanced by pre-exposure to oxygenated liquid sodium. The corrosion interface formed during exposure to sodium has been analyzed at the nanoscale by transmission electron microscopy using the focused ion beam sampling. A thin layer of sodium chromite (Na_xCrO_2 with $x \leq 1$) is detected at the interface validating wetting on an oxide mechanism for the enhanced wetting after pre-exposure. Fracture micromechanisms and the crack path of liquid sodium-embrittled austenitic steel 304L at 573 K have been investigated down to the nanoscale. High-resolution orientation mapping analyses immediately below the fracture surface show that abundant martensitic transformations ($\gamma \rightarrow \alpha$) and twin

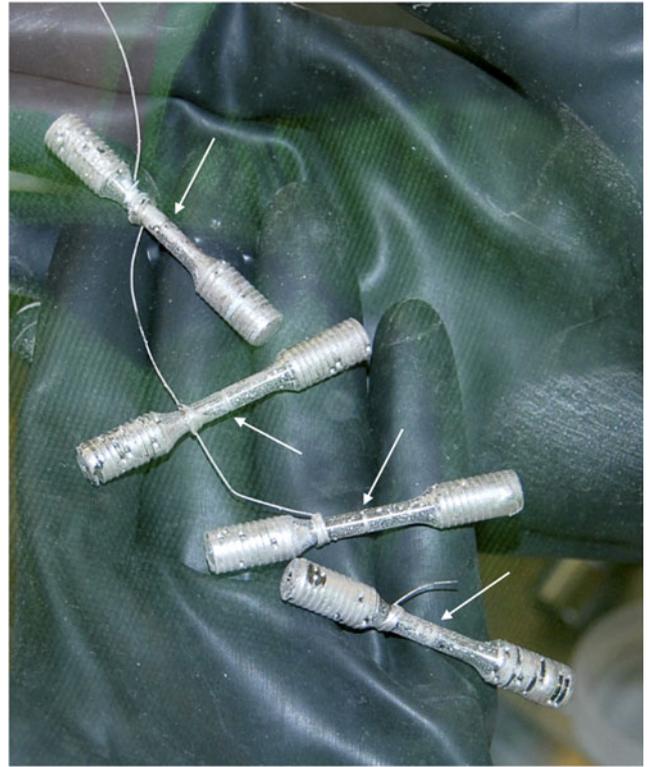
FIG. 1. Image of sodium wetted specimens extracted from the sodium bath after 250 h pre-exposure at 550 $^\circ\text{C}$ (sodium wetted notches indicated by arrows).

The initial surface of the mechanical test specimen was in the state left by machining i.e., a bright and shiny surface. After exposure to liquid sodium for 250 h at 550 $^\circ\text{C}$ with 200 $\mu\text{g/g}$ dissolved oxygen, the surface had a dark aspect indicating that either roughness had developed on the surface or that a compound had formed (sodium was removed by a few minutes immersion in ethanol). The SEM analysis of the surface of the exposed sample is shown in Fig. 2. One can see a continuous coverage of the surface by small crystallites that formed during the immersion in liquid sodium. Therefore, a clear change in the surface phase composition induced by pre-exposure had occurred. Grazing angle X-ray analysis was carried out but did not allow identification of the phase forming this very thin layer.

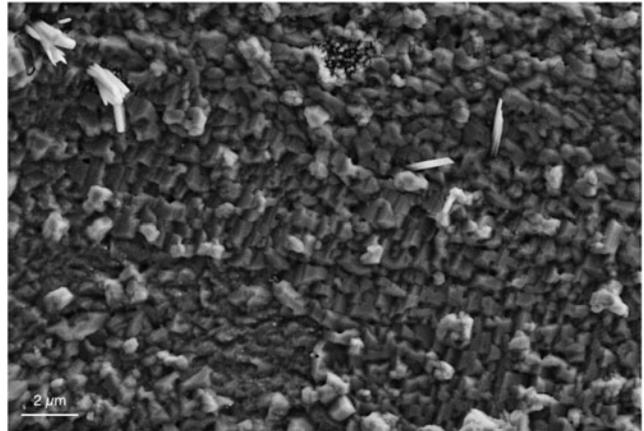
FIG. 2. SEM images of the 304L surface after pre-exposure.

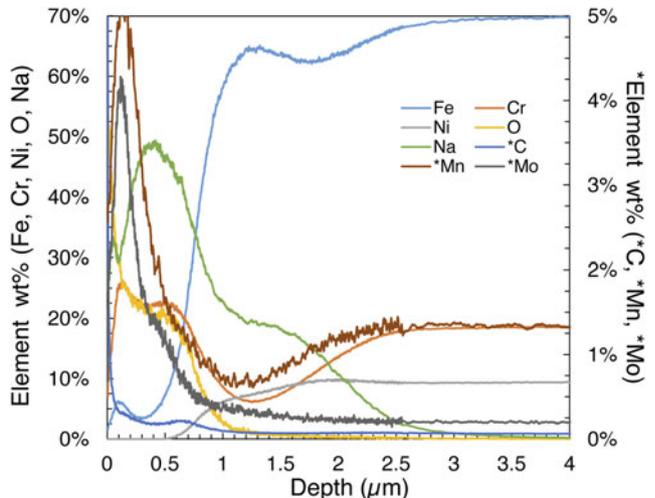
FIG. 3. GD-OES profile of sodium-exposed 304L's surface.

surface (at the left side of the graph), one notices a drop in the steel's iron and nickel constituents correlated with a plateau in chromium, oxygen, and sodium. Other minor elements (carbon and molybdenum) have a peak concentration at the extreme surface potentially indicative of mass transfer between the liquid, the molybdenum crucible, and the steel during pre-exposure. The increase in manganese could be explained by the formation of NaMnO_2 since it is possible at a high temperature above 80 wppm oxygen.³ One notices a secondary peak for sodium between 1 and 1.5 μm depth.

The GD-OES profile carried out on the flat plate introduced with the samples is shown in Fig. 3. At the

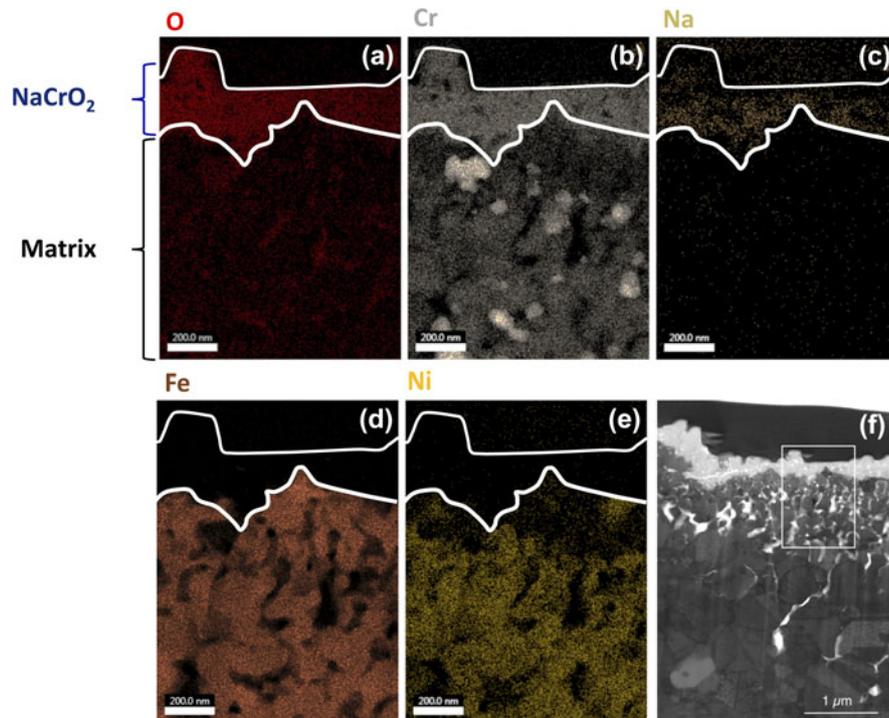
The nanoscale-resolved chemical mapping performed on the TEM lift out is shown in Fig. 4. It indicates that a layer composed mainly of sodium, chromium, and oxygen elements is clearly separated from the underlying matrix elements (iron, chromium, and nickel). The thickness of that layer is of the order of one hundred nm, and the steel/oxide interface is rough. One can note as well that chromium-rich particles formed below the outer NaCrO_2 . This constitutes an unambiguous evidence of the formation of a continuous layer of this phase over a short-term exposure time in oxygenated sodium. This is the key to explain the role of dissolved oxygen on the wettability of sodium over 304L's steel.

Immediately, underneath this oxide layer, a Cr-depleted zone is found which is certainly caused by the oxidation reaction. The TEM bright field (BF) image of the interface is shown in Fig. 4(f). This corrosion zone presents intergranular pores that are clearly seen on the

FIG. 4. (a–e) EDX mapping of main elements (f) TEM BF micrograph of the area (the rectangle indicates the area of EDX mapping).

TEM foil. These porosities were probably filled with liquid sodium so that it explains the secondary sodium peak on the GD-OES profile. The preferential dissolution of iron along the grain boundaries could be the result of the formation of soluble Na_4FeO_3 .

The interface is constituted of small grains of a few hundred nm with holes in between at over a depth of several μm . The microstructure at the surface therefore evolved remarkably from a large grain size to small grains in the machining-affected area. This finding bears similitude with the early finding of Moberly et al. of intergranular precipitates forming during the contact with liquid sodium in the 304L steel.⁸ The corroded area below the oxide layer is then porous and not protective. One can note that this constitutes a posteriori justification for taking the reference measurement from a batch of sodium-exposed samples since the corrosion-affected area develops some voids that weaken the surface layer.

Early on, it was shown that the 304L steel interacted with sodium by the formation of an intergranular phase.⁸ Here, it is found that the first few microns of the corroded layer develop some porosity and Cr-rich precipitates (see BF TEM image in Fig. 4). This might also be an ingredient favoring early crack initiation. Within a wetted crack, the capillary flow of sodium induced by good wetting is then the key to supply liquid sodium at the crack tip at the earliest stage of LME in a self-maintained process. Once started, a crack is filled and will remain filled as it propagates.

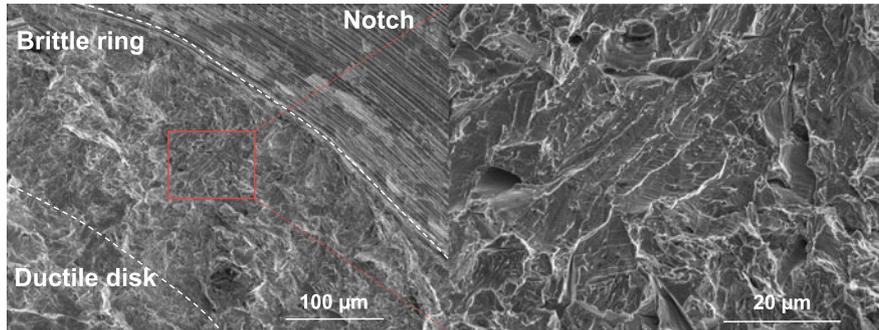
The SEM analysis of the fracture surface is shown in Fig. 5. A brittle ring of 200–300 μm starting at the notch is visible, while the final fracture formed a ductile central ring. Therefore, the fracture surface has a mixed brittle/ductile character that can be explained by the strain rate acceleration at the center during final cracking. A higher magnification view of the fracture surface in the brittle area reveals that some clear intergranular cracks occurred, but the majority of the fracture surface is covered with

FIG. 5. Fracture surface analysis after tensile test in sodium at 573 K for 304L.

a quasi-cleavage type fracture surface and numerous step ridges. This is the type of fracture surface that we aimed at investigating further.

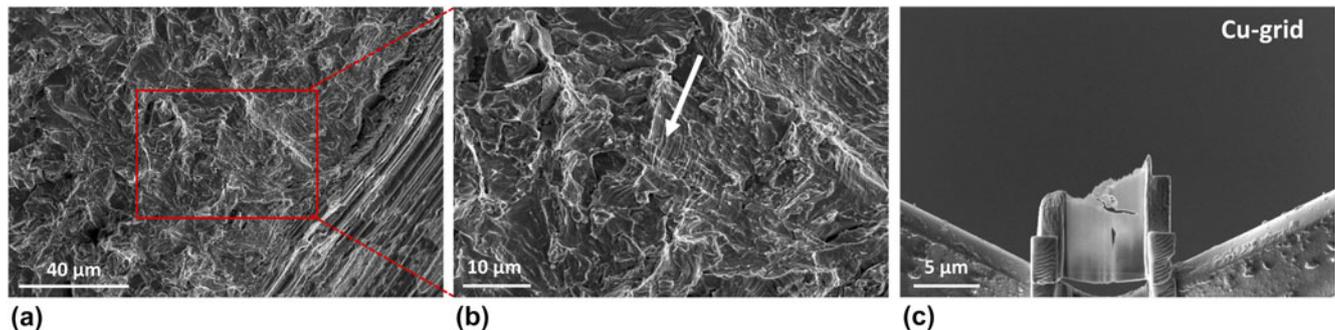
The standard lift out procedure is applied here on carefully selected areas of the fracture surface. The sites were chosen to allow for a potential analysis of the microstructure lying underneath specific features of the fracture surface. The TEM foil 1 was extracted to look for an explanation of the numerous step ridges that are seen on the fracture surface. Arrested cracks were also looked for to analyze the crack path by preserving its crack tip. It was selected looking for cracks seemingly going in the material's bulk that might have a chance to be short cracks fully captured within the thinned area of the TEM lamella. Such a case is presented here in the TEM foil 2. Figure 6 shows the fracture surface from the FIB preparation of that TEM lamella.

FIG. 6. Steps of TEM thin foil 2 preparation using FIB: (a, b) choice of the site of interest (arrow) (c) transfer of the thin foil to the Cu-grid and thinning.

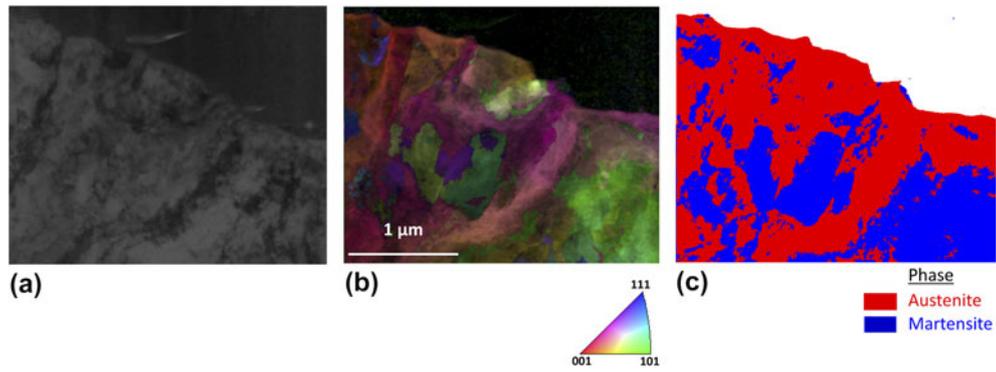
The microstructures indexed by the ACOM-TEM tool of foil 1 and foil 2 are shown in Figs. 7 and 8. The thin foil 1 analysis detected numerous areas with α' (bcc) phase transition underneath the fracture surface [Fig. 7(c)]. At the same time, twinning and grain refinement was induced by plastic deformation prior to cracking creating a wealth of newly formed interfaces. One can note the clear correlation between the presence of step ridges at the fracture surface [top part of the orientation map in Fig. 7(b)] and large abrupt orientation

changes just below the surface ridges. This indicates that the step ridges visible on the fracture surface are a legacy of the deformed microstructure lying below. Indeed, the ridges are correlated with newly formed large grains transverse misorientations or eventually mechanical twin boundaries.

FIG. 7. Microstructure beneath the fracture surface in thin foil 1: (a) TEM BF micrograph (b, c) corresponding orientation map superposed with image quality (IQ) with respect to the normal direction and phase mapping.

Firstly, the 304L steel microstructure is heavily deformed with a large amount of α' phase transformed material. Twinning at the microscale is also observed right below the fracture surface. These processes created a microstructural refinement with a large increase in the density of sub-grain boundaries. The step ridges structure is correlated with a large underlying orientation change (subgrains or twin boundaries) and is the trace of the interplay of twinning or phase transform and fracture.

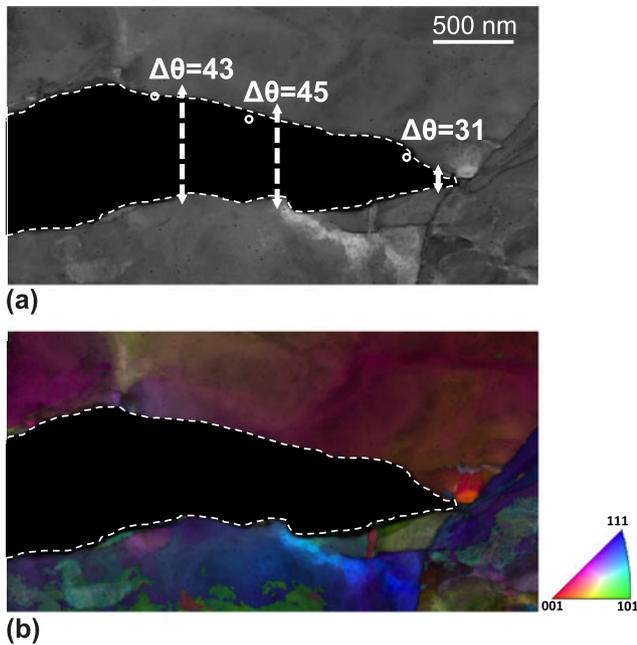
An arrested crack was captured in the TEM foil 2 and subsequently indexed (see Fig. 8). The crack has an opening angle of roughly 20° . The crack is clearly intergranular in the γ matrix and was stopped at an interface (a twin boundary) that was slanted toward the presumed vertical loading axis (therefore not oriented favorably for crack propagation). Several measurements of the misorientation across the cracked interface show that the interface belongs to the general type, the one with a misorientation higher than 15° (not corrected for the crack opening angle). The rapid variation of orientations above and below the cracked interface also indicates highly inhomogeneous plastic deformation. The crack stopped at a twin boundary oriented diagonally but did not go further by a cleavage process. The crack path in this case is fully γ/γ interfacial.

FIG. 8. Microstructure beneath the fracture surface in thin foil 2: (a) The TEM BF micrograph and (b) The corresponding orientation map superposed with IQ with respect to the normal direction (the detected phase is entirely austenitic).

Secondly, the arrested crack of foil 2 shows a typical case of γ/γ interfacial fracture. The underlying microstructure is extremely complex with numerous twins and subgrain boundaries. The fracture surface in the analyzed area was typical of the quasi-cleavage-like fracture area. We can infer that a large part of the crack propagation proceeds as an interfacial fracture.
