Yessine AYED, Guénaël GERMAIN - High-pressure water-jet-assisted machining of Ti555-3 titanium alloy: investigation of tool wear mechanisms - International Journal of Advanced Manufacturing Technology - Vol. 96, n°1-4, p.845-856 - 2018

# High-pressure water-jet-assisted machining of Ti555-3 titanium alloy: investigation of tool wear mechanisms

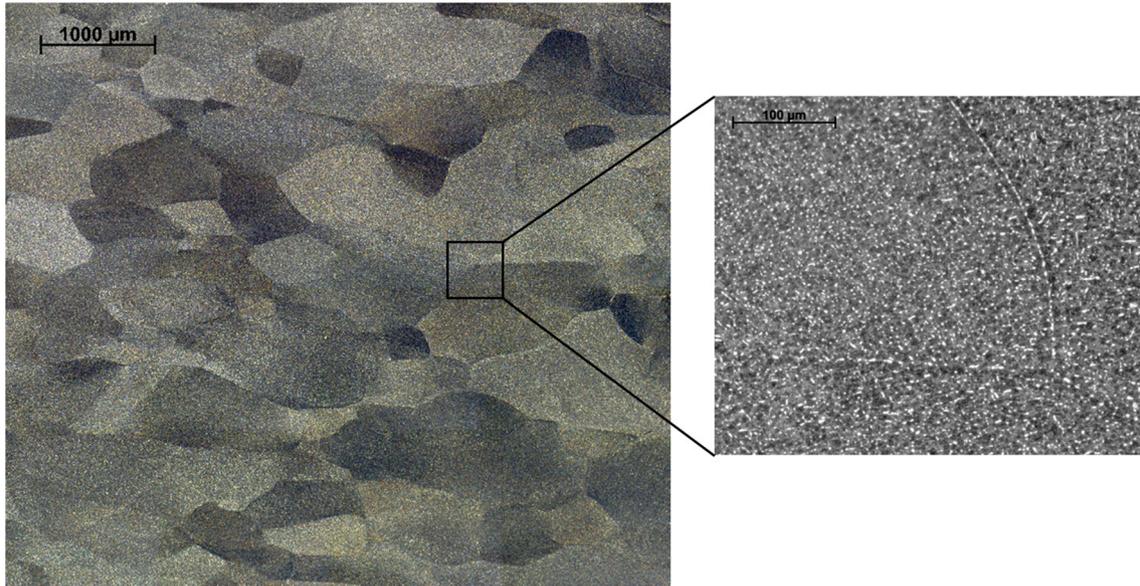
Fig. 1 Microstructure of the Ti555-3 alloy

The Ti555-3 near-beta titanium alloy was selected for this study. It has improved mechanical properties compared to the Ti-10V-2Fe-3Al alloy and is mainly intended for landing gear and other aeronautical structural components. It also has high hardenability, high fracture toughness and a good strength to weight ratio [28, 29]. The microstructure of the as-delivered material, etched with Kroll's reagent, is shown in Fig. 1. It displays a two-phase microstructure: lamellar and globular  $\alpha$  phase within the  $\beta$  matrix.

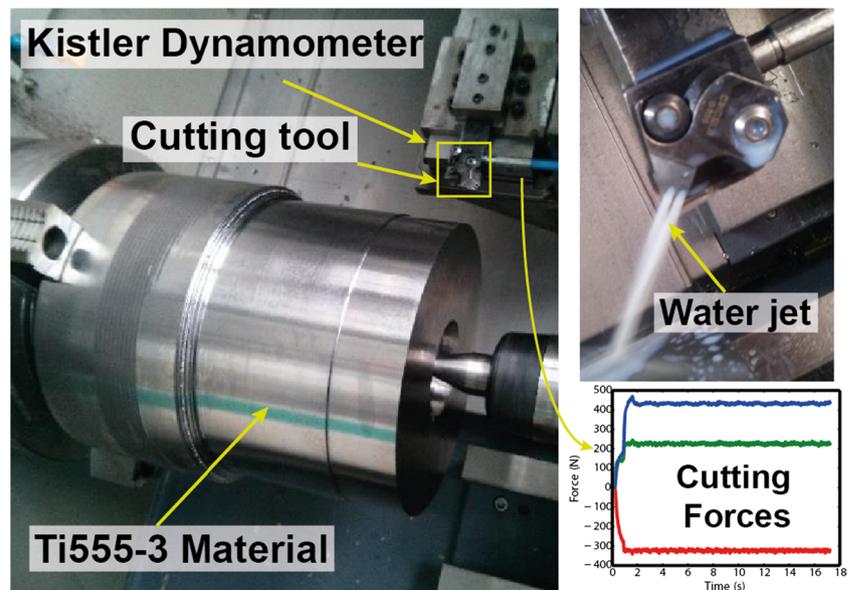
Fig. 2 Experimental setup

Longitudinal turning tests have been carried out on Leadwell LTC25iL CNC turning lathe supplying a maximum power of 24 kW. Based on the recommendations from previous studies [5] and due to the high chemical reactivity of titanium alloys, uncoated tungsten carbide inserts (ISO designation CNMG 12 04 12-23 H13A) have been used. An emulsion-based cutting fluid (5% concentration) has been used for the conventional lubrication tests and HPWJA tests at 100 bar (15 l/min) and 250 bar (26 l/min). Instrumented experiments have been carried out to track and to analyse tool wear evolution. A Kistler dynamometer (9257B) has been used to measure the evolution of the cutting forces. Flank wear has been measured using a stereo microscope on the basis of the standard ISO3685. The tool wear rejection criterion used is  $VB = 0.3$  mm ( $VB$  represents the average flank wear). For a more comprehensive investigation of the tool wear mechanisms, a SEM and a 3D profilometer have been used. Figure 2 illustrates the experimental procedure.

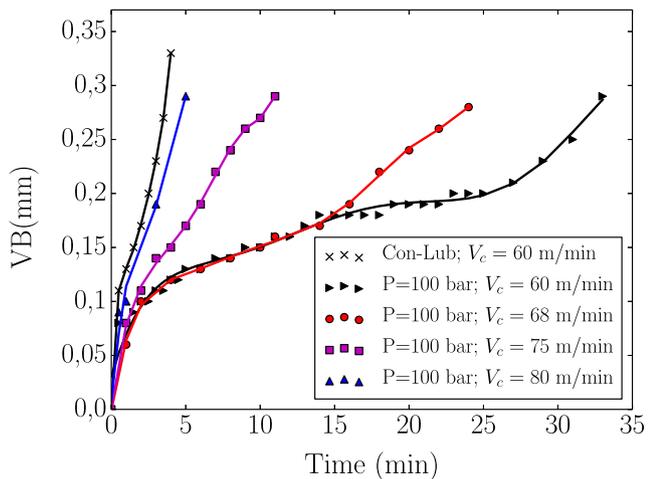
**Fig. 3** Influence of the cutting speed and the high-pressure water-jet assistance on tool life ( $a_p = 1.5$  mm,  $f = 0.1$  mm/rev)

Figure 3 demonstrates that the cutting speed could be further increased to 75 m/min while maintaining an acceptable tool life of up to 11 min. Beyond this speed, HPWJA is no longer efficient. The acceleration of wear as a consequence of an increase in cutting speed is mainly related to the activation of different tool wear mechanisms. During the cutting process, heat is generated in the cutting zone due to plastic deformation and friction. The amount of heat generated is increased by an increase in the cutting speed. As reported by Moura et al. [10],

at the cutting edge, the temperature may reach 1000 °C. Hence, the high temperature levels accelerate diffusion and adhesion (plucking mechanism) [10]. In the case of HPWJA, the lubricant jet insures good cooling of the cutting zone, thereby slowing tool wear evolution. However, the progressive increase of the cutting speed leads to a rapid temperature increase that the lubricant jet cannot evacuate quickly. This finally leads to a reduction of the HPWJA efficiency (80 m/min).

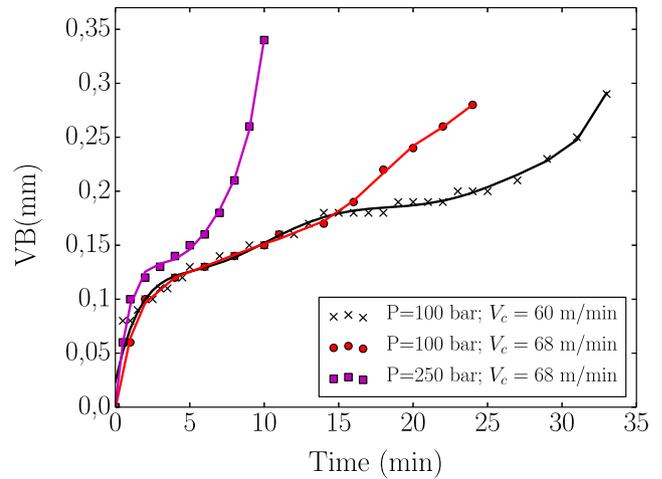
**Fig. 4** Influence of the cutting speed and coolant pressure on tool life ( $a_p = 1.5$  mm,  $f = 0.1$  mm/rev)

This part of the study has been achieved by a comparative analysis of the impact of the lubricant-jet pressure on tool life. Figure 4 illustrates the evolution of the tool wear curves. It shows that a pressure increase causes a considerable decrease in tool life.

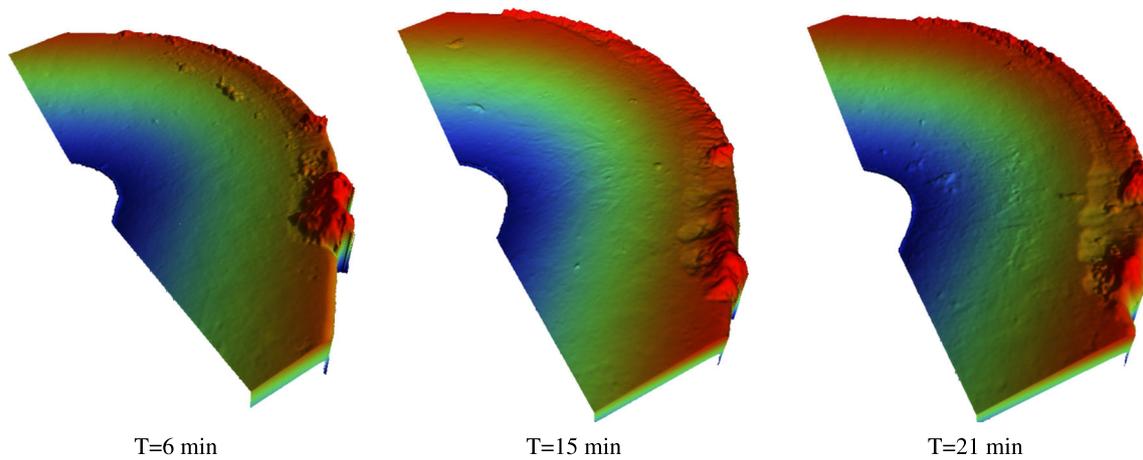
Fig. 5 Tool wear evolution ( $P = 100$  bar)

For both cases, observations of the tool using a stereo microscope revealed the formation of a crater at the cutting face. To get more information about tool wear evolution and mechanisms, cutting tools have been analysed using a 3D profilometer and a SEM. Figures 5 and 6 show different stages of crater formation.

For a pressure of 100 bar, tool wear evolves gradually and crater wear takes place only after 15 min of machining. However, for a pressure of 250 bar, excessive tool wear

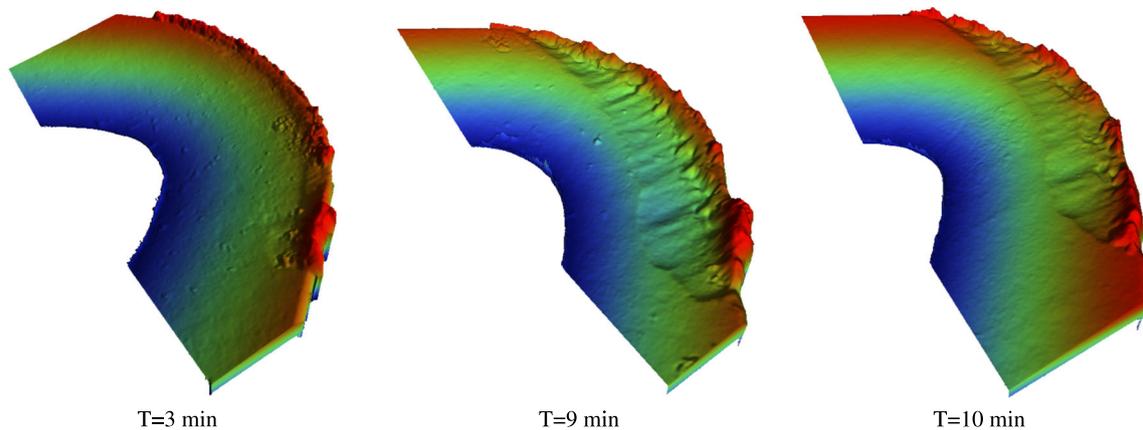
Fig. 6 Tool wear evolution ( $P = 250$  bar)

is seen, notably at the level of the tool rake face. The crater becomes larger and deeper as shows by Fig. 7. The progressive formation of the crater weakens the cutting tool. Hence, machining up to 10 min has caused the cutting edge to break and substantial material chipping.

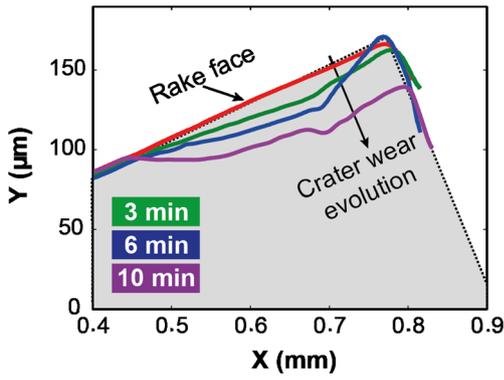
Fig. 7 Crater wear evolution ( $P = 250$  bar)

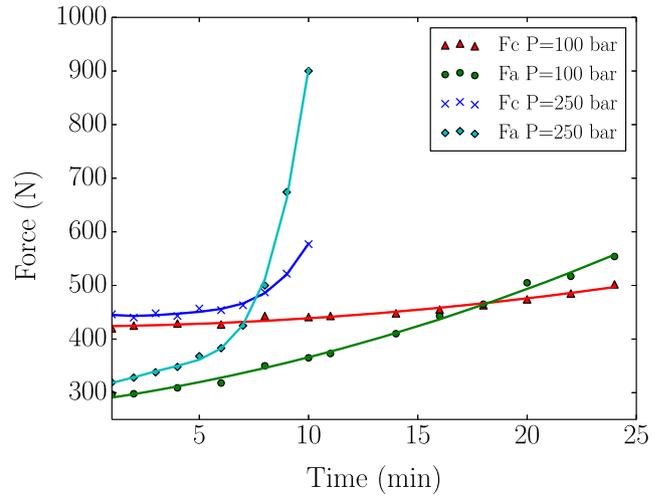
Fig. 10 Evolution of the cutting forces

The evolution of the mean arithmetic (average value) cutting force and the axial force ( $F_c$ ,  $F_a$ ) during machining is presented in Fig. 10. It can be seen that for 100 bar, the cutting force evolves gradually. However, for 250 bar, a sharp and rapid evolution can be observed. This could be linked to flank wear, crater wear and material chipping at the cutting edge which causes a local change of the tool geometry, cutting angles and contact length.

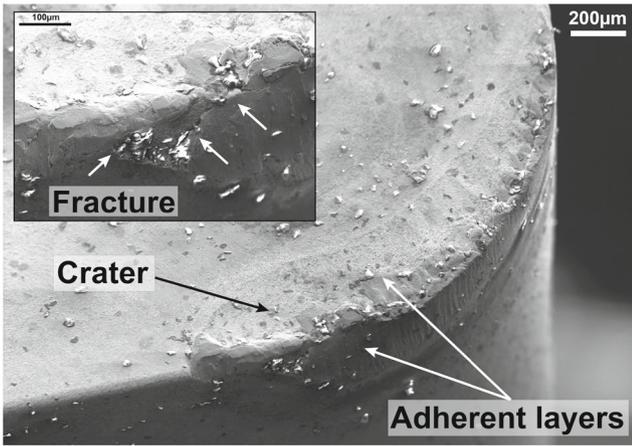
Fig. 8 SEM observation of tool wear ( $P = 250$  bar,  $T = 9$  min)

The SEM observations, illustrated in Fig. 8, show the existence of adherent layers on the tool rake and flank faces. The parallel scratches on the tool flank face are a sign of abrasion wear. Micro-cracks have also been detected and they are mainly due the combination of tool stiffness degradation and high cutting forces.

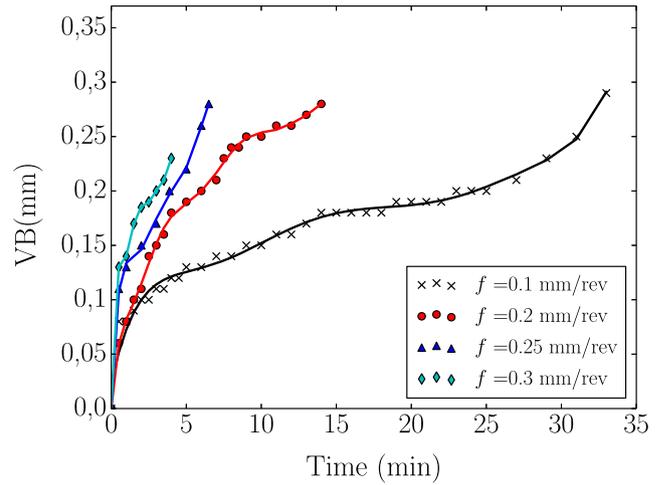
Fig. 11 Feed rate influence ( $a_p = 1.5$  mm,  $V_c = 60$  m/min,  $P = 100$  bar)

At a cutting speed of 60 m/min and a pressure of 100 bar, the feed rate has been varied from 0.1 to 0.3 mm/rev. The experimental results are plotted in Fig. 11. It shows a sharp decrease in tool life (at least 50%); tool life does not exceed 4 min at 0.3 mm/rev. Also, for high feed rates, a large notch occurs and weakens the tool insert. In this context, it is necessary to point out that under these conditions and with conventional lubrication, machining of the Ti555-3 alloy is almost impossible (only 5 min at 0.1 mm/rev). Machining is accompanied by high temperature generation and smoke that ends by the collapse of the cutting edge after a few seconds.

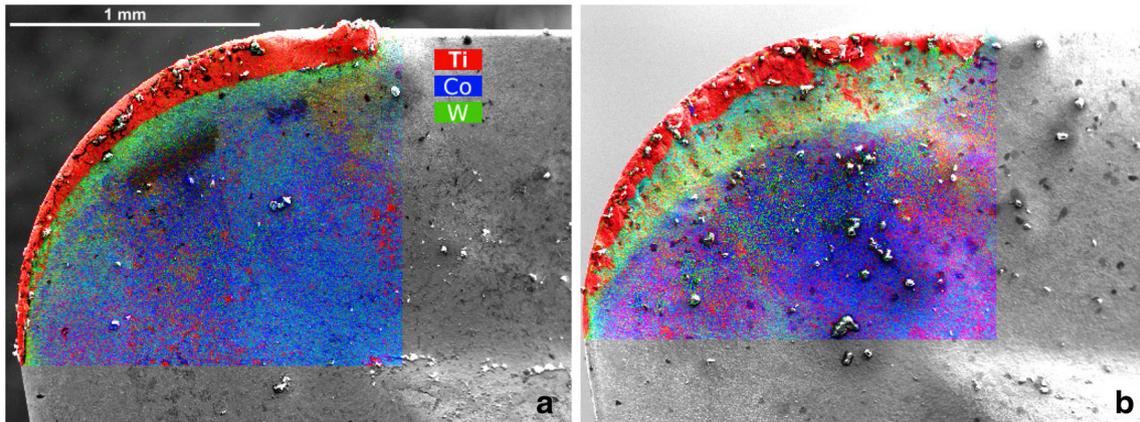
Fig. 9 SEM observation of tool wear: **a** Conventional lubrication,  $T = 4$  min; **b**  $P = 250$  bar,  $T = 9$  min

An EDS examination of the adherent layers has confirmed the activation of an adhesion mechanism by the detection of titanium on the tool rake face as illustrated by Fig. 9. For the case of conventional machining, titanium deposits are uniformly distributed along the contact area. However, for the case of high-pressure water-jet assistance, the amount of these deposits has been greatly reduced which is mainly due to the reduction of the tool/chip contact length.

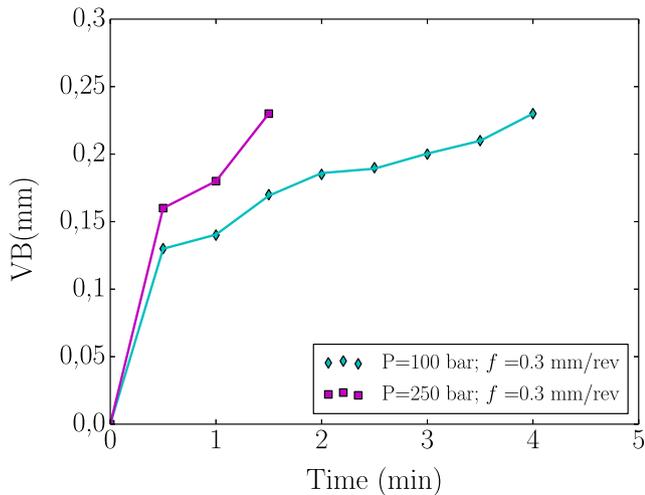
**Fig. 12** Feed rate and pressure influence ( $a_p = 1.5$  mm,  $V_c = 60$  m/min)

Figure 12 emphasizes the influence of the water-jet pressure at 100 bar and 250 bar. Tests have been stopped at  $VB = 0.23$  mm to preserve the highly damaged cutting edge for further analysis. As well as the last tests, the increase of pressure leads to a more degradation of the tool.

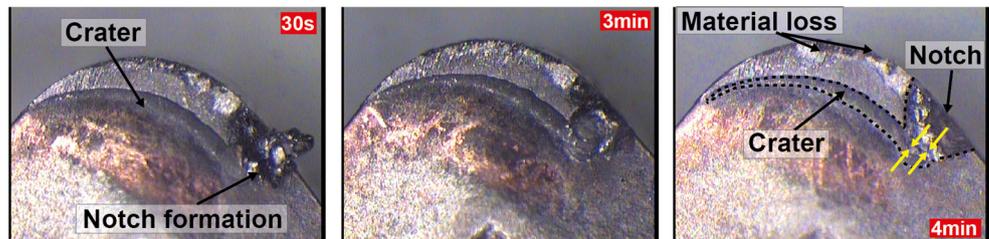
**Fig. 13** Observation of tool wear evolution on the tool rake face ( $a_p = 1.5$  mm,  $f = 0.3$  mm/rev,  $V_c = 60$  m/min,  $P = 100$  bar)

Monitoring of tool wear evolution using a stereo microscope is illustrated in Fig. 13. It shows that after only 30 s, severe wear has taken place. A notch and a crater have been formed; material chipping has been observed on

the cutting edge. Over time, tool wear evolves rapidly; the notch becomes larger and reaches the crater. At this point, the tool tip becomes very fragile and it could collapse under the action of the increasing cutting forces, even if the flank wear remains stable.

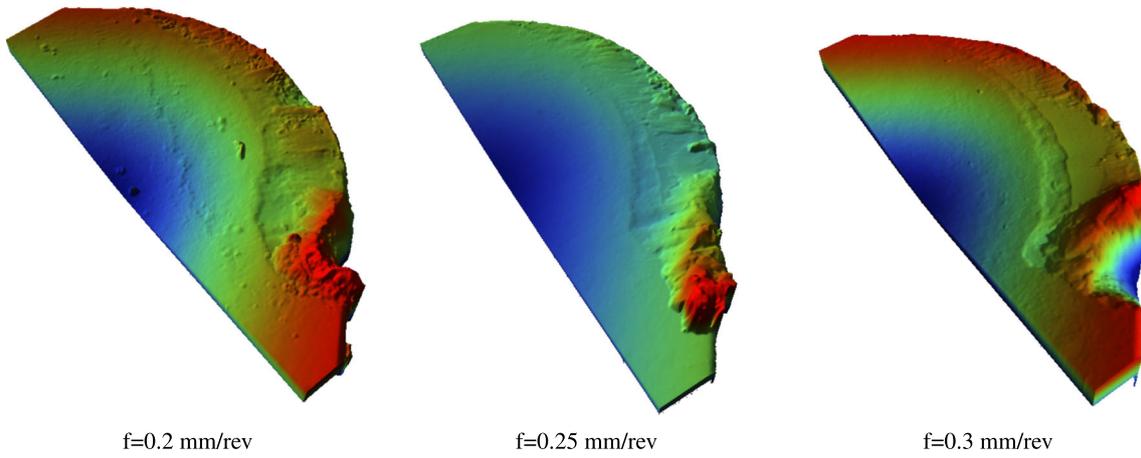
**Fig. 14** Tool wear at the end of tool life ( $a_p = 1.5$  mm,  $V_c = 60$  m/min,  $P = 100$  bar)

For a more exhaustive tool wear analysis, tool inserts have been observed using a SEM and scanned using a 3D profilometer. Figure 14 shows the scanned surfaces of the cutting tools at the end of the tool life. Figures 15 and 16 show the SEM observations of the worn tools.

These analysis have permitted a closer view of the damaged areas. Material deposits (adherent layers) and material chipping are clearly distinguishable ( $f = 0.2$  mm/rev and  $f = 0.3$  mm/rev) on the flank face, the rake face and the notch. For a feed rate of 0.3 mm/rev, the tool seems to have undergone very severe thermo-mechanical loads, given the significant deterioration of the cutting edge. Indeed, a large notch of approximately 400  $\mu$ m wide and material chipping along the cutting edge have occurred in only 4 min.

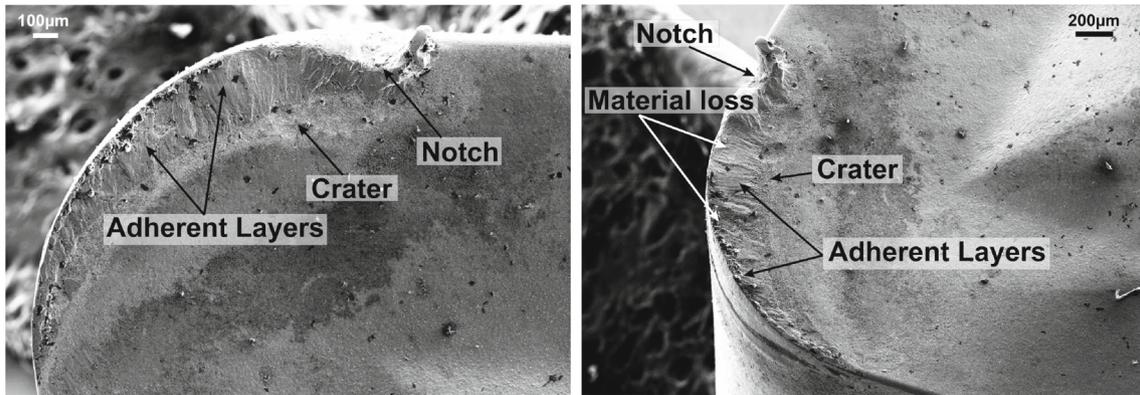
**Fig. 15** Tool wear  $f = 0.2$  mm/rev ( $a_p = 1.5$  mm,  $V_c = 60$  m/min,  $P = 100$  bar)

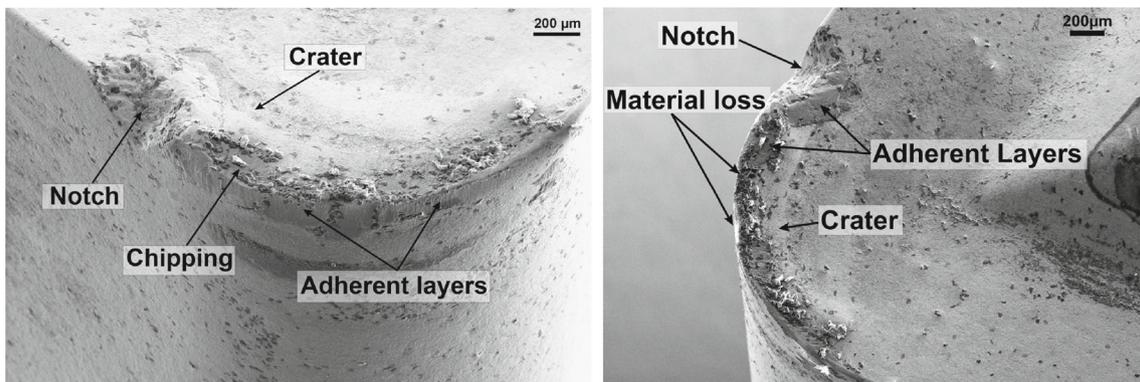
**Fig. 16**  $f = 0.3$  mm/rev ( $a_p = 1.5$  mm,  $V_c = 60$  m/min,  $P = 100$  bar)

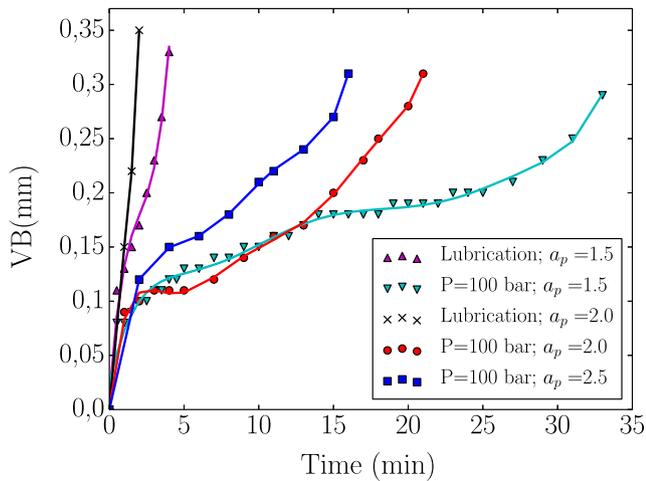
Fig. 17 Depth of cut impact ( $f = 0.1$  mm/rev,  $V_c = 60$  m/min)

A final series of tests have been carried out in order to investigate the impact of the depth of cut on tool wear using HPWJA. The depth of cut has been varied from 1.5 to 2.5 mm ( $f = 0.1$  mm/rev,  $V_c = 60$  m/min). The results of these tests are presented in Fig. 17.

First of all, it could be noted that the Ti555-3 titanium alloy is almost not machinable under these cutting conditions, using conventional lubrication; the tool life does not exceed 2 min at  $a_p = 2.0$  mm. However, the use of the high-pressure water-jet assistance significantly increases tool life. Indeed, for  $a_p = 1.5$  mm, tool life has been multiplied by a factor of 8 and for  $a_p = 2$  mm, it has been multiplied by a factor of 10 (from 2 to 21 min).

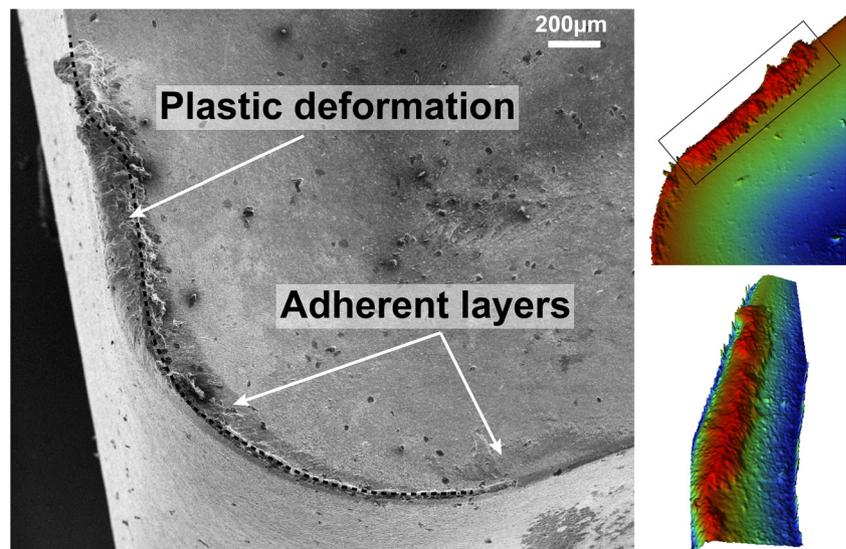
Fig. 18 Plastic deformation of the cutting edge (conventional lubrication,  $a_p = 2$  mm,  $T = 2$  min)

collapse [34]. This has been confirmed by analyses using the SEM and the 3D profilometer. Figure 18 illustrates the plastic deformation at the cutting edge (conventional lubrication); the cutting edge has been deformed by approximately 0.15 mm.

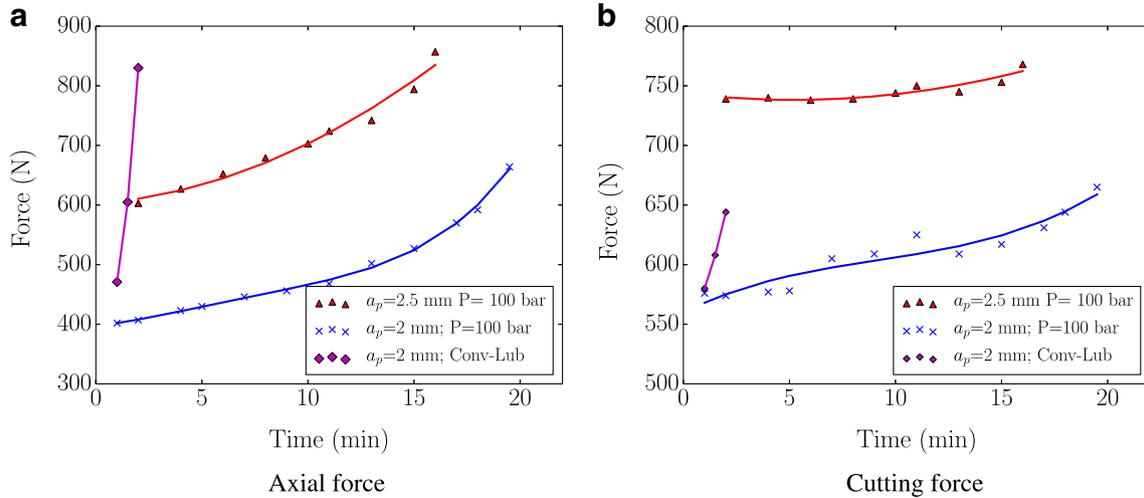
Fig. 19 Cutting force evolution

The evolution of the cutting forces is provided by Fig. 19. Hence, it can be deduced that the initial specific cutting force ( $K_c = \frac{F}{a_p f}$ ) is approximately 2800 MPa and it reaches 3520 MPa at the end of the tool life. This further explains the plastic deformation phenomenon which has occurred. On the bases of the work by Astakhov [34], to prevent thermal softening of tungsten carbide, the temperature should not exceed 800 °C for such a loading level. However, this temperature is far exceeded during machining of titanium alloys even for a lower cutting conditions [35]. In the case of water-jet assistance, a large part of the generated heat is evacuated.

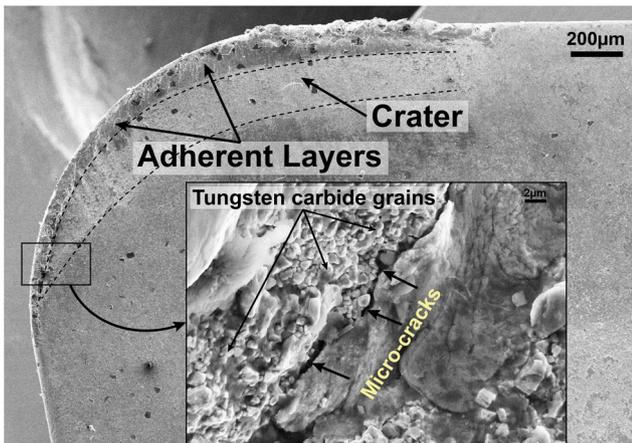
Fig. 20 Tool wear:  $a_p = 2$  mm,  $P = 100$  bar,  $T = 19$  min

The efficient lubrication provided by the high-pressure water jet avoids the plastic deformation wear mechanism. Figure 20 shows the rake face of the tool at the end of the tool life (19 min). It shows the zones of material adhesion and a large crater; it also shows micro-cracks on the border between the crater and the cutting edge. The gradual formation of the crater under the action of the adhesion mechanism (accelerated by the water jet) weakens the tool. Meanwhile, wear on rake and flank faces leads to an increase in the cutting forces. At this time, micro-cracks begin to form; this will end by the rupture of the cutting edge.
