Alexander NIKITIN, Claude BATHIAS, Thierry PALIN-LUC, Andrey SHANYAVSKIY - Crack path in aeronautical titanium alloy under ultrasonic torsion loading - Frattura ed Integrità Strutturale / Fracture and Structural Integrity - Vol. 10, n°35, p.213-222 - 2015

## Crack path in aeronautical titanium alloy under ultrasonic torsion loading

**ABSTRACT.** This paper discusses features of fatigue crack initiation and growth in aeronautical VT3-1 titanium alloy under pure torsion loading in gigacycle regime. Two materials: extruded and forged VT3-1 titanium alloys were studied. Torsion fatigue tests were performed up to fatigue life of  $10^9$  cycles. The results of the torsion tests were compared with previously obtained results under fully reversed axial loading on the same alloys. It has been shown that independently on production process as surface as well subsurface crack initiation may appear under ultrasonic torsion loading despite the maximum stress amplitude located at the specimen surface. In the case of surface crack initiation, a scenario of crack initiation and growth is similar to HCF regime except an additional possibility for internal crack branching. In the case of subsurfa

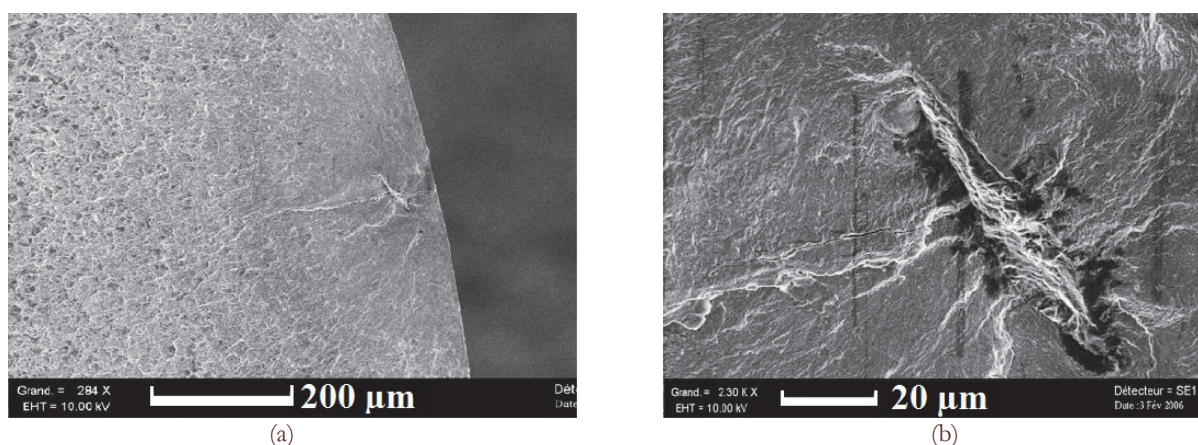
Figure 1: Subsurface fatigue crack initiation in 100C6 steel under ultrasonic torsion, shear stress is 360 MPa,  $N_f$  is  $10^9$  cycles [10].

Results of ultrasonic tests on high-strength aluminum shows that torsion fatigue crack in VHCF regime have a qualitative similarity to crack in HCF regime [9]. It has been shown that crack initiation under torsion is located at the surface of specimen. The first stage of growth is found in the plane of maximum shear stress with further formation of circumferential crack. However, a few years after, it has been shown that under torsion loading in VHCF range as surface, as well a subsurface cracks may also appears if material contains a non-metallic inclusions. In reference [10] high-strength steel was studied up to a fatigue life of  $10^9$  cycles. In the case of surface initiation, the fracture surface of 100C6 steel shows a similar to HCF 'factory roof' pattern, but in the case of subsurface crack initiation, an initiation mechanism is more similar to push-pull fatigue. In this case a 'fish-eye' pattern is formed around an elongated non-metallic inclusion, fig.1b. The torsion fatigue crack does not show a significant branching and 'factory roof' fracture is absent, fig.1a. Unlike high-strength aluminum, a 38MnSV5S steels shows a surface crack initiation on the plane of maximum normal stress ( $45^\circ$  by the specimen's axis) [11] and further propagation in inclined (by the specimen's length) plane with tendency to turn back to the maximum shear stress plane.

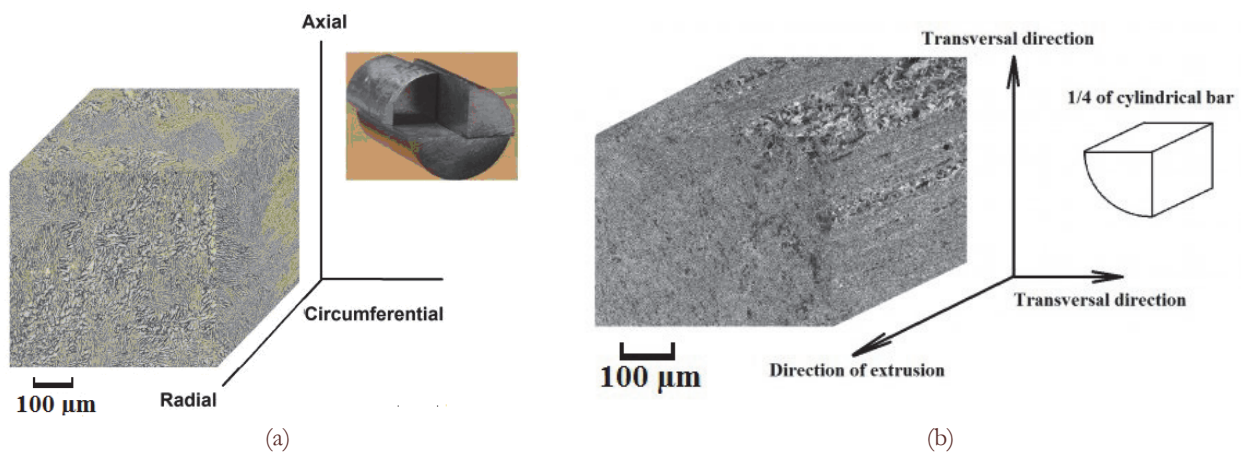
Figure 2: The 3D mapping of micro-structure for (a) forged and (b) extruded VT3-1.

Both alloys have fully lamellar micro-structure with elongated alpha-platelets. In the case of forged VT3-1 platelet size is larger (about 2 μm in width and 10-15 μm in length), while  $w = 1 \mu\text{m}$  by  $l = 2-3 \mu\text{m}$  for the extruded one. Moreover, micro-structure of extruded titanium alloy is more homogeneous (except some zones in the core of the bar), while the micro-structure of forged titanium is processed in macroscopically large zones with similar platelets morphology. These zones called 'macro-zones' [14] and characterized by similar crystallographic orientations of the platelets within each macro-zone. The existence of such specific of micro-structure explains the large scatter obtained in micro-hardness values for forged VT3-1.

The 3D mapping of the micro-structure is shown on Fig. 2 for forged and extruded alloys.

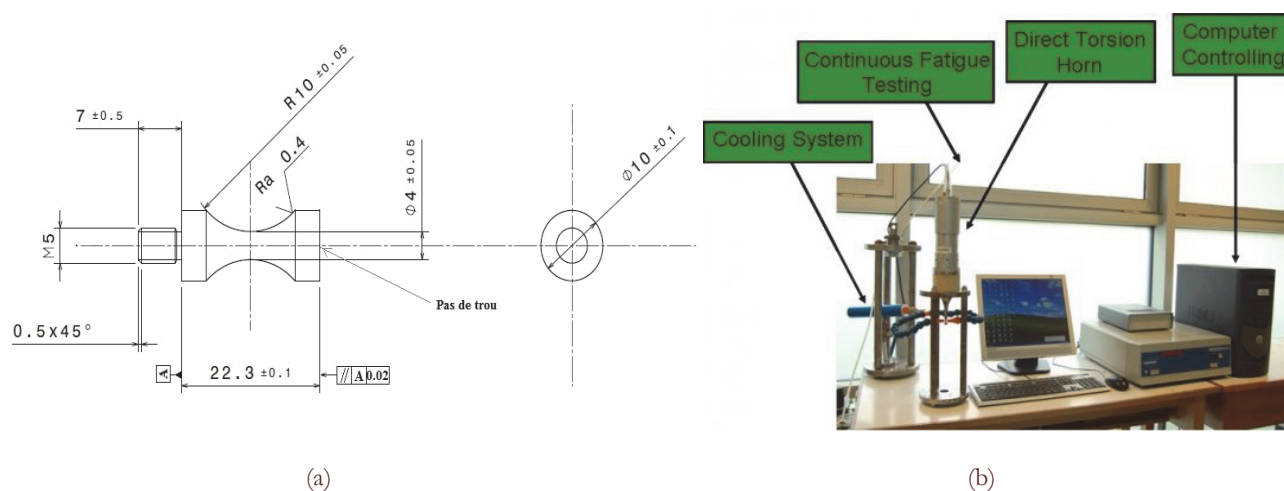
Torsion fatigue tests were performed on specimens, designed according to ultrasonic concept applied to torsion [3, 14] and taking into account dynamic elastic properties of materials at 20 kHz (Tab.2). Specimens made of forged VT3-1 were cut from the rim part of compressor disk along an axis of disk symmetry. Specimens made of extruded VT3-1 were machined from bar so that specimen's longitudinal axis is the same than extrusion direction. Geometry of ultrasonic torsion specimens is presented on Fig.3a. Working section of specimen was polished by emery papers from grade 600 to 1000. Fatigue tests were performed continuously (without pulse - pause) by using a self-designed ultrasonic torsion system [14], (Fig.3b) up to fatigue failure or run out limit of  $10^9$  cycles. All the tests were performed at room temperature with permanent compressed dry-air cooling. An infrared camera was used for monitoring surface temperature of specimen during fatigue tests. Result shows that there is now significant self-heating effect in VT3-1 titanium alloy under torsion loads [15].

Figure 3: (a) Geometry of ultrasonic torsion specimen and (b) ultrasonic torsion testing system.

The calibration of the testing system was performed with strain gauge and Vishay conditioning device with a large bandwidth (up to 100 kHz). Calibration shows a perfect linear relation between applied tension and measured deformation.

The fatigue crack under torsion is detected by drop of resonance frequency. This crack detection is done automatically with a high-performance computer feedback controller. After each test the crack existence is verified by optical microscope.

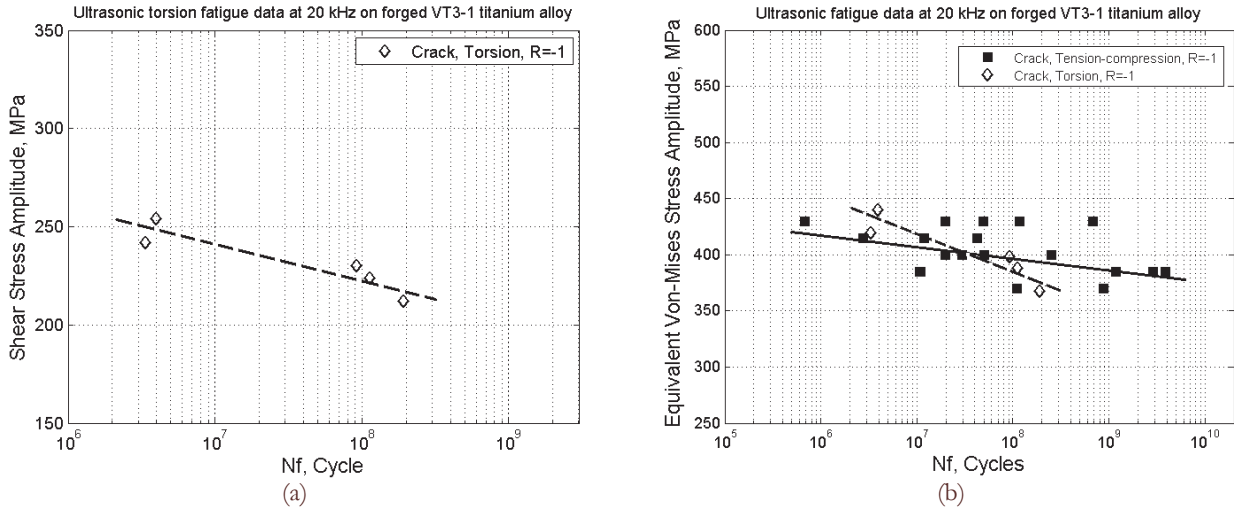
The results of fatigue tests on both forged (Fig.4a) and extruded (Fig.5a) titanium alloy shows that fatigue failure under pure torsion loading may occur well beyond  $10^6$  cycles. In spite of limited fatigue data on forged VT3-1 it is possible to plot a curve fitting the results. This curve will have an important slope in the VHCF range. Decreasing in fatigue strength with increasing number of loading cycles is more pronounced for torsion mode compared to results of axial tension-compressing tests [16] that is presented on Fig.4b. In order to compare the results of torsion and axial tests, the following equation was used to recalculate the shear stress amplitude into equivalent (Von Mises) normal stress

$\sigma = \sqrt{3} \cdot \tau$ . It can be pointed out that points plotted in equivalent stress terms for forged VT3-1 show a good agreement and grouped near to 400 MPa that is about 40 % of UTS. This result is similar to typical results on titanium alloys in the HCF range.

Figure 4: Results of fatigue tests on forged VT3-1 titanium alloy (a) torsion data in terms of shear stress amplitude and (b) tension compression R=-1 and torsion data in terms of equivalent normal stress amplitude.

The torsion results cover a range of fatigue life from about 10<sup>6</sup> to 10<sup>8</sup> cycles. Based on previous results obtained on forged VT3-1 under fully reversed tension loading, the crack initiation mechanisms could be quite different at such fatigue life for forged alloy [16]. Besides a changing from surface to subsurface crack initiation mode, it has been reported about micro-structural fatigue life controlling mechanisms. In the case of torsion loading, a transition from surface to subsurface initiation after longer fatigue life was also found. However, this transition appears at fatigue life of about two order of magnitude longer. Detailed analysis on fatigue crack initiation mechanisms under torsion loading will be provided in the section 'Discussion'.

First of all, the comparison of SN-curves for push-pull and torsion loadings (Fig.4 and 5) shows a more important slope of SN-curve in the case of torsion loading. This tendency keeps being the same as for forged, as well for extruded titanium alloy in spite of small difference of SN-curves for these alloys under push-pull fatigue. This means that VT3-1 titanium is more sensitive to shear stress than to normal one. This is typical for ductile metals. However, long crack propagation is observed in planes of maximum normal stress which is typical for more brittle material. Therefore, at the very first stage of fatigue crack initiation, when a crack length is about the same order than the grain size the fatigue behavior of titanium is similar to ductile material and fatigue damage accumulation is due to sliding process. In the case of two-phase  $\alpha + \beta$  titanium alloy a higher capacity to accommodate plastic sliding has a hexagonal alpha-phase. Thus, the fatigue resistance of titanium alloy to torsion loading may be related to features of alpha-platelets. In the case of surface torsion crack it can be observed macroscopically at surface in one of two maximum shear stress planes: along or perpendicularly to specimen’s axis. Fig.8b shows an example of first torsion crack growth stage along an axis.

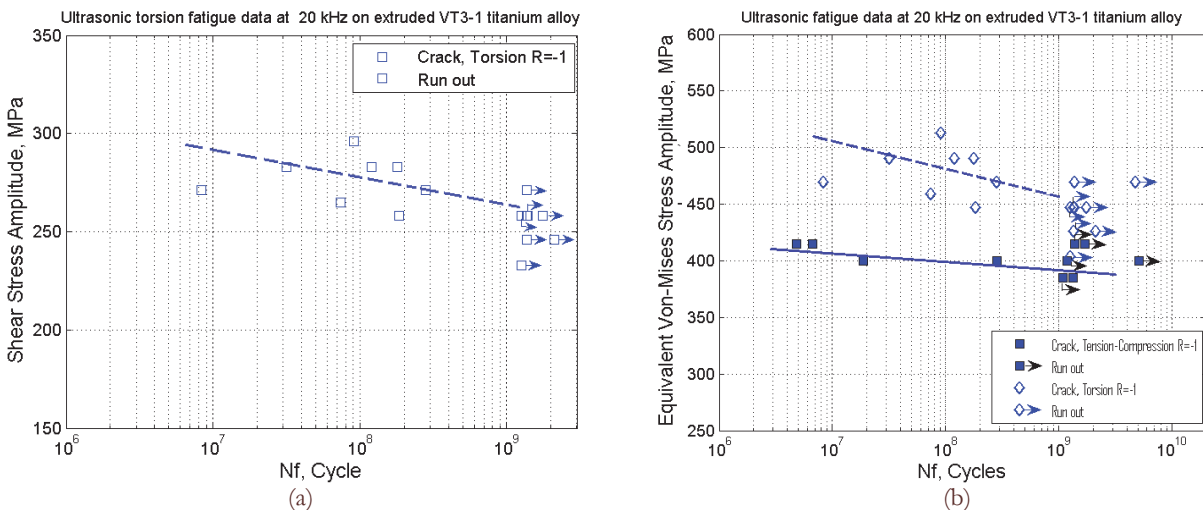
Figure 5: Results of fatigue tests on extruded VT3-1 titanium alloy (a) torsion data in terms of shear stress amplitude and (b) tension compression R=-1 and torsion data in terms of Von Mises equivalent stress amplitude.

Like for the forged alloy, the SN curve in torsion for the extruded VT3-1 titanium alloy exhibits a significant slope in VHCF regime, Fig.5a. Since the fatigue tests were stopped around 10<sup>9</sup> cycles, most of the cracks were observed in the fatigue life range below 10<sup>9</sup> cycles. As already was done for the forged alloy, the results of torsion tests on extruded VT3-1

titanium alloy were compared with previous results [17] obtained on the material but under fully reversed tension, Fig. 5b. In terms of Von Mises equivalent stress amplitude, like for the forged alloy, the slope of the SN-curve is more important under torsion than under tension-compression. However, unlike the forged alloy, fatigue strength of extruded titanium is higher (about 50 MPa) in torsion than in tension-compression. This shows that the Von Mises equivalent stress is not suitable to describe the VHCF strength of this alloy. In order to try to explain such mechanical behavior the analysis of the fracture surface was carried out both by optical microscopy and SEM. Unlike tension-compression, where only subsurface crack were observed, in case of torsion load a transition from surface to subsurface crack initiation was found. Comparison of results on forged and extruded titanium alloy (Fig.4 and Fig.5) shows that fatigue strength of extruded titanium alloy is higher compared to the forged one that is in good agreement with mechanical properties of materials (Tab.2).

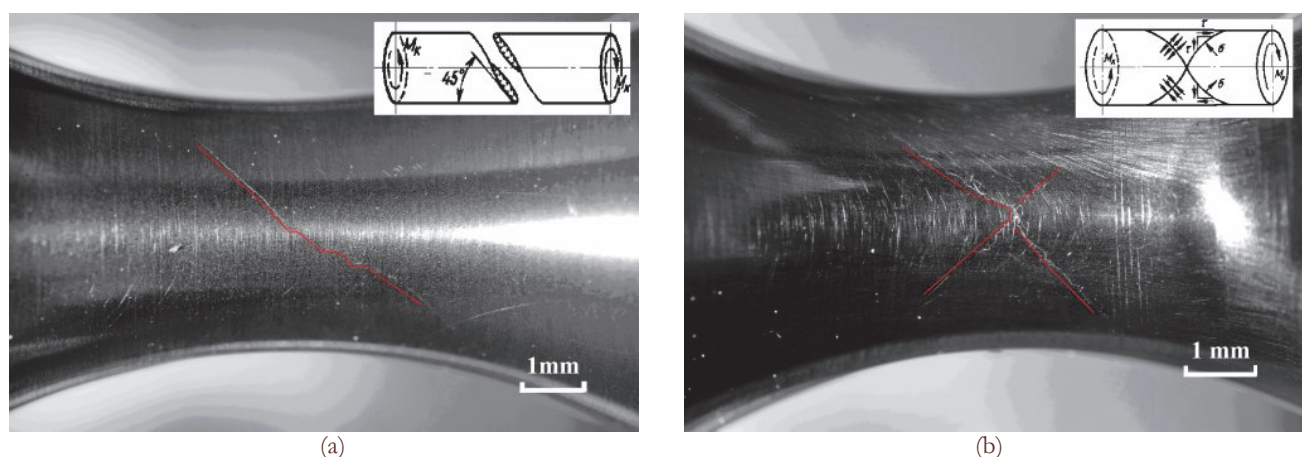
Cracks in torsion specimens were first observed on a lateral surface of specimens by optical microscopy. It was pointed out, that for most of the investigated specimens the first stage of crack propagation was observed on a plane experiencing the maximum shear stress amplitude i.e. perpendicular or parallel to the specimen's longitudinal axis. Further, when the crack became longer it bifurcated (Stage II) and propagated in Mode I on plane(s) of maximum normal stress (i.e. on plane having an angle about  $45^\circ$  with regard to the specimen's longitudinal axis). The propagation of long crack was never observed in the plane of maximum shear stress amplitude up to the final length (corresponding to the end of the test). It should be noted, that crack growth in the plane of maximum normal stress may be found as in a single plane, as well in two planes at the same time (X-type cracks), Fig.6b. This is similar to HCF regime on many metals.

Figure 6: Optical microscopy at the surface of torsion specimens: (a) single crack in the plane of maximum normal stress and (b) two cracks in two  $45^\circ$  orientated planes of maximum normal stress or X-type crack.

Crack growth under torsion loading in the plane of maximum normal stress looks to be quite sensitive to material microstructure. Comparing the surface crack path of extruded and forged titanium alloy it is notable, that branching of the crack is higher for forged titanium alloy represented by less homogenous microstructure. An example of crack path in extruded titanium alloy is showing on the Fig.6a. In this case the crack is quite well orientated on the  $45^\circ$  plane, while in case of forged titanium alloy, Fig.6b, the crack path is more 'zigzag' (alternative branching mode I and mode II). Sometimes crack make a clear 'steps' or even sometimes it is propagating in a two parallel  $45^\circ$  planes.

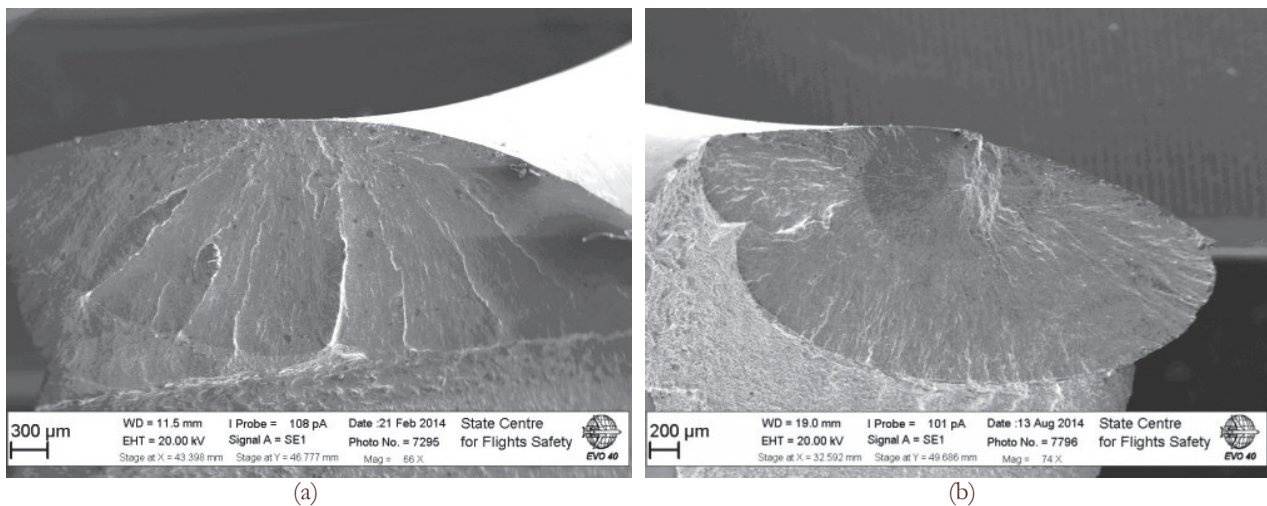
An observation on a fracture surface of torsion specimens (after opening) shows two types of crack for both alloys: (1) surface crack and (2) subsurface crack. In the case of extruded VT3-1 these two mechanisms are more clear, Fig.7

In the case of surface crack initiation the roughness of the fracture surface is lower. That can be concluded based on a more homogeneous color. In the case of subsurface crack initiation, a roughness of fracture surface in the area of subsurface and surface crack propagation is not the same, that clearly seen by pronounceable color change. Subsurface crack initiation under torsion loading leads to forming a well known (in push-pull) 'fish eye' pattern [3]. But unlike push-pull loading, torsion cyclic loading produced an oval 'fish-eye'

Figure 7: Surface (a) and subsurface ‘fish-eye’ (b) crack initiations in extruded VT3-1 titanium alloy under torsion loading.

The next difference between torsion and pull-push ‘fish-eye’ is the nature of smooth area. In the case of axial loading, the formation of such area is governed by crack growth rate, while in the case of torsion ‘fish-eye’ a second factor can be stated. Indeed the smooth area of torsion crack is limited by an ellipse, that ‘touches’ the specimen surface. More rough fracture surface is starting to form when an internal crack reaches the specimen surface. Probably, there are several factors acting together and leading to fracture roughness modification. One can say: (1) the crack growth rate increasing when the crack reaches the specimen surface; (2) presence of environment (gasses) into the crack, when it connects to the surface. Anyway, a smooth area of torsion ‘fish-eye’ exists till an internal crack turns to a surface crack. The next pronounceable difference between surface and subsurface initiation is less expressed branching of internal crack. On Fig.7a several clear traces can be observed. These traces are formed due to crack propagation in series of parallel planes, orientated at 45° with regard to the specimen longitudinal axis. In the case of subsurface crack initiation, growth of several cracks in 45° planes is also possible, but this is well limited. It is interesting to point out, that in the case of high strength steel, Fig.1a [10], a fracture surface with internal crack initiation does not show a significant branching pattern (no 45° ‘wings’).

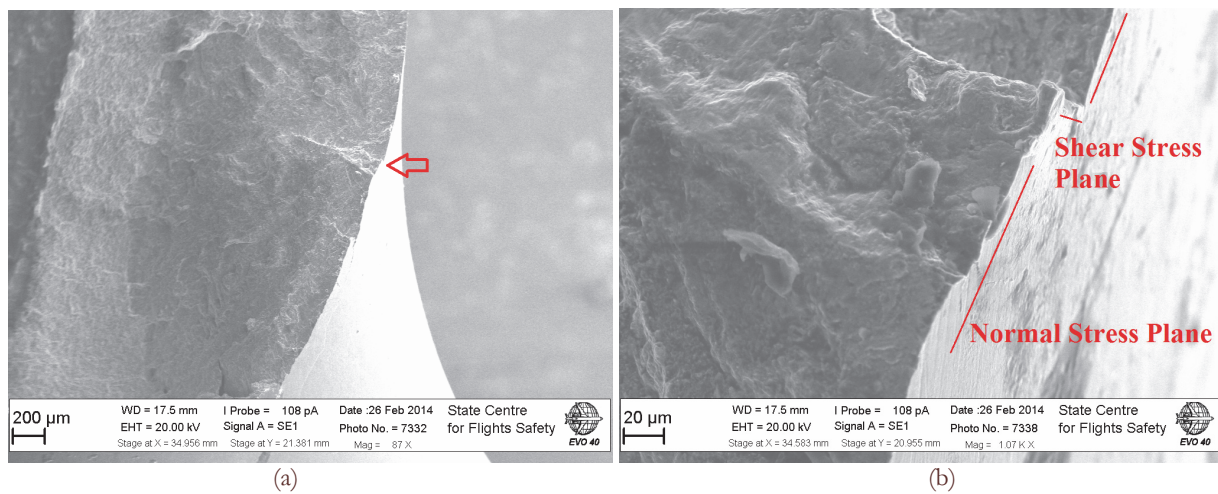
When torsion crack reaches a length of several micrometers, the crack growth turns into a plane of maximum normal stress, Fig. 8b. Typical size of alpha-platelets is very small for the studied titanium alloys and micro-plasticity of alpha-phase is not enough to accumulate fatigue damage at later stage of crack growth that turns fatigue behavior of material to the brittle-mode failure (governed by the normal stress cracking mechanisms). Another reason that can limit the stage of crack growth in shear plane is quite high deformation rate in the case of ultrasonic loading. But anyway, a transition from maximum shear to normal stress plane is typical for torsion cracking at different loading frequencies. In reference [18] fully reversed torsion fatigue tests were carried out on titanium alloy Ti-6Al-4V in HCF regime at a loading frequency of

Figure 8: Surface crack initiation in forged VT3-1 under torsion loading (a) overview of torsion crack with initiation site marked by arrow and (b) detailed crack initiation view.

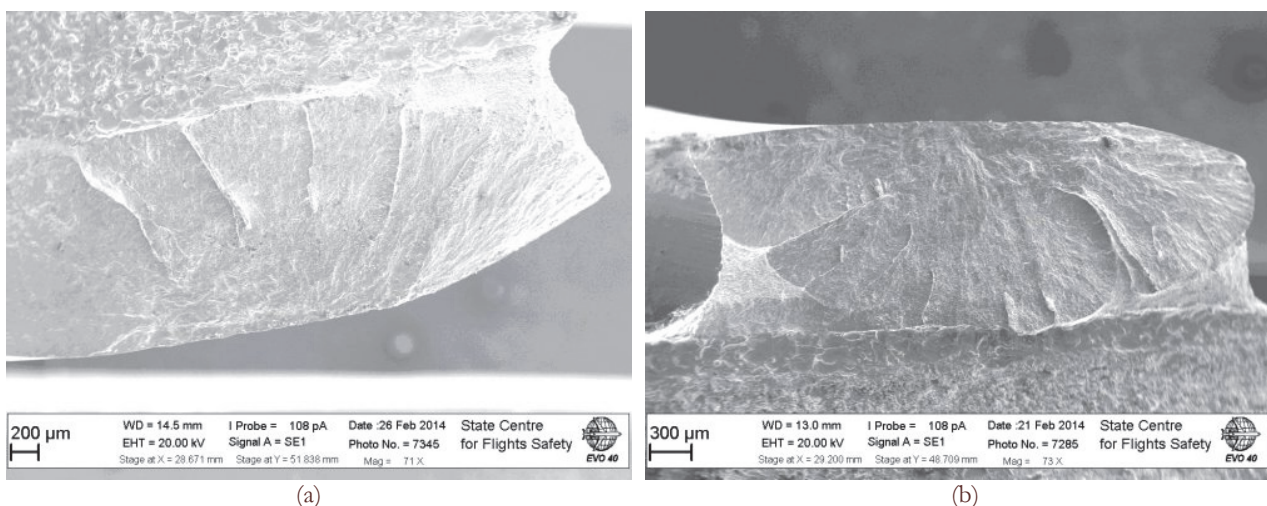
In the case of surface crack initiation a sort of crack branching threshold or critical crack length was found, Fig.9. It seems that at a certain crack length internal crack branching is also possible in the case of VHCF loading that is different from HCF. A slight difference in the fracture surface color in zones before and after branching is due to different roughness that is usually associated with difference in stress intensity factors or crack growth rate.

Figure 9: Fracture surfaces of specimens (a) S=; Nf= (b) S=; Nf=; with clear border of fatigue crack branching.

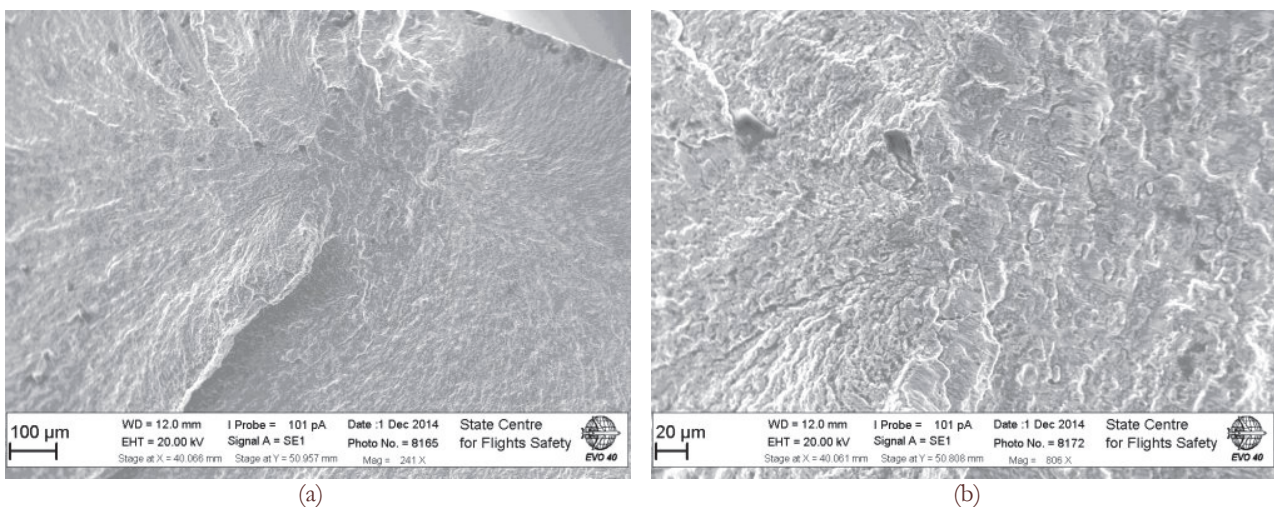
growth in Mode II at the very first stage, but a crack growth bifurcation mechanism seems different for HCF and VHCF. In the case of VHCF branching can be observed in the bulk of material, while in HCF it appears at the surface [18]. Such difference in the branching mechanism may have the same nature with one more interesting feature of VHCF torsion behavior. That is an internal crack initiation under VHCF torsion loading in spite of maximum shear stress located at the surface. An analysis of internal crack initiation site in VT3-1 titanium alloy did not show any structural flaw in the microstructure so that inclusions or clusters of alpha-platelets, Fig. 10. The crack initiation site is significantly destroyed by friction that is clearly seen in Fig.10b. A 'step' at the fracture surface and followed crack growth in two parallel planes means that internal crack is also initiated in the plane of maximum shear stress. After reaching a certain length (that is shorter than the distance from initiation site to surface) the crack branches on the plane of maximum normal stress. Sometimes there is a sort of competition between two maximum normal stress planes that produce a 'wing' like structure at the surface. Excluding this 'wing'-like structures, a further branching is limited in the case of internal crack initiation and no branching 'threshold' (like in case of surface crack) can be found at the fracture surface. In contrary, another notable zone or critical crack length can be reported. As shown in Fig.7b the crack front shape is changing as soon as it arrives at the surface, probably because the stress intensity factor is increasing and consequently the crack growth rate too.

Figure 10: Fracture surfaces of specimens (a) S=; Nf= (b) S=; Nf=; with clear border of fatigue crack branching.
