Alexander NIKITIN, Claude BATHIAS, Thierry PALIN-LUC, Andrey SHANYAVSKIY - Crack path in aeronautical titanium alloy under ultrasonic torsion loading - Frattura ed Integrità Strutturale / Fracture and Structural Integrity - Vol. 10, n°35, p.213-222 - 2015

Crack path in aeronautical titanium alloy under ultrasonic torsion loading

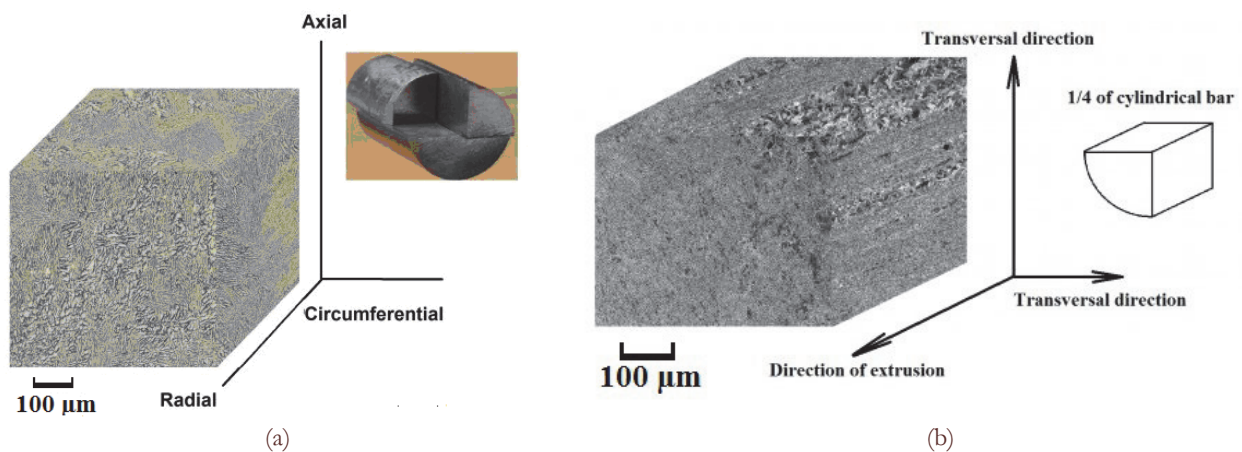
Figure 2: The 3D mapping of micro-structure for (a) forged and (b) extruded VT3-1.

Both alloys have fully lamellar micro-structure with elongated alpha-platelets. In the case of forged VT3-1 platelet size is larger (about 2 μm in width and 10-15 μm in length), while $w = 1 \mu\text{m}$ by $l = 2-3 \mu\text{m}$ for the extruded one. Moreover, micro-structure of extruded titanium alloy is more homogeneous (except some zones in the core of the bar), while the micro-structure of forged titanium is processed in macroscopically large zones with similar platelets morphology. These zones called 'macro-zones' [14] and characterized by similar crystallographic orientations of the platelets within each macro-zone. The existence of such specific of micro-structure explains the large scatter obtained in micro-hardness values for forged VT3-1.

The 3D mapping of the micro-structure is shown on Fig. 2 for forged and extruded alloys.

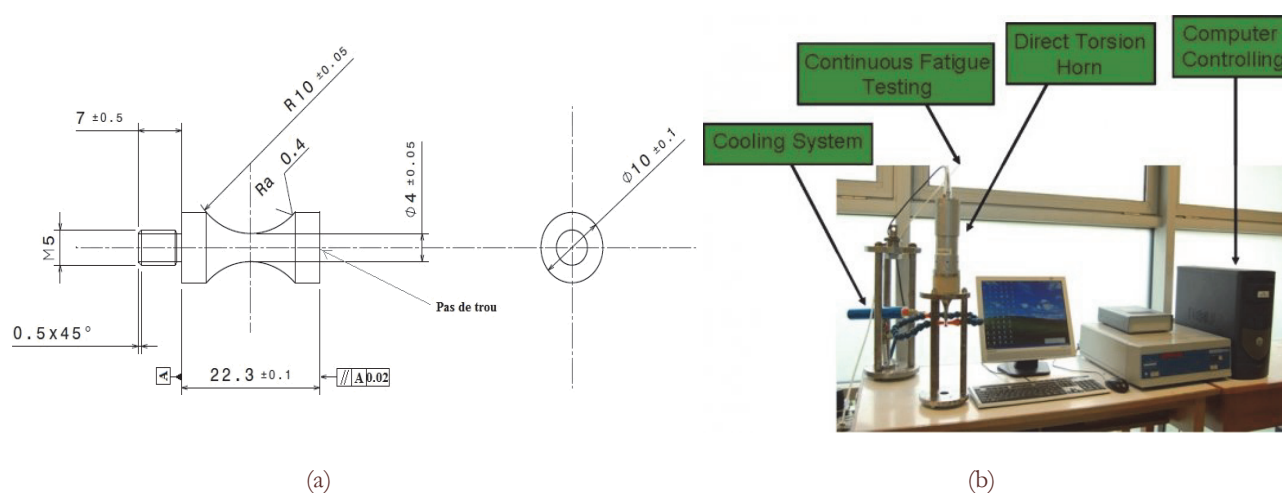
Torsion fatigue tests were performed on specimens, designed according to ultrasonic concept applied to torsion [3, 14] and taking into account dynamic elastic properties of materials at 20 kHz (Tab.2). Specimens made of forged VT3-1 were cut from the rim part of compressor disk along an axis of disk symmetry. Specimens made of extruded VT3-1 were machined from bar so that specimen's longitudinal axis is the same than extrusion direction. Geometry of ultrasonic torsion specimens is presented on Fig.3a. Working section of specimen was polished by emery papers from grade 600 to 1000. Fatigue tests were performed continuously (without pulse - pause) by using a self-designed ultrasonic torsion system [14], (Fig.3b) up to fatigue failure or run out limit of 10^9 cycles. All the tests were performed at room temperature with permanent compressed dry-air cooling. An infrared camera was used for monitoring surface temperature of specimen during fatigue tests. Result shows that there is now significant self-heating effect in VT3-1 titanium alloy under torsion loads [15].

Figure 3: (a) Geometry of ultrasonic torsion specimen and (b) ultrasonic torsion testing system.

The calibration of the testing system was performed with strain gauge and Vishay conditioning device with a large bandwidth (up to 100 kHz). Calibration shows a perfect linear relation between applied tension and measured deformation.

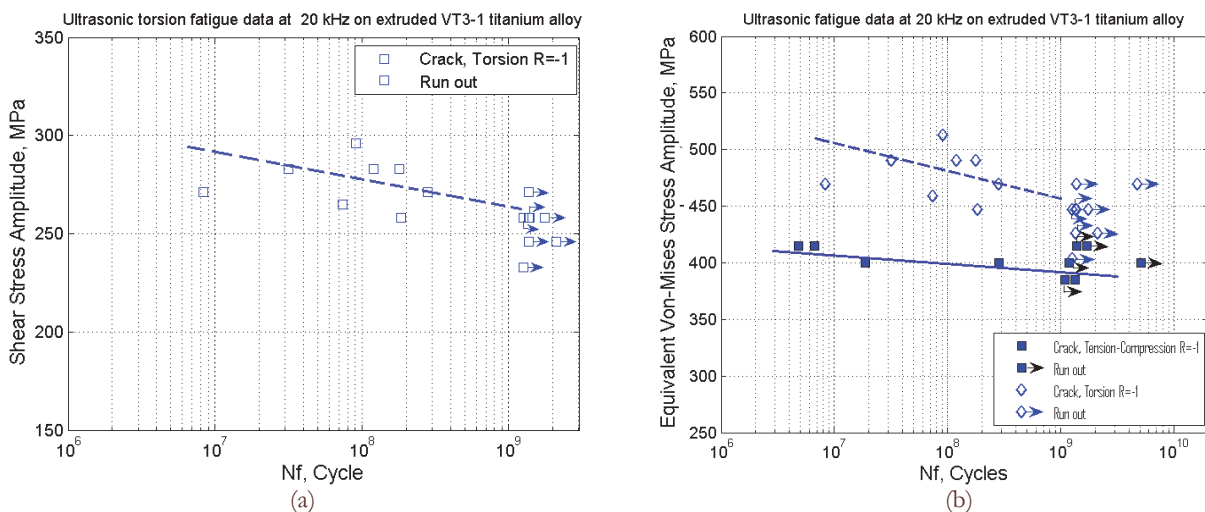
Figure 5: Results of fatigue tests on extruded VT3-1 titanium alloy (a) torsion data in terms of shear stress amplitude and (b) tension compression R=-1 and torsion data in terms of Von Mises equivalent stress amplitude.

Like for the forged alloy, the SN curve in torsion for the extruded VT3-1 titanium alloy exhibits a significant slope in VHCF regime, Fig.5a. Since the fatigue tests were stopped around 10⁹ cycles, most of the cracks were observed in the fatigue life range below 10⁹ cycles. As already was done for the forged alloy, the results of torsion tests on extruded VT3-1

titanium alloy were compared with previous results [17] obtained on the material but under fully reversed tension, Fig. 5b. In terms of Von Mises equivalent stress amplitude, like for the forged alloy, the slope of the SN-curve is more important under torsion than under tension-compression. However, unlike the forged alloy, fatigue strength of extruded titanium is higher (about 50 MPa) in torsion than in tension-compression. This shows that the Von Mises equivalent stress is not suitable to describe the VHCF strength of this alloy. In order to try to explain such mechanical behavior the analysis of the fracture surface was carried out both by optical microscopy and SEM. Unlike tension-compression, where only subsurface crack were observed, in case of torsion load a transition from surface to subsurface crack initiation was found. Comparison of results on forged and extruded titanium alloy (Fig.4 and Fig.5) shows that fatigue strength of extruded titanium alloy is higher compared to the forged one that is in good agreement with mechanical properties of materials (Tab.2).

First of all, the comparison of SN-curves for push-pull and torsion loadings (Fig.4 and 5) shows a more important slope of SN-curve in the case of torsion loading. This tendency keeps being the same as for forged, as well for extruded titanium alloy in spite of small difference of SN-curves for these alloys under push-pull fatigue. This means that VT3-1 titanium is more sensitive to shear stress than to normal one. This is typical for ductile metals. However, long crack propagation is observed in planes of maximum normal stress which is typical for more brittle material. Therefore, at the very first stage of fatigue crack initiation, when a crack length is about the same order than the grain size the fatigue behavior of titanium is similar to ductile material and fatigue damage accumulation is due to sliding process. In the case of two-phase $\alpha + \beta$ titanium alloy a higher capacity to accommodate plastic sliding has a hexagonal alpha-phase. Thus, the fatigue resistance of titanium alloy to torsion loading may be related to features of alpha-platelets. In the case of surface torsion crack it can be observed macroscopically at surface in one of two maximum shear stress planes: along or perpendicularly to specimen’s axis. Fig.8b shows an example of first torsion crack growth stage along an axis.

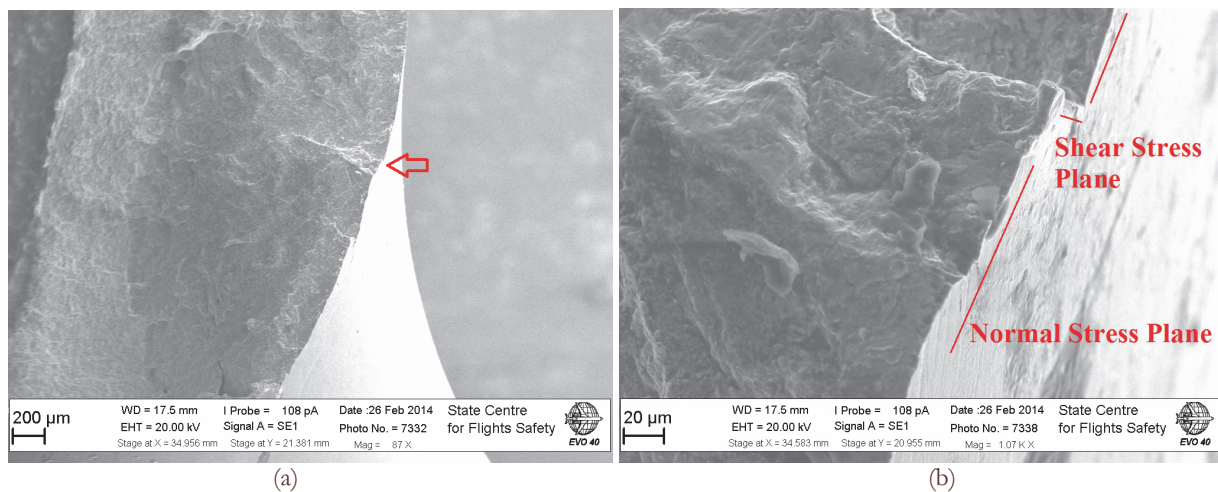
When torsion crack reaches a length of several micrometers, the crack growth turns into a plane of maximum normal stress, Fig. 8b. Typical size of alpha-platelets is very small for the studied titanium alloys and micro-plasticity of alpha-phase is not enough to accumulate fatigue damage at later stage of crack growth that turns fatigue behavior of material to the brittle-mode failure (governed by the normal stress cracking mechanisms). Another reason that can limit the stage of crack growth in shear plane is quite high deformation rate in the case of ultrasonic loading. But anyway, a transition from maximum shear to normal stress plane is typical for torsion cracking at different loading frequencies. In reference [18] fully reversed torsion fatigue tests were carried out on titanium alloy Ti-6Al-4V in HCF regime at a loading frequency of

Figure 8: Surface crack initiation in forged VT3-1 under torsion loading (a) overview of torsion crack with initiation site marked by arrow and (b) detailed crack initiation view.

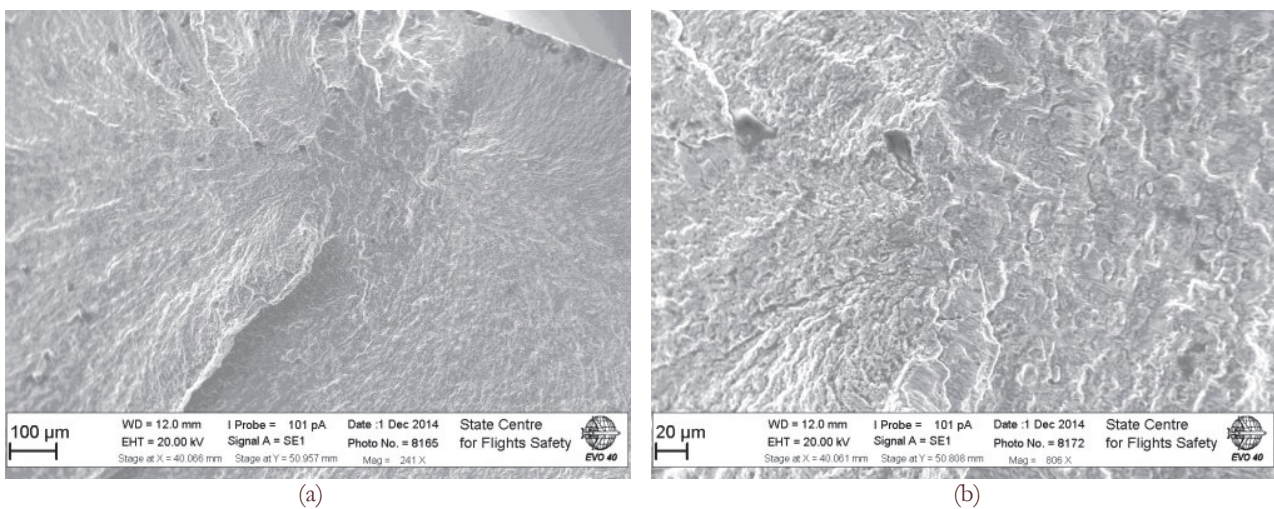
growth in Mode II at the very first stage, but a crack growth bifurcation mechanism seems different for HCF and VHCF. In the case of VHCF branching can be observed in the bulk of material, while in HCF it appears at the surface [18]. Such difference in the branching mechanism may have the same nature with one more interesting feature of VHCF torsion behavior. That is an internal crack initiation under VHCF torsion loading in spite of maximum shear stress located at the surface. An analysis of internal crack initiation site in VT3-1 titanium alloy did not show any structural flaw in the microstructure so that inclusions or clusters of alpha-platelets, Fig. 10. The crack initiation site is significantly destroyed by friction that is clearly seen in Fig.10b. A 'step' at the fracture surface and followed crack growth in two parallel planes means that internal crack is also initiated in the plane of maximum shear stress. After reaching a certain length (that is shorter than the distance from initiation site to surface) the crack branches on the plane of maximum normal stress. Sometimes there is a sort of competition between two maximum normal stress planes that produce a 'wing' like structure at the surface. Excluding this 'wing'-like structures, a further branching is limited in the case of internal crack initiation and no branching 'threshold' (like in case of surface crack) can be found at the fracture surface. In contrary, another notable zone or critical crack length can be reported. As shown in Fig.7b the crack front shape is changing as soon as it arrives at the surface, probably because the stress intensity factor is increasing and consequently the crack growth rate too.

Figure 10: Fracture surfaces of specimens (a) S=; Nf= (b) S=; Nf=; with clear border of fatigue crack branching.
