Jianguang BAO, Siyuan BAO, Xiaofeng GUO, Yonghong WANG, Wei SUN, Adil BENAARBIA - High temperature strain heterogeneities tracking within hole-specimens of fv566 turbine steel via digital image correlation - Materials Science and Engineering: A - Vol. 777, p.139068 - 2020

# High temperature strain heterogeneities tracking within hole-specimens of FV566 turbine steel via digital image correlation

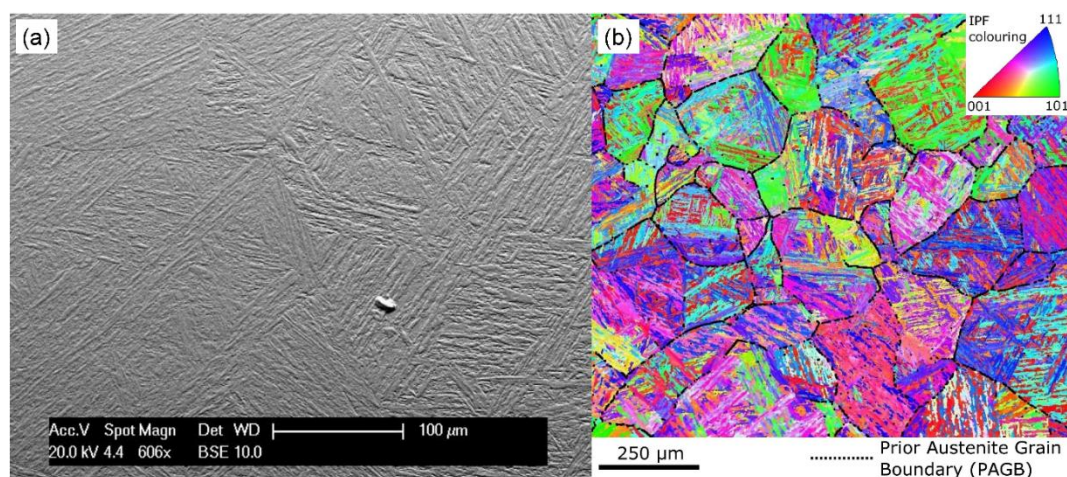
**Fig. 1.** (a) Backscattered electron image and (b) an EBSD orientation map of the as received FV566 material. The prior austenite grain boundaries are highlighted in black using 23° - 41° misorientation angles.

Fig.1a presents the microstructure of the FV566 steel after heat treatment with the average grain size of 30  $\mu\text{m}$ . After tempering, a typical tempered martensitic microstructure in the as-received material can be seen in Fig.1b [33]. Prior austenite grains (PAGs), packets, blocks, sub-blocks and laths, were involved, as has been noticed in [34]. Also, according to the Kurdjumov-Sachs orientation relationship with the parental austenitic phases [35], the PAGs in the as-received material are less than 300 $\mu\text{m}$  in size with the misorientation in a range of 23° - 41°. Sub-blocks and laths have the average misorientation angles of 1.8° and 8.3°, respectfully.

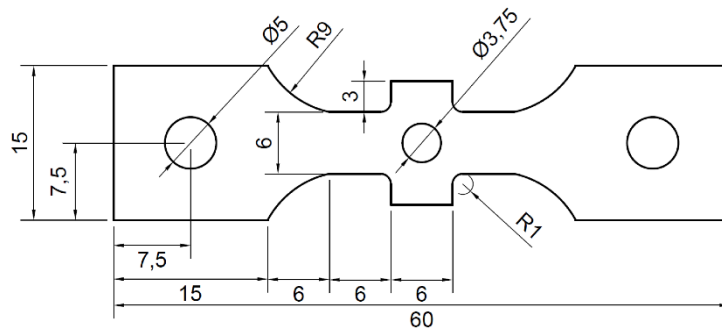
**Fig. 2.** Specimen configuration (All dimensions are in mm, the thickness is set at 2 mm).

Many structural components possess geometrical features such as holes, corners or gaps that are necessitated by design to accommodate fasteners, joints, or for weight reduction. Under the influence of combined thermal and mechanical loads, such stress concentration sites may become initiation sites of void nucleation and fracture [30]. The local strain fields can be highly inhomogeneous in such biaxial, or in general triaxial, stress states [36]. Hence, specimens with a hole of  $\varnothing 3.75$  mm at the central part and symmetrical protrusions of 3 mm on both extremities were designed and tested under high temperature tensile loading. The holes of  $\varnothing 5$  mm on both sides were machined to satisfy the loading pins' requirement. Dimensions of the specimen are shown in Fig. 2.

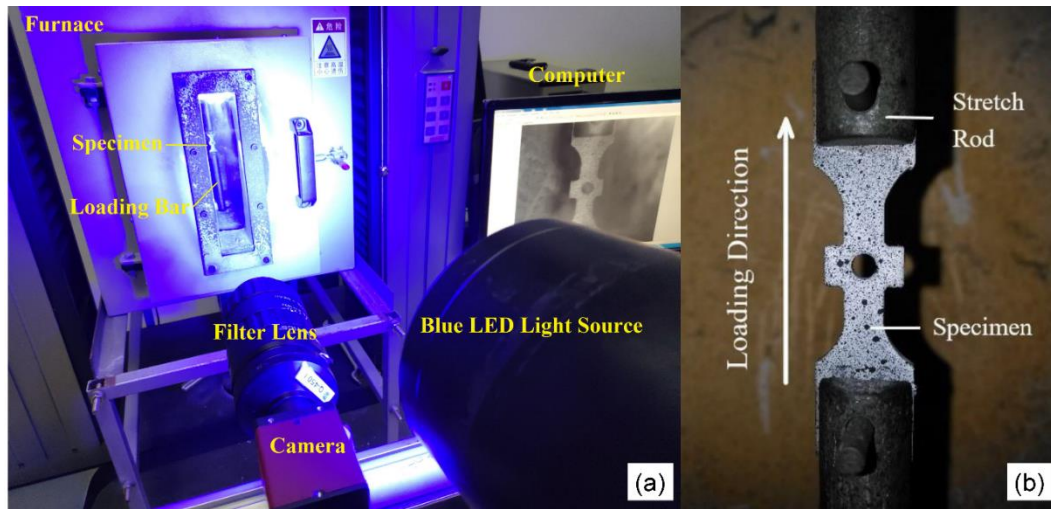
**Fig. 3.** (a) The experimental setup showing the digital camera used for the DIC measurements, a high temperature furnace, a narrow band pass filter lens of 441 nm  $\pm$  10 nm bandwidth and a monochromatic light source with the wavelength of 440 nm  $\pm$  20 nm. (b) The test specimen sprayed with a black/white speckle.

Different techniques are available in the literature to generate the high temperature resistance speckle for DIC [38]. In order to increase the contrast between the speckle pattern and the background, the specimens were first covered with white inks and then, after a drying process, the black ink speckle pattern was sprayed. The pretreatment was necessary for a better adhesion of spray painting for high temperature environments. The gauge part was first ground with coarse grind paper to increase its surface roughness. After cleaned the grease on the surface and rinsed with water, the specimens with white painting were placed in a furnace for 2 hours at 200°C in order to make the white paint solidified completely. The same procedure was repeated for the black one. Furthermore, the white uniform ink layer serves to avoid "shiny" surface, sensitive to the light reflection [39]. The example of obtained speckle pattern for the test specimens is presented in Fig. 3b.

The experimental setup is shown in Fig. 3. It consists of a high temperature furnace equipped with a glass window, a charged-coupled-device (CCD) camera (AVT Stingray F-504B), a band-pass filter (441 nm  $\pm$  10 nm), a blue LED light source and a stretching machine. The

furnace was employed to monitor the test temperature up to 600 °C. The detector of the camera was operated with a 2452 by 2056 pixels window size and 19  $\mu\text{m}$  pixel size. The camera was positioned on a tripod approximately 1 m from the specimen surface. It was fixed and kept perpendicular to the gauge part during the loading in order to collect reliable visible images. The camera frame rate was set at 4 frames per second to obtain enough sampled data while the integration time was set at 50 ms. The blue LED light source with a wavelength of 440 nm  $\pm$  20 nm was used to provide quasi-monochromatic illuminations.

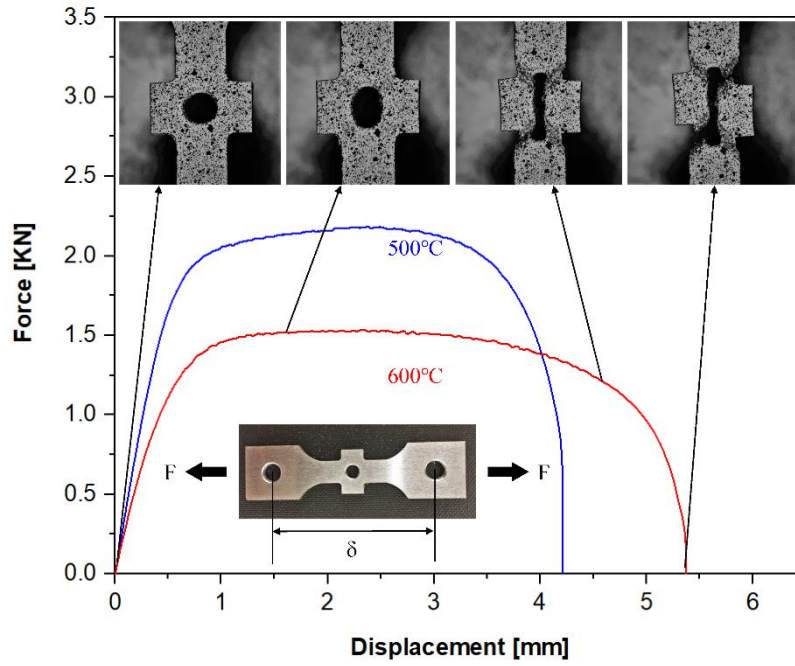
**Fig. 4.** The  $F$  (force) vs.  $\delta$  (displacement) curve of the test specimens under both 500 °C and 600 °C temperatures, along with four images captured by the digital camera at different stages of the test.

The tensile responses (force vs displacement) of the investigated specimens for both 500 °C and 600 °C test temperatures are given in Fig. 4. The results show a maximum reachable load increases for low temperatures (the ultimate force decreases by about 30% when going from 500 °C to 600 °C). Also, the tensile strength at 500 °C was higher than that at 600 °C, showing a noticeable temperature dependence effect. A macroscopic structural softening, highlighted by a displacement of necking lips, is also observed followed by a broad plateau. This ductile behavior is more pronounced for the high test temperature conditions, exhibiting the fracture displacements of  $\sim 4.2$  mm and  $\sim 5.4$  mm for 500 °C and 600 °C, respectively.

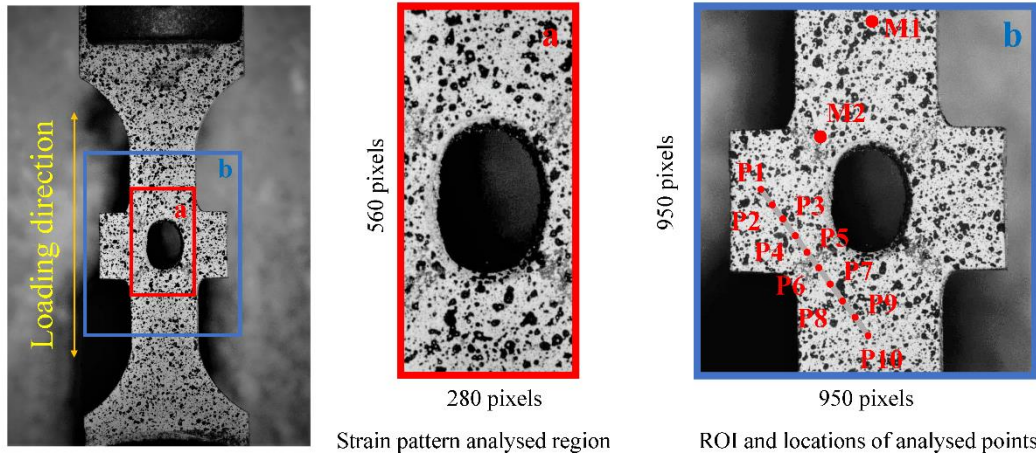
**Fig. 5.** Subfigures highlighting the region of interest, region for strain pattern analysis and locations of points of interest for the local kinematic analysis.

The kinematic assessments were analyzed in terms of the mean logarithmic strain components. The objective was to track the possible development of strain localization zones throughout the tensile test. The local mechanical response of the test specimens at the region of interest (ROI) was thus evaluated (see Fig.5). Dantec Dynamics software was used to post-process the visible images and assess the strain maps. Note that a preload of 100 N was performed prior to the tensile test in order to eliminate the superfluous load and strain resulted from the vacuum and thermal expansion. A subset of  $41 \times 41$  pixels and a grid step of 17 pixels were used to evaluate the strain tensor at each point of interest. Cubic B-spline interpolations with normalized squared differences criterion were chosen. An area corresponding to a hole of  $\varnothing 3.75$  mm at the ROI and symmetrical protrusions of 3mm on both extremities, with a size of 300000 pixels (Approximately 820 subsets per specimen), was chosen as the ROI (see Fig. 5).

Selected points  $\{M_k\}_{k=1,2}$  were considered for the time dependent strain analysis (see Fig. 5b). Figs. 9a and b depict the temporal evolution at both 500 °C and 600 °C test temperatures of the selected longitudinal and transverse strain components,  $\epsilon_{xx}$  and  $\epsilon_{yy}$ , respectively. It can be seen that at the beginning of the tests, all strain components had very small magnitudes. After 300s, the absolute strain values at  $M_2$  started to increase rapidly with time, while those at  $M_1$  seemed to slightly evolve throughout the test. Indeed, Fig. 9a shows that the transverse strain curves at both temperatures were almost identical. Fig. 9b shows that the orders of magnitude of the longitudinal component for  $M_1$  were smaller compared to those of  $M_2$ ,

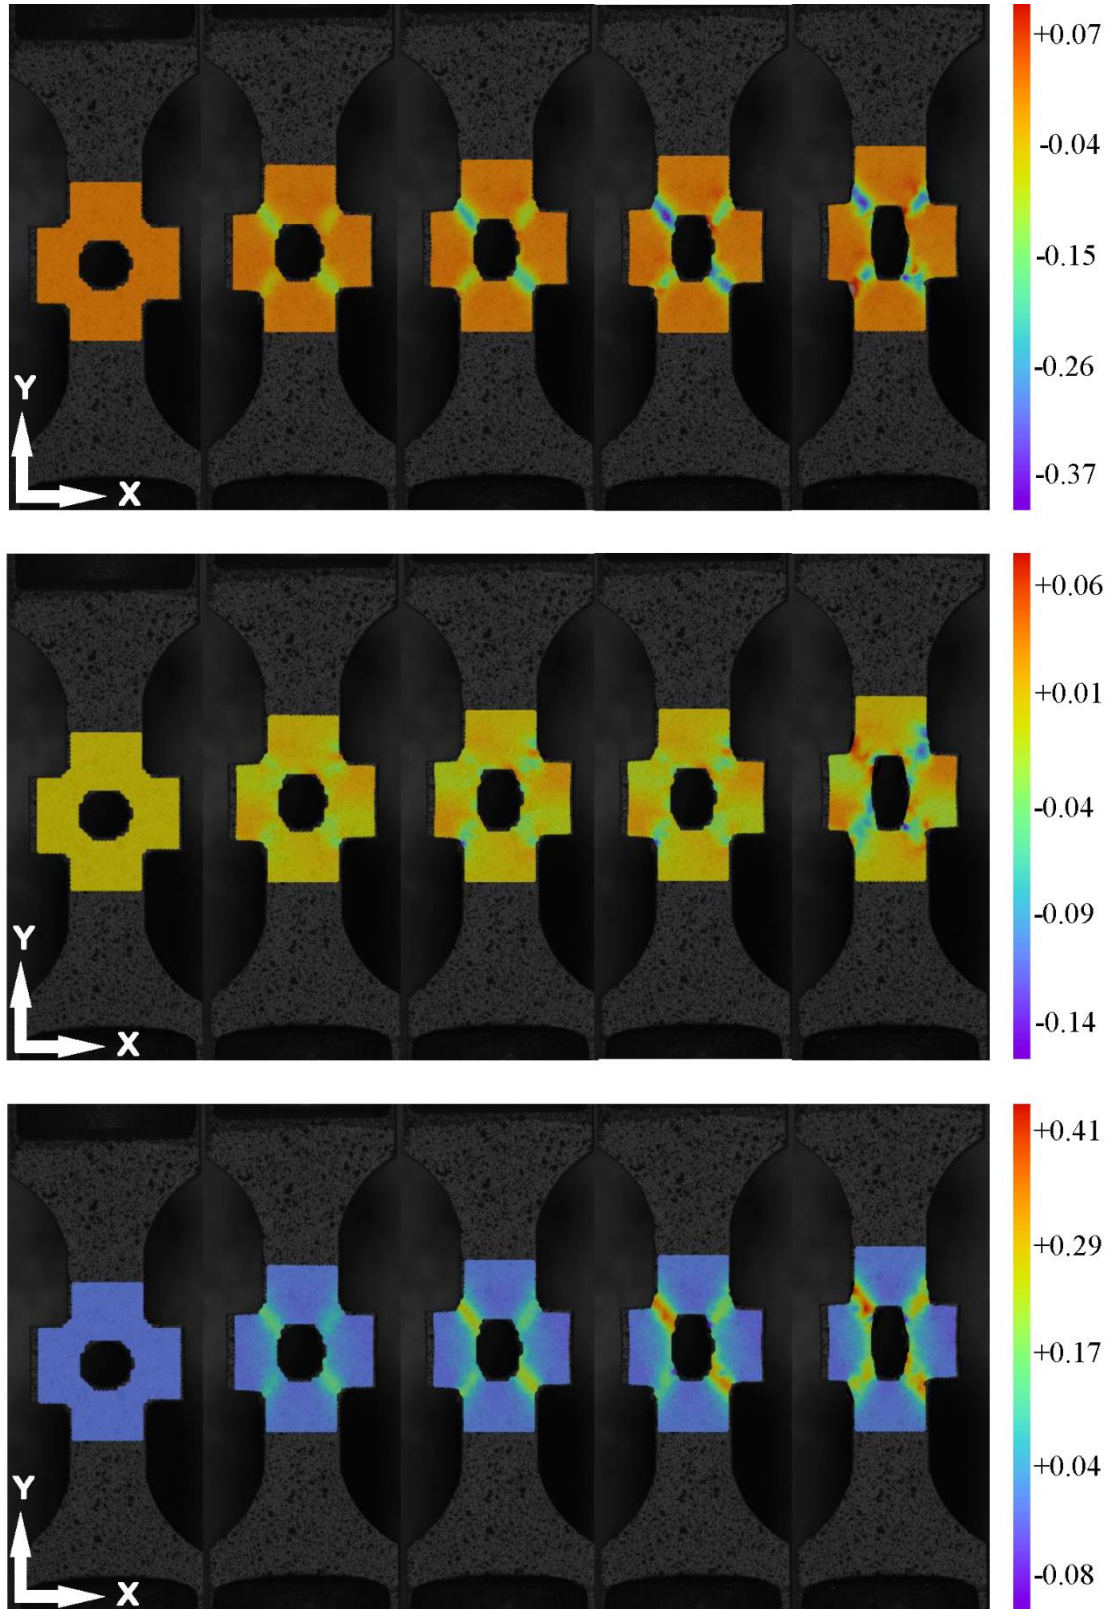
**Fig. 7.** 2D maps of the transverse strain,  $\epsilon_{xx}$  (top), shear strain,  $\epsilon_{xy}$  (middle), and longitudinal strain,  $\epsilon_{yy}$  (bottom) at: the very beginning of the test ( $\tau_1=0s$ ), intermediate times ( $\tau_2=810s$ ,  $\tau_3=1060s$  and  $\tau_4=1310s$ ) and the last stage before the macroscopic fracture ( $\tau_5=1709s$ ). These results were extracted from measurements performed under the 600 °C test temperature.

Fig. 6 and Fig. 7 show the full-field strain maps for the investigated FV566 tensile specimens at both 500 °C and 600 °C test temperatures, selected at different specimen life stages ( $\tau_1$ ,  $\tau_2$ ,  $\tau_3$ ,  $\tau_4$ ,  $\tau_5$ ). The spatial resolution was set at 20  $\mu\text{m}$  per pixel. The results show a precocious and gradual development of strain localization zones. These zones were clearly visible for all the strain components (longitudinal,  $\epsilon_{yy}$ , transverse,  $\epsilon_{xx}$ , and shear,  $\epsilon_{xy}$ , components). For 500 °C condition, at the very beginning of the loading, the spatial heterogeneities were less visible as indicated at  $\tau_1$ . These heterogeneities started to intensify at the following life stages till the macroscopic failure (see Fig. 6). It is worth noting that the painting near the strain concentration zones (where the hole is located) eroded due to the high temperature and large displacement exhibited by the test specimens. This results in inaccurate strain estimate at the last stages before the macroscopic fracture. Note that most of the observed hotspots were located around the specimen hole at the ROI due to the geometry singularity. Nevertheless, the strain field contours show that the strain concentrations were not perfectly symmetric. For the transverse strain, the top-left and the bottom-right sides of the hole were slightly intensive than these on the top-right and the bottom-left sides. However, at the instant  $\tau_5$ , some of strain localization zones were significantly less intensive than others. This is probably caused by inhomogeneous features of the investigated specimen and/or the inaccuracy of the measurements. The spatial distributions of the longitudinal strain component on the top-left side of the hole were more intensive than these on the bottom-right side. From a statistical point of view, the absolute values of both the minimum and maximum longitudinal strain were almost the same at the

very beginning of the loading, highlighting the homogeneous character of the investigated gauge part. However, with the increase of the load, the absolute value of the minimum longitudinal strain was about thousand-fold lower than the maximum longitudinal strain. For the shear component, the spatial strain concentrations were mostly located on the top-left and top-right sides of the hole. As expected, the localization patterns seemed to progress preferably according to 45° angle (with a shape of “X” letter). At 600 °C (see Fig. 7), the strain localizations for the transverse and longitudinal components showed similar patterns as those obtained for the 500 °C condition while the higher values of the shear strain were appeared at top-right and bottom-left side with a shape of “/” from where sample fractured finally.

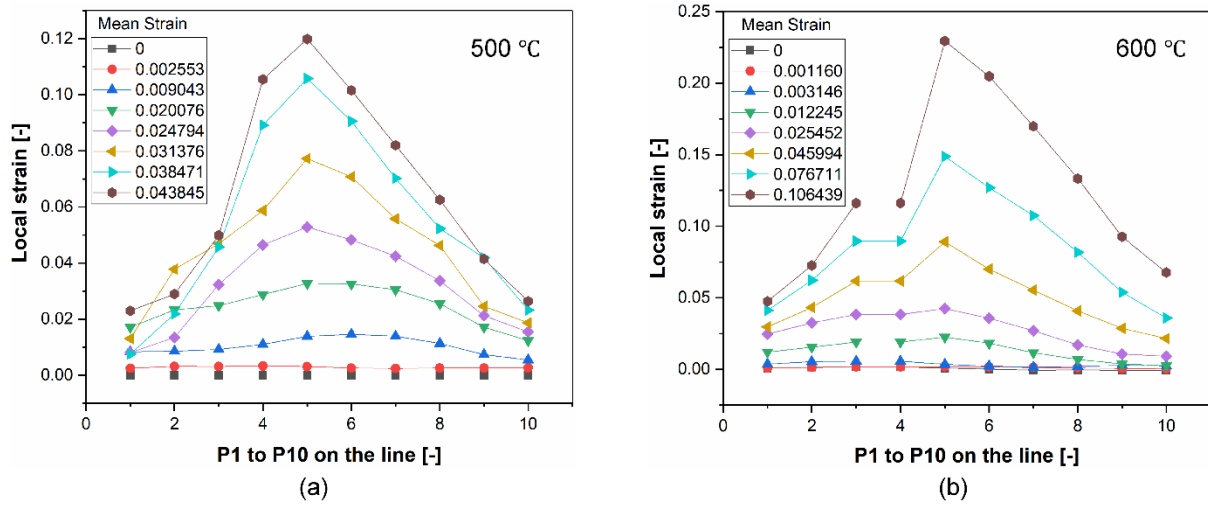
**Fig. 8.** Spatial-temporal distributions of the longitudinal strain component extracted at the selected points  $\{P_i\}_{i=1,\dots,10}$ .

Fig. 8 depicts the local spatial profiles of the longitudinal strain component, selected at different life stages (corresponding to different average strain values on the total line) and different location points  $\{P_i\}_{i=1,\dots,10}$  (see Fig. 5b), from which a strain concentration zone is activated. At the very beginning of the loading, the strain distribution on the selected points was uniform. Then, strain concentrations started to appear for both temperatures when the local maximum strain magnitude reached 0.01. As expected, the local strain magnitude for both P5 and P6 was higher compared to that of the other location points. This is due to the fact that these points (where the peak of strain is occurred) are located close to the regions where the strain heterogeneities are more pronounced. The necking is especially driven by these high strain concentrations as it is highlighted in Fig. 4.

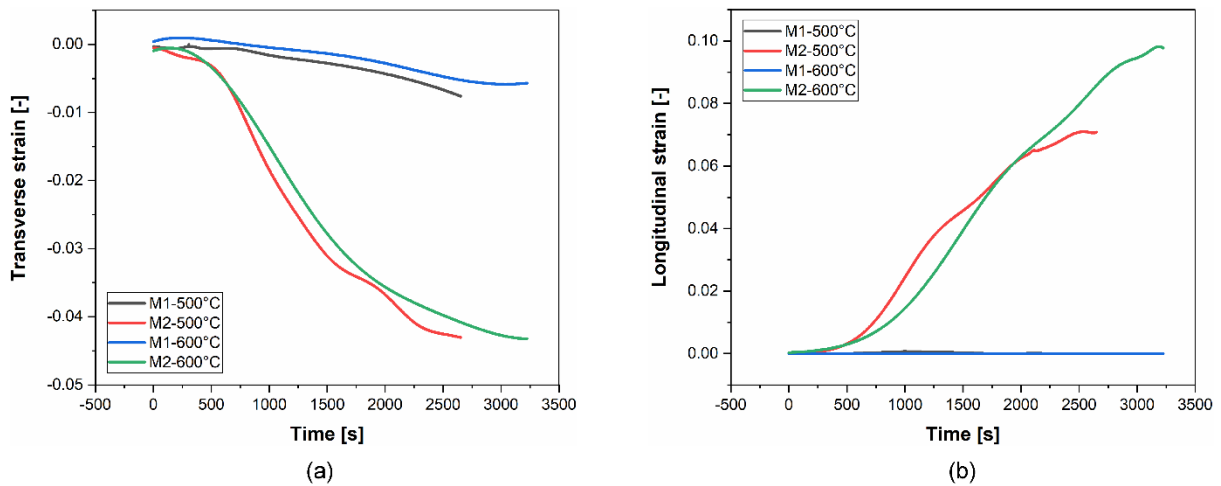
**Fig. 9.** (a) True transverse strain curves, and (b) true longitudinal strain curves with respect to the test time at M<sub>1</sub> and M<sub>2</sub>.

which were almost identical to the true principle strains under both test temperatures. This allows to suggest that the longitudinal strain component significantly contributed to the ductile failure of the specimen. The maximum longitudinal strain value at 600 °C was around 0.1, while this value reached 0.07 at 500 °C, highlighting the effect of temperature on the ductile damage evolution of the FV566 steel under investigation.

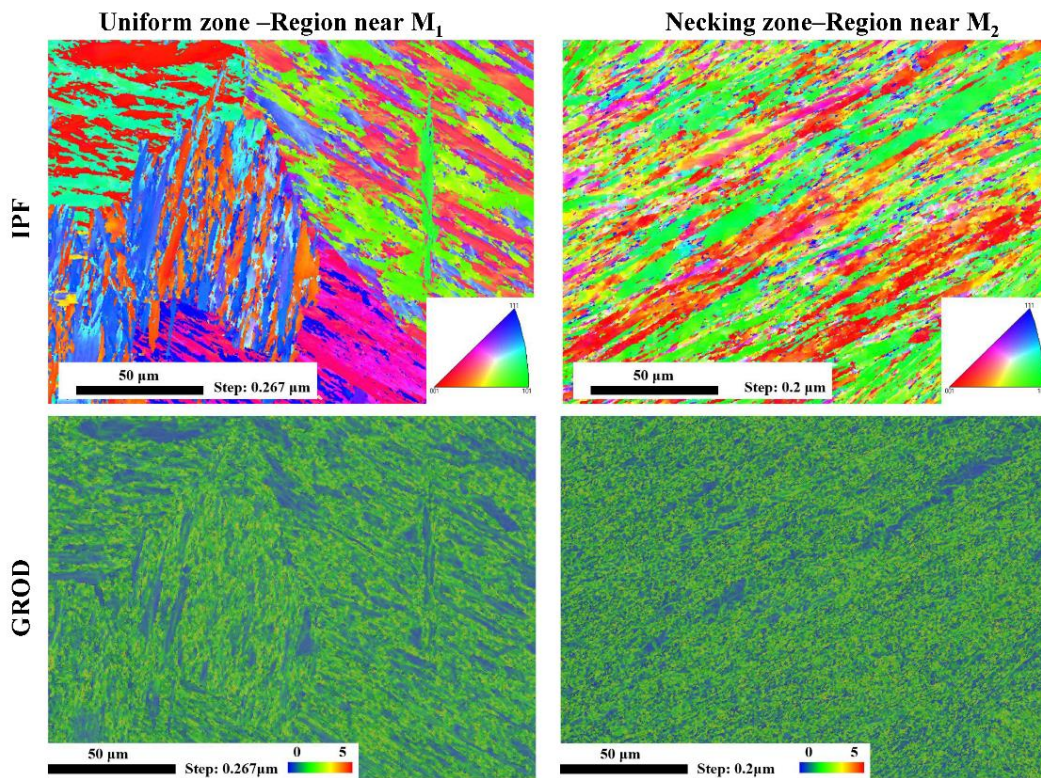
**Fig. 10.** EBSD results of the uniform  $M_1$  (left) and necked  $M_2$  (right) zones extracted from 600 °C test fractured sample.

Two areas from the ruptured surface, close to the DIC time dependent analysis regions (i.e. M<sub>1</sub> and M<sub>2</sub>) were further investigated to highlight the microstructure evolution. Extensive EBSD examination has been conducted and the results are presented in Fig. 10. The inverse pole figure (IPF) images show that the pre-existing martensitic microstructure was significantly distorted along the principal loading direction, accompanied with the formation of a finer martensitic substructure. In addition, the presence of sub-block boundaries at 5 to 6 degrees in the as-received material as well as the variation of sub-block boundaries and the frequency of the low angles boundaries are highlighted in Fig. 11. The findings suggest that the dislocation slip could be the dominant deformation mechanism for the material, since dislocation slip activated by the high temperature and tensile loading may generate a large number of dislocation accumulations, which can contribute to the formation of the low angles boundaries [40]. As is well known, dislocation movement in the crystal is normally arrested by various obstacles (e.g. solid solution atom, forest dislocation, grain boundaries, etc.) during

the tensile deformation process, however the mobile dislocation can slip through the obstacles due to the thermal activation and the applied stress. In the present work, the slip system of the crystal in the FV566 steel was activated under the high temperature conditions, thereby a part of the crystal sliding was relative to the other part, which finally lead to plastic deformation.

Additionally, the grain reference orientation deviation (GROD) parameter was introduced to compare the local crystal deformation in two separate zones of the fractured specimens. It is proven to be linearly related to the nominal plastic strain under both tension and creep condition [41]. The higher value of GROD extracted from the necked zone implies that the plastic deformation in the necked area is larger than that in the uniform zone away from the fracture area, which is consistent with the aforementioned DIC measurement results. As is observed in Fig. 6 and Fig. 7, significant strain concentration was observed around the necked area due to the geometry singularity of the tested specimens. The strain concentrations in the necked area result in the deformation heterogeneity and microstructural rearrangements of the FV566 specimen at high temperature tensile conditions.

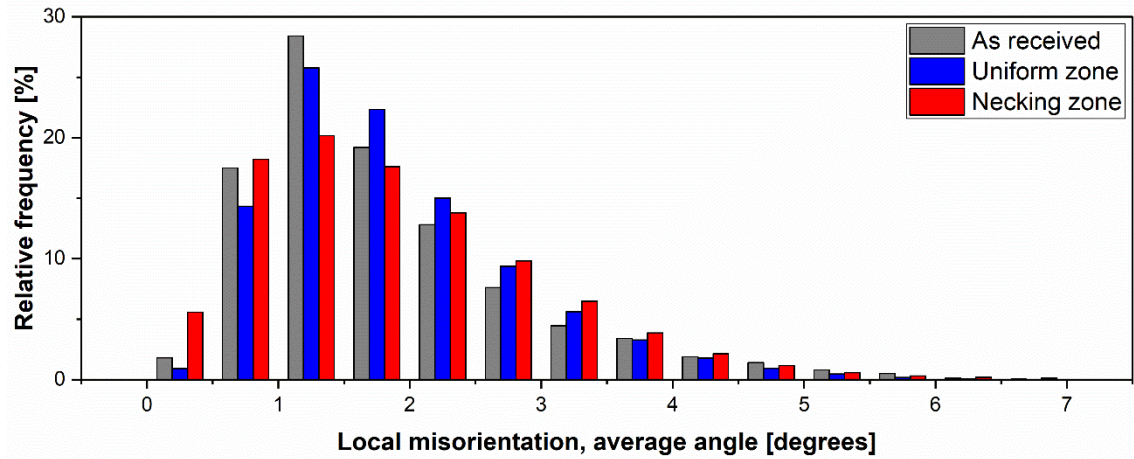
**Fig. 11.** The distributions of the misorientation angles across the lath and sub-block boundaries for the as-received material and uniform/necked zones of fractured sample.

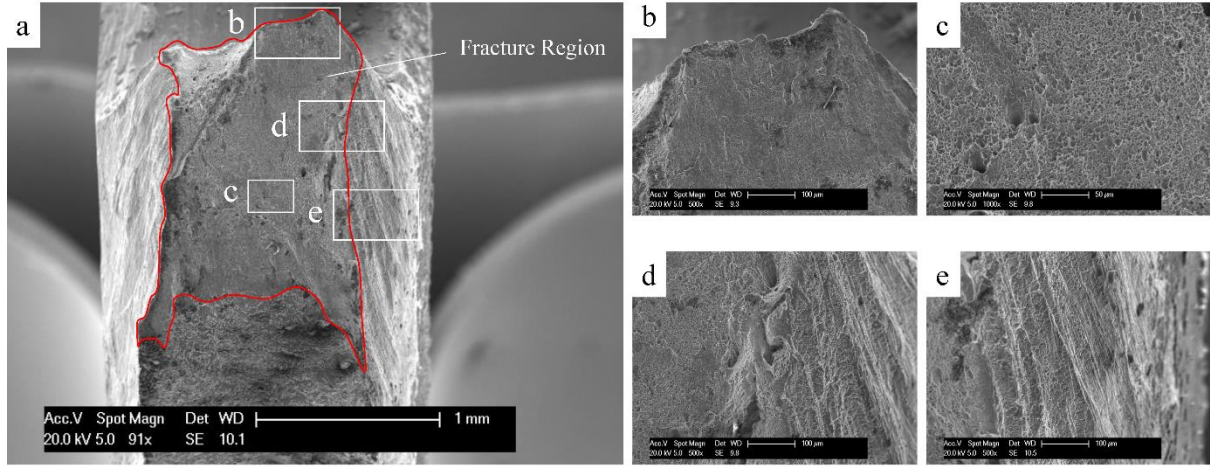
**Fig. 12.** Scanning electron micrographs of fractured specimens tested at 500 °C showing (a) the overall fracture morphology and (b-e) zoomed details of the local fracture features.

In Fig. 12a and Fig. 13a, a visible necked area as well as a rough surface can be observed on SEM fractography images of both fractured samples subjected to 500°C and 600°C test temperatures, highlighting a large amount of plastic deformation. Zoomed details of other subset areas (namely b, c, d and e in Fig. 12a and Fig.13a) are exhibited in order to deeply investigate the fracture characteristics. A typical dimpled zone and some equiaxed shear dimples surrounded by a shear lip show the typical ductile fracture behavior of the fractured samples at high temperature conditions. The rough surface caused by the large amount of plastic slip during tensile deformation is observable on the plastic deformation path and the micrographs near the shear lip of the sample are also illustrated. Different from the fracture surface of the sample tested at 500 °C, 600 °C tested sample involves a more distinct necking lip on the fracture surface as shown in Fig .13a. Highly correlated to the displacement of ~ 4.2 mm and ~ 5.4 mm for both 500 °C and 600 °C, respectively, see Fig. 4, this fractography observation proves, from micro scale aspect, that the ductile behavior is more pronounced for the specimen tested at higher temperature.

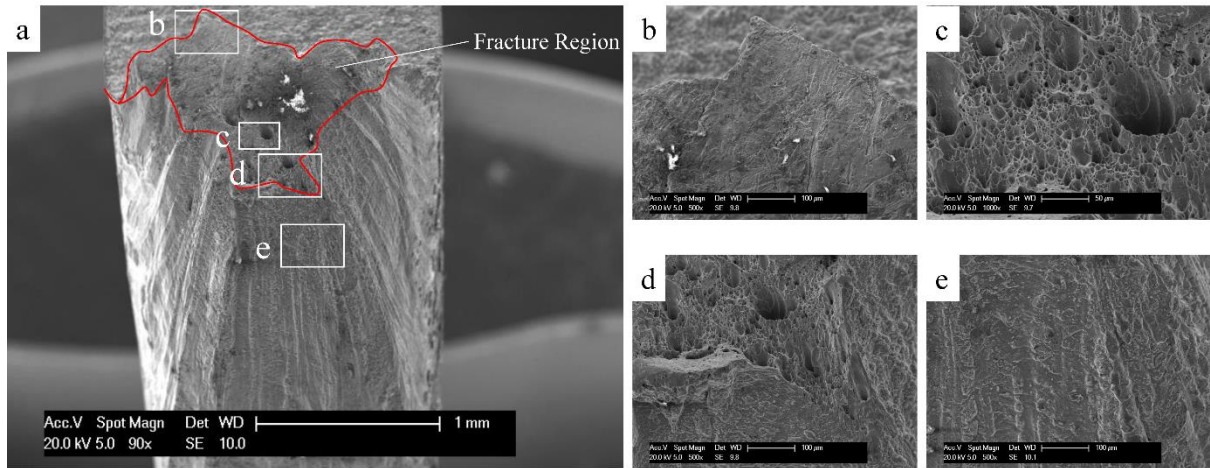
**Fig. 13.** Scanning electron micrographs of fractured specimens tested at 600 °C showing (a) the overall fracture morphology and (b-e) zoomed details of the local fracture features.

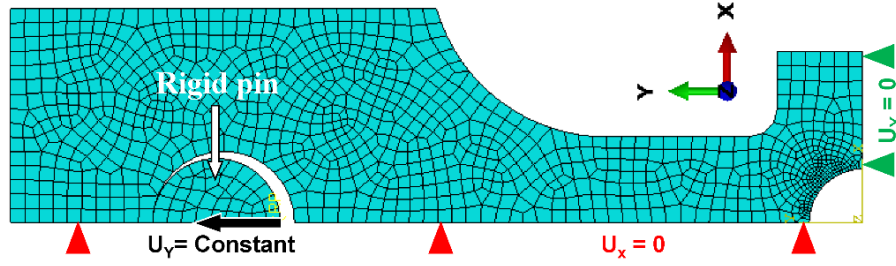
**Fig. 14.** FE model showing the mesh properties and boundary conditions ( $U_y = 1.8\text{mm}$  for the  $500^\circ\text{C}$  test and  $U_y = 2\text{mm}$  for the  $600^\circ\text{C}$  test) used for comparison with the experimental DIC results. Two symmetry conditions were considered with a sample quarter body modelled.

A quarter of the specimen was considered for the FE analyses as indicated in Fig. 14. The loading pins were modelled by a rigid body while a friction free contact was considered between the pins and the specimen holes. The contact between the pin and the specimen was assumed as standard surface to surface interaction where the outer surface of pin was the master surface and the inner surface of the specimen hole was the slave one. A constant displacement loading was applied in the Y-direction at the pin reference point in order to simulate a similar experimental protocol, for which the magnitude was set at 1.8 mm and 2 mm for both the 500 °C and 600 °C test temperatures, respectively. The 3D FE model mesh consisted of 4979 C3D8R elements with 8-noded linear brick, reduced integration, and hourglass controlled.

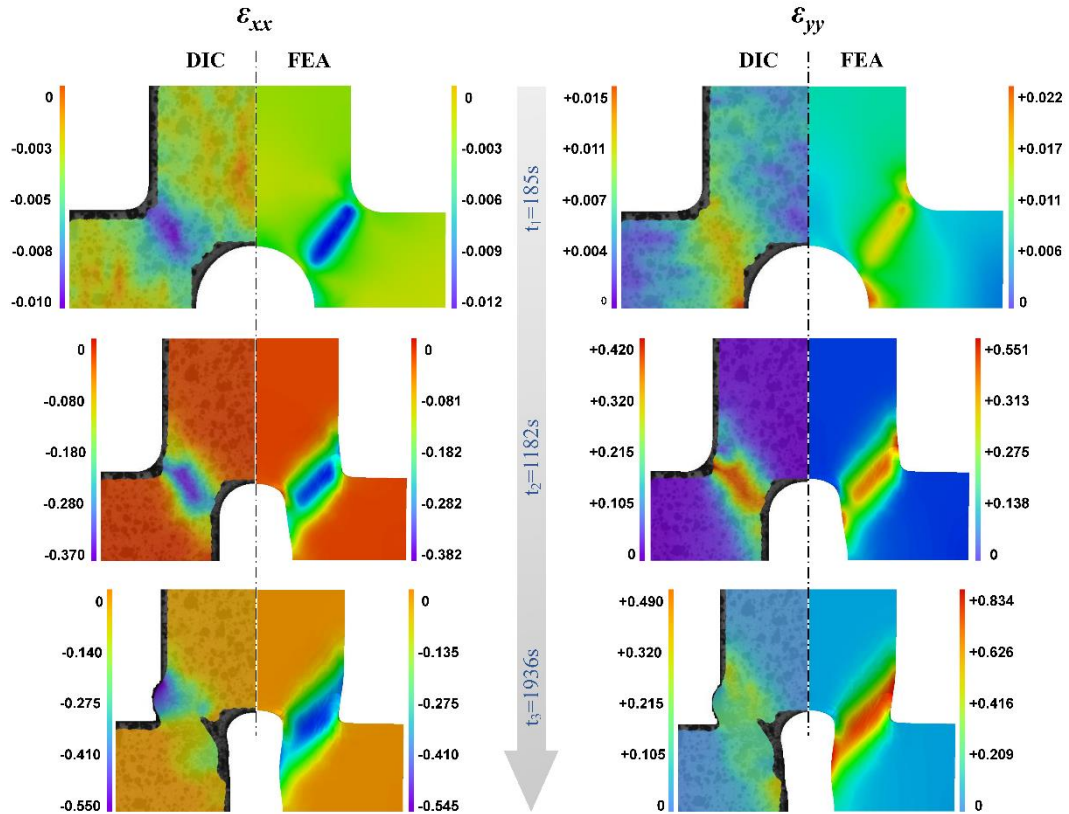
**Fig. 15.** Comparison of the DIC (left) and numerical (right) strain contours at 500°C test temperature.

Transverse and longitudinal strain patterns of the ROI obtained by DIC measurement and FE analysis are presented and compared in Fig. 15 and Fig. 16. For both  $500^\circ\text{C}$  and  $600^\circ\text{C}$  investigated temperatures, the spatial-temporal strain distributions and magnitudes were found to be in good agreement, revealing that DIC data trends were consistent with the FE simulation results. The strain localization zones for both experimental and FE data were almost identical even on an atypical strain concentrations area. However, an important difference in the strain magnitude was reported for the longitudinal strain component at the last stages of the loading. This difference may be attributed to the error accumulation of the loading rig, inaccuracy of the DIC measurements, inhomogeneous character of the investigated specimens and/or limitations of current FE model. Fig. 17 shows a comparison of the longitudinal strain plots for both DIC and FE analysis on positions extracted from the same line as introduced in Fig. 5b. The FE simulation results show strain magnitudes that were mostly higher than those of the DIC measurements especially for the high strain locations. Although the magnitude differences are not ignorable, it can be inferred that this methodology provides a good quantitative validation of the DIC measurements at high temperature conditions.

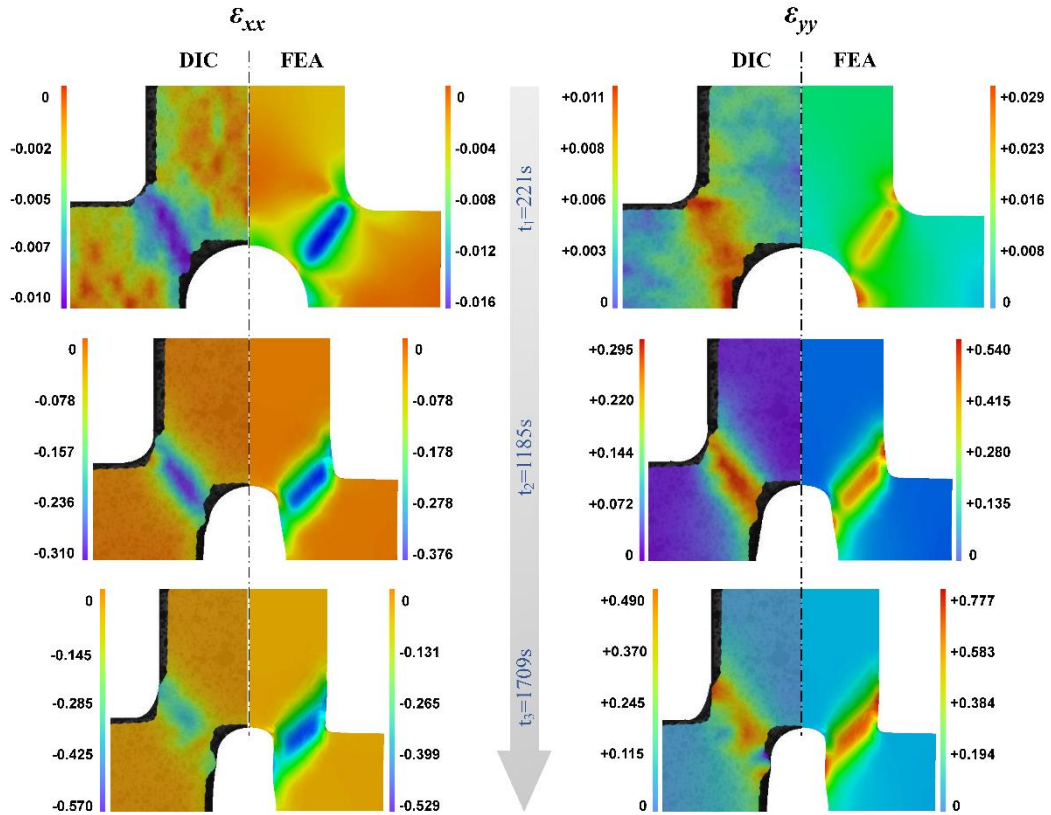
**Fig. 16.** Comparison of the DIC (left) and numerical (right) strain contours at 600°C test temperature.

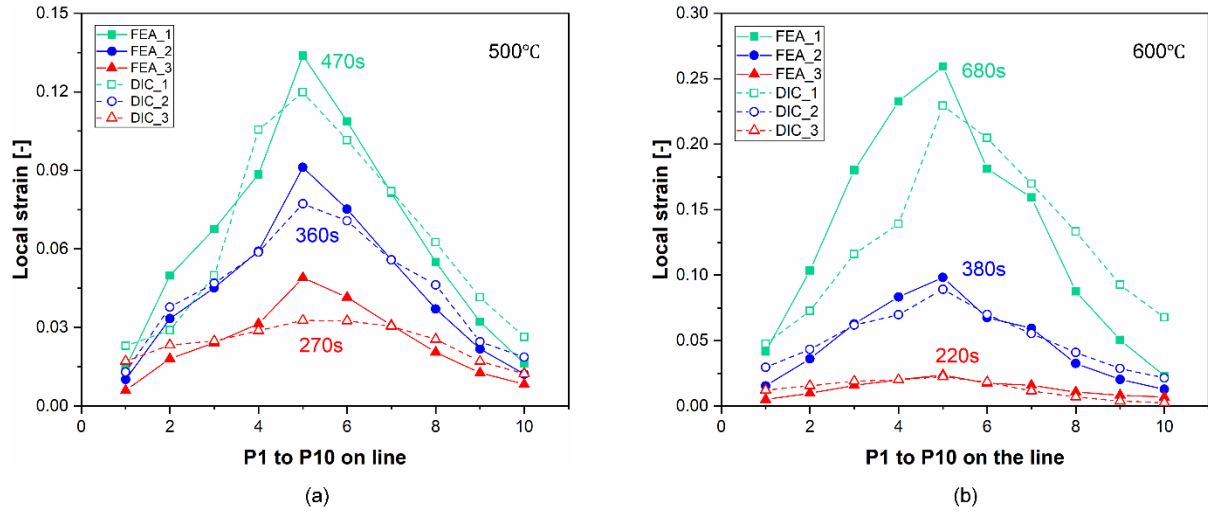
Fig. 17. DIC and FEA longitudinal strain profiles on positions extracted from the same line P1 to P10 (see Fig. 5b).
