Abir ABDESSALEM, Sahbi TAMBOURA, Hachmi Ben DALY, Abbas TCHARKHTCHI, Joseph FITOUSSI, Fodil MERAGHNI - Microstructure investigation of hydrothermal damage of aged SMC composites using Micro-computed tomography and scanning electron microscopy - Engineering Failure Analysis - Vol. 121, p.105177 - 2021

Microstructure investigation of hydrothermal damage of aged SMC composites using Micro-computed tomography and scanning electron microscopy

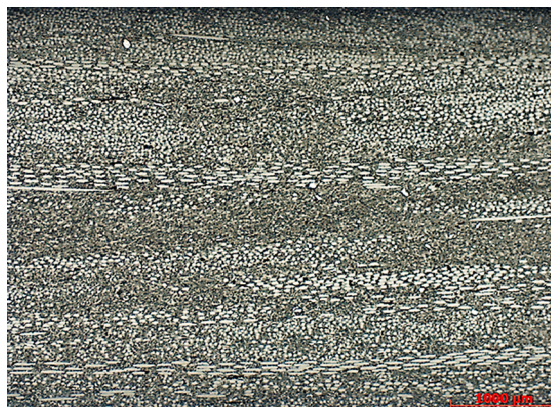
Fig. 3. Microscopic observation of the non-aged sample surface.

From microscopic images we found, for the non-aged material, porosities $7\% \pm 0.4\%$ and average diameter of $6.5 \mu m$ to $9 \mu m$.

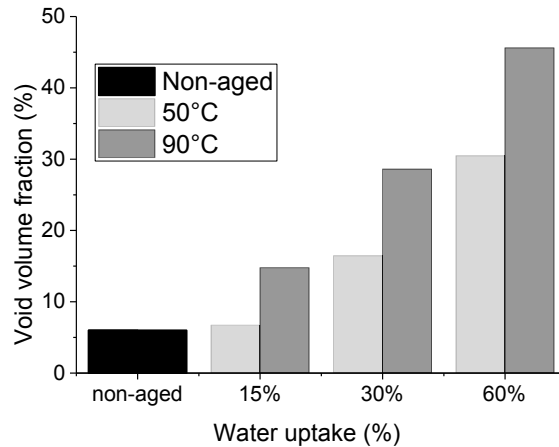
Fig. 10. Evolution of the void volume fraction of non aged sample and 50 °C and 90 °C aged samples versus the water uptake level.

In Fig. 10, quantitative data of the increase in voids during the hygroscopic ageing is shown.

It was supposed that the initial void fraction corresponds to the defects present in the material before conditioning. The increase in voids was attributed to the development of damage. The calculated increase is prone to error which could be a result of small variations in image quality, segmentation and examined volume.
