Abir ABDESSALEM, Sahbi TAMBOURA, Joseph FITOUSSI, Hachmi Ben DALY, Abbas TCHARKHTCHI, Fodil MERAGHNI - Microstructure investigation of hydrothermal damage of aged SMC composites using Micro-computed tomography and scanning electron microscopy - Engineering Failure Analysis - Vol. 121, p.1-14 - 2021

# Microstructure investigation of hydrothermal damage of aged SMC composites using Micro-computed tomography and scanning electron microscopy

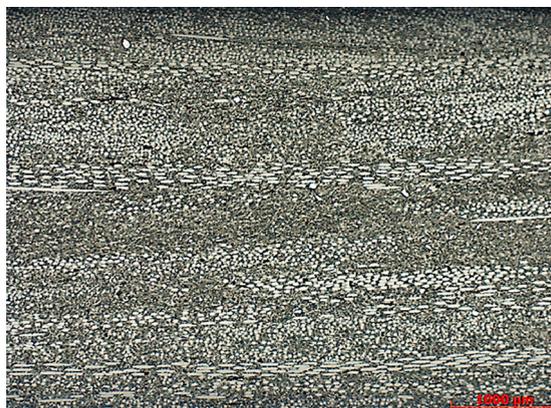
Fig. 3. Microscopic observation of the non-aged sample surface.

From microscopic images we found, for the non-aged material, porosities  $7\% \pm 0.4\%$  and average diameter of  $6.5 \mu m$  to  $9 \mu m$ .
