Abir ABDESSALEM, Sahbi TAMBOURA, Hachmi Ben DALY, Abbas TCHARKHTCHI, Joseph FITOUSSI, Fodil MERAGHNI - Microstructure investigation of hydrothermal damage of aged SMC composites using Micro-computed tomography and scanning electron microscopy - Engineering Failure Analysis - Vol. 121, p.1-14 - 2021

Microstructure investigation of hydrothermal damage of aged SMC composites using Micro-computed tomography and scanning electron microscopy

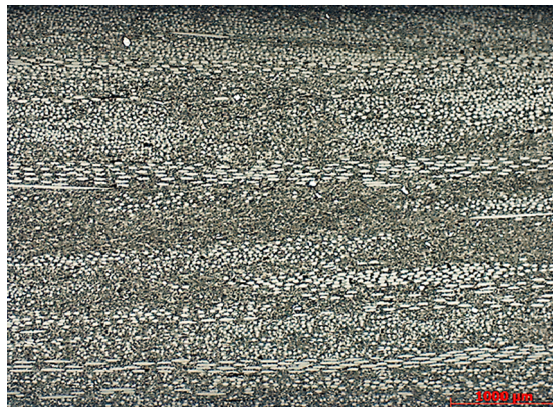
Fig. 3. Microscopic observation of the non-aged sample surface.

From microscopic images we found, for the non-aged material, porosities $7\% \pm 0.4\%$ and average diameter of $6.5 \mu m$ to $9 \mu m$.
